## **PRELIMINARY ECOLOGICAL APPRAISAL (BATS) AT 66 CHAPEL HILL TILEHURST**

**Prepared for:  
Mr R Longmate  
28 Cockney Hill  
Tilehurst  
Reading  
RG30 4EU**

**1<sup>st</sup> April 2019**

**Ref: SPH/PEA-01/26.03**

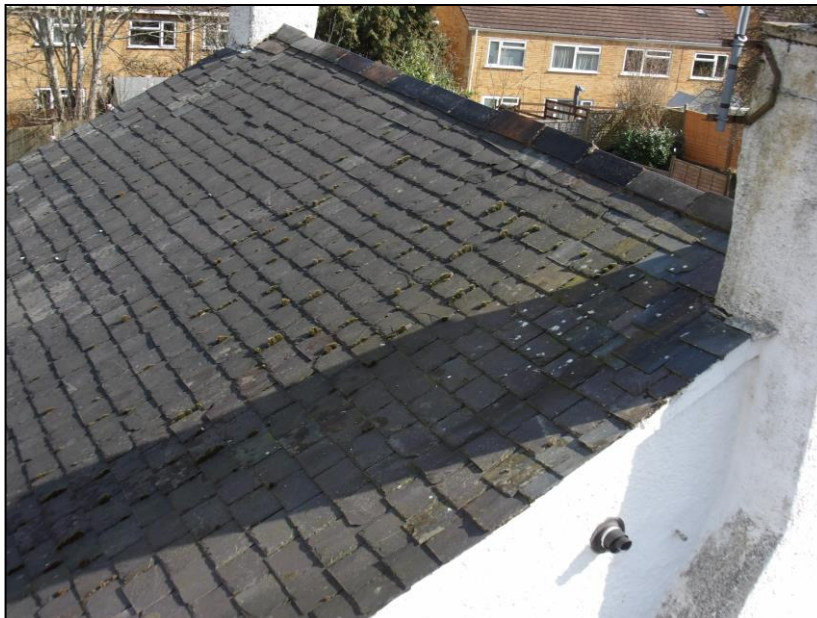
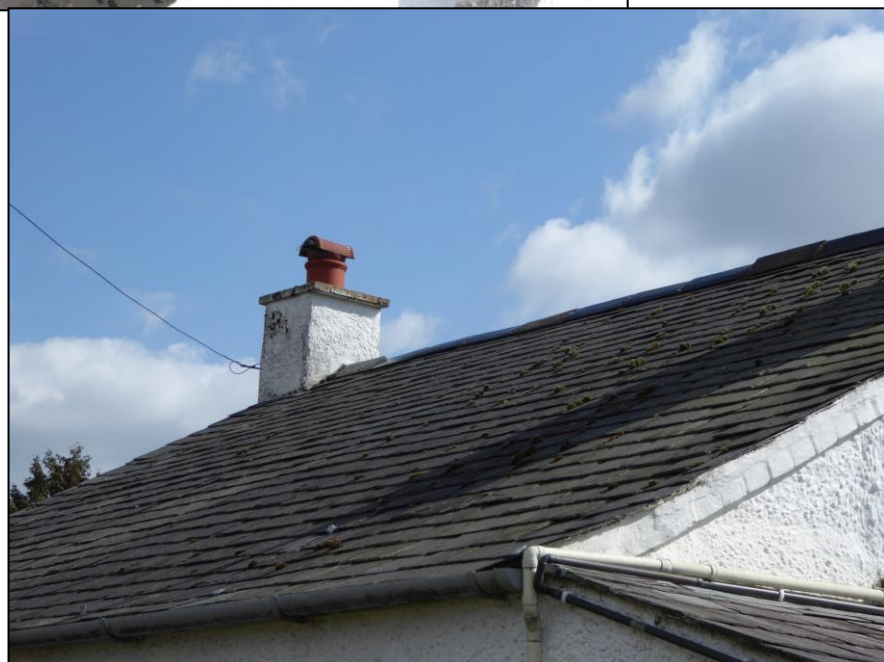
Figure 4. Main roof covering, 66 Chapel Hill, Tilehurst. 26.03.19

The property is a detached, brick-built and rendered house with no cavity walls. It is in a fair condition internally and externally. The pitched roof is covered in close fitting slate tiles, none of which are missing or broken, see Figure 4 below. The roof tiles are well sealed to the chimney breasts, see Figure 5 on page 9. The verges are well sealed, see Figure 6 on page 9, and the fascias/soffits have no gaps, see Figure 7 on page 10. The windows are well sealed with no gaps that could be exploited by bat species.

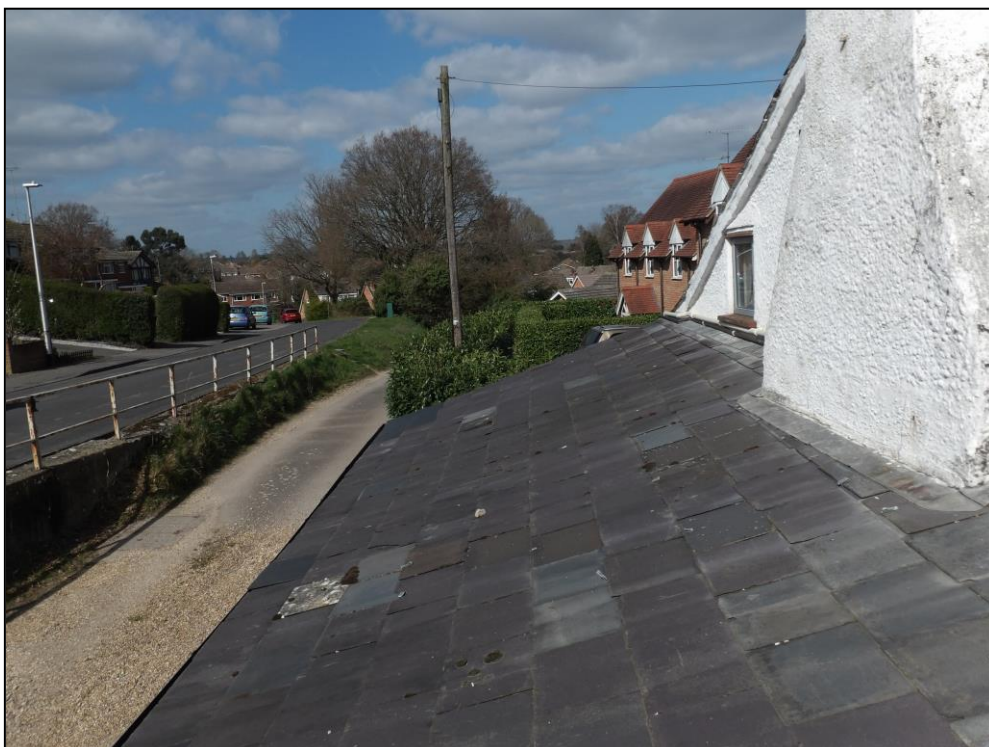
Figure 8. West side element with close fitting slate tiles and lead flashing. 66 Chapel Hill, Tilehurst. 26.03.19

On the west side of the property is a large single storey element that is covered in close fitting slate tiles and the lead flashing is fully sealed (see Figure 8 below) and, on the east side are two further small lean to extensions, both of which are covered in corrugated roofing, all of which is close fitting to the wall, see examples at Figure 9 on page 11.

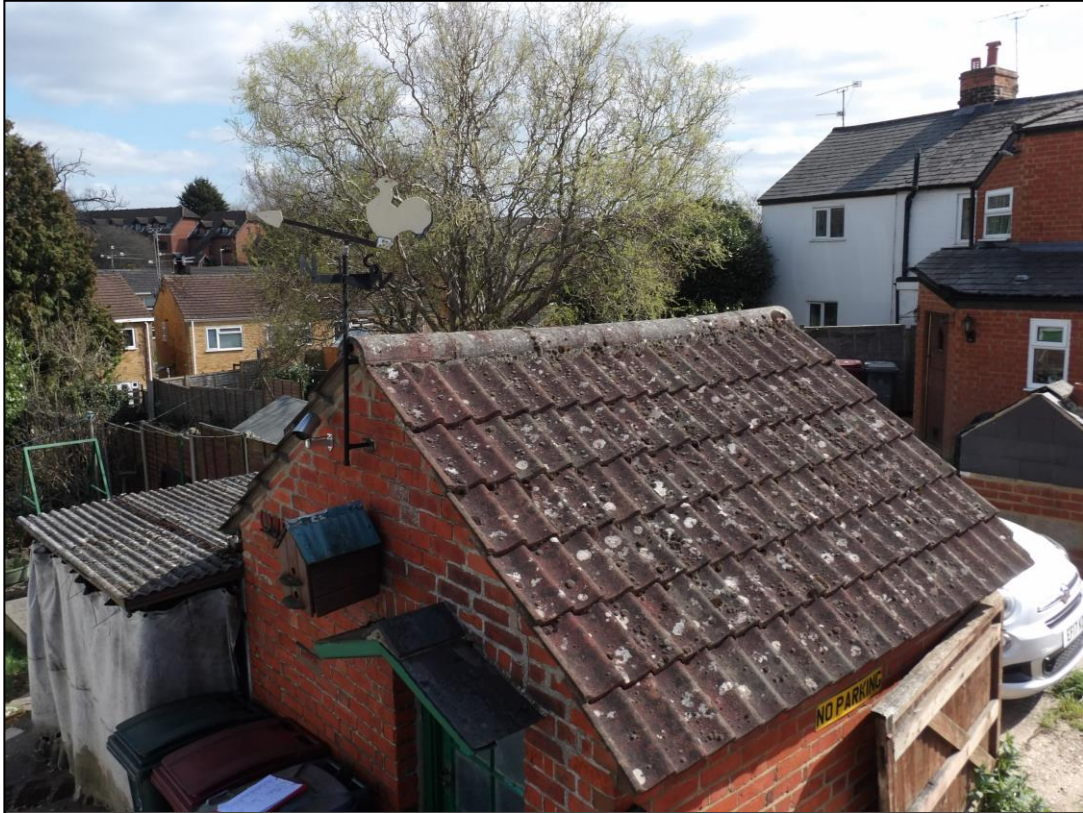
Figure 10. Brick built outhouse. 66 Chapel Hill, Tilehurst. 26.03.19

In the garden is a detached, brick build single storey outbuilding with attached lean to, see Figure 10 on page 12. The outbuilding roof is covered in close fitting composite tiles, the ridge tiles are fully sealed, see Figure 11 on page 12 and the verges are sealed with no gaps that could be exploited by bat species, see Figure 12 on page 13. The lean to is constructed of corrugated panels with a tarpaulin curtain at the front, see Figure 10 and Figure 13 on page 13. Due to the light levels and open nature, the lean to offers no bat roosting potential so a detailed internal inspection was not carried out.

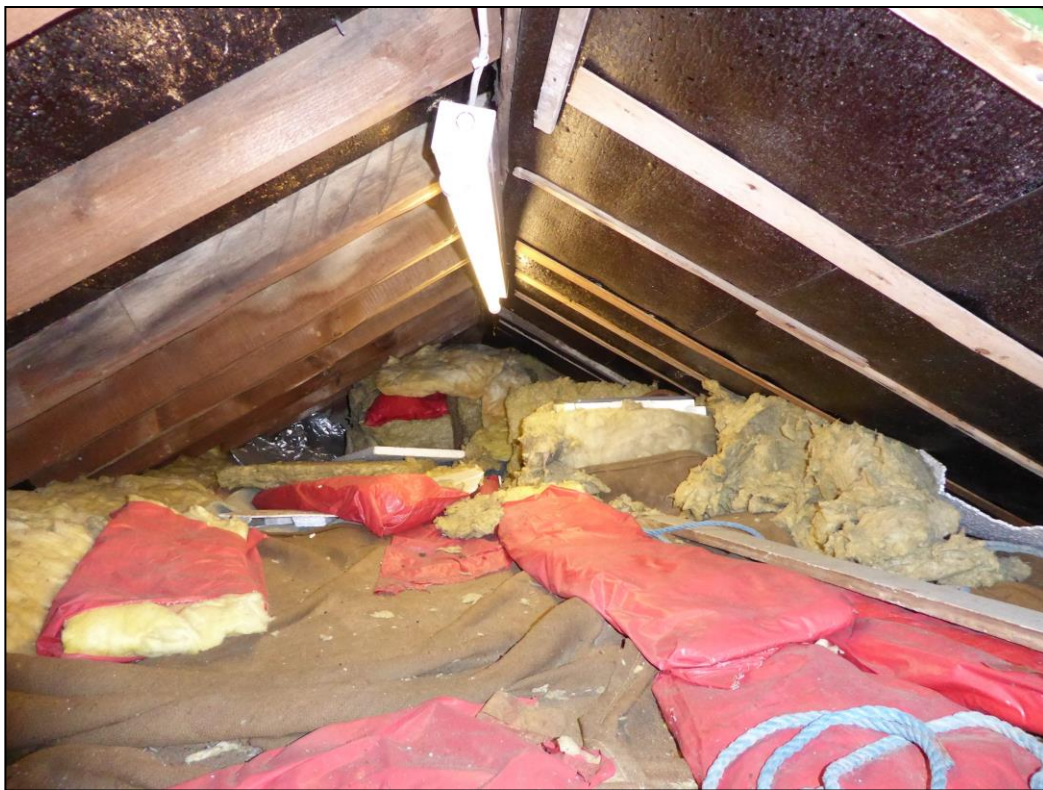
Figure 14. Example of loft space, 66 Chapel Hill, Tilehurst. 26.03.19

The loft over the property was accessed from the first floor, via a ladder. The loft was illuminated and insulated but not boarded, see Figure 14 below. Whilst there was a low ceiling to ridge height, this did not hinder the inspection.

No bats or evidence of bats was recorded during the internal inspection of the property.

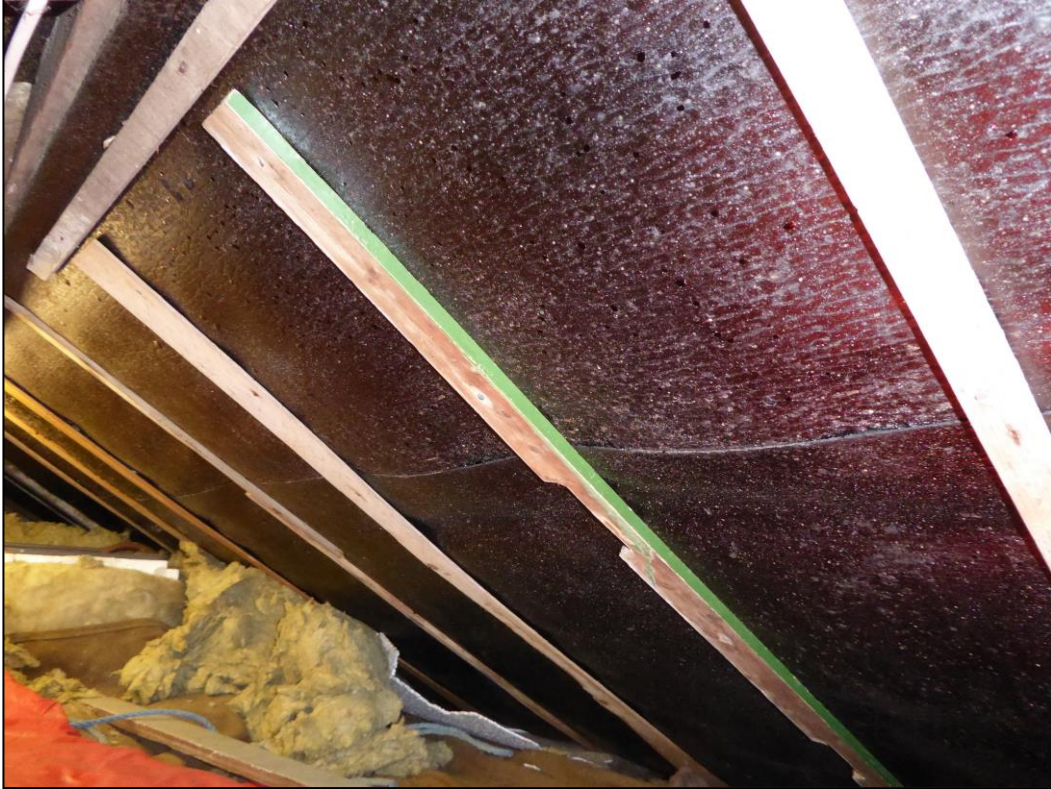
Figure 15. Example of bitumen lining, loft at 66 Chapel Hill, Tilehurst. 26.03.19

The roof was bitumen lined and is in good condition, see Figure 15 on page 15. There was no light spilling into the loft when the loft light and torch were turned off.

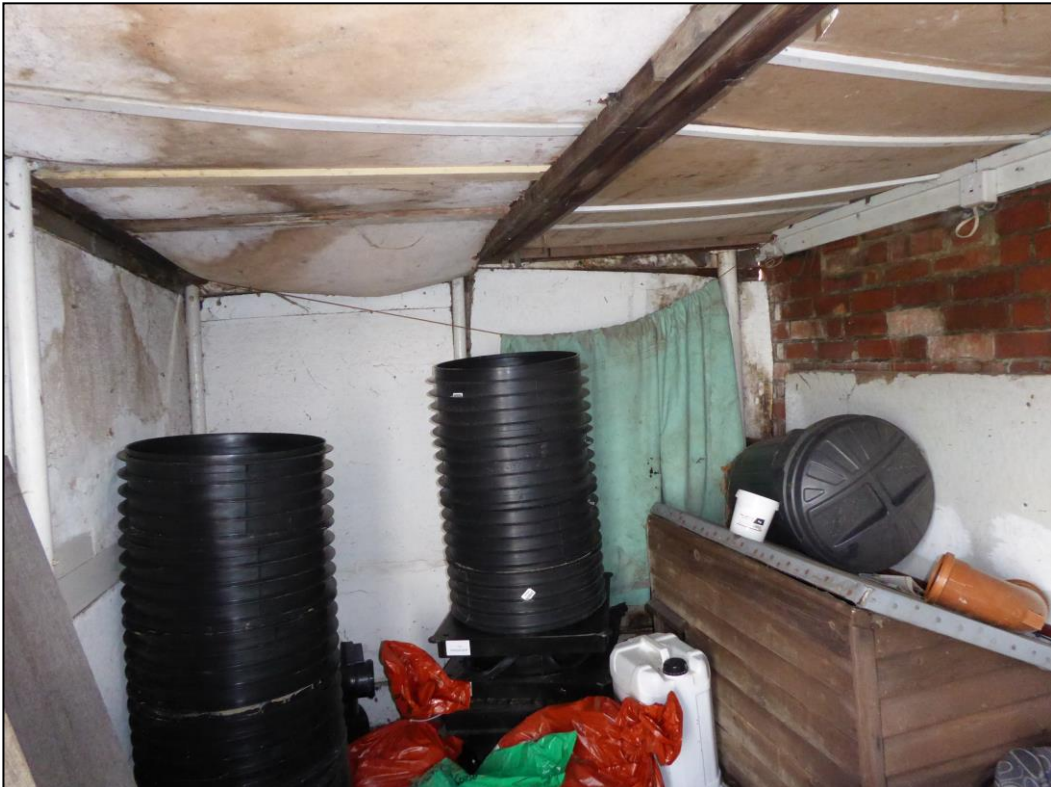
Figure 16. Internal view of outbuilding at 66 Chapel Hill, Tilehurst. 26.03.19

The outbuilding is used for storage, see Figure 16 on page 15. Only part of the building had a roof void. The void was not insulated or boarded and is used for personal storage, but this did not hinder the inspection, see Figure 17 on page 16. The roof was bitumen lined and is in good condition, see Figure 17 on page 16. No bats or evidence of bats was recorded during the internal inspection of the outbuilding.
