## Geoenvironmental Investigation

Prospect Street

Reading

Report Ref: R0271/19

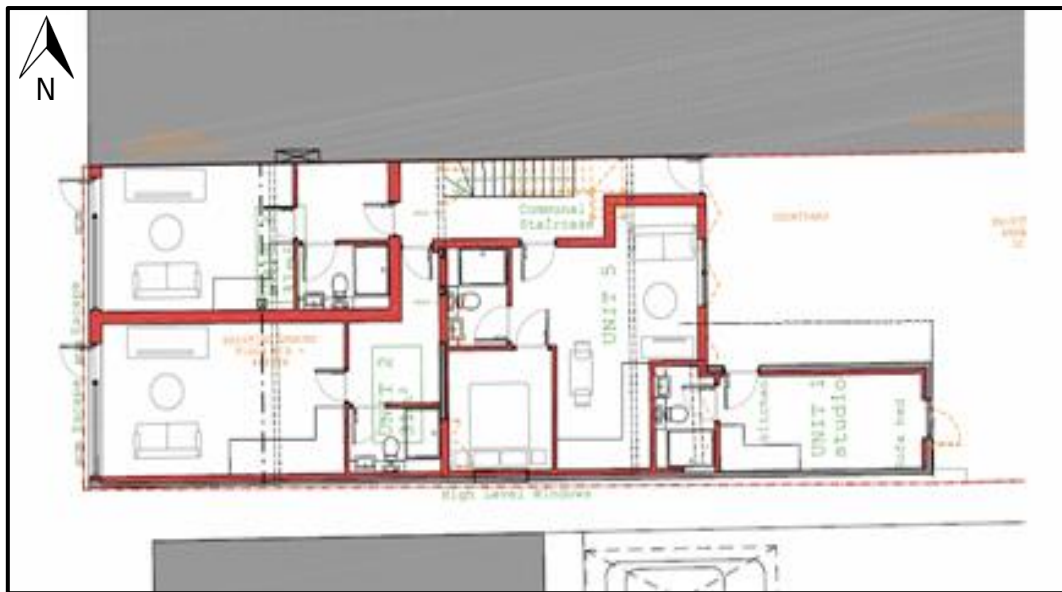
Figure 2: Proposed Site Layout Plan

It is understood that the current use of the premises is Light industrial (Class B1(c)) and will be converted to 5 residential dwellings (Class C3). To enable this conversion, it is understood that the structure of the current building will be retained but the internal layout will be altered to accommodate for the new residential use.

A proposed site layout plan is provided within Figure 2 below.
