114 Southcote  
Lane,  
Reading,  
Berkshire,  
RG30 3AF

## Preliminary Roost Assessment Report

August 2019

Ref: 19-6061

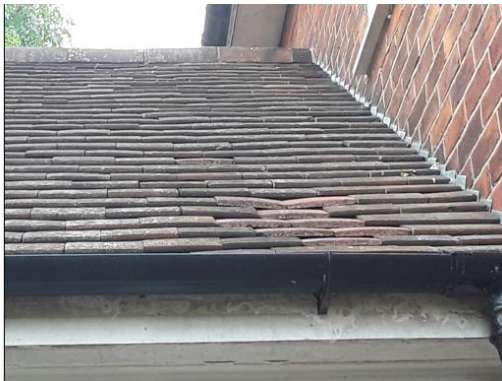
| Location | Feature | Confirmed Presence or Potential |
|---|---|---|
| Roof | Plain clay tiled roof with clay ridge | Typical lifts associated with this type of roof. Gaps noted in ridge tiles (northern side). Rear extension roof noted lifts and gaps. OVERALL: Potential for Access and Crevice Space |

gaps and lifts within rear single storey extension

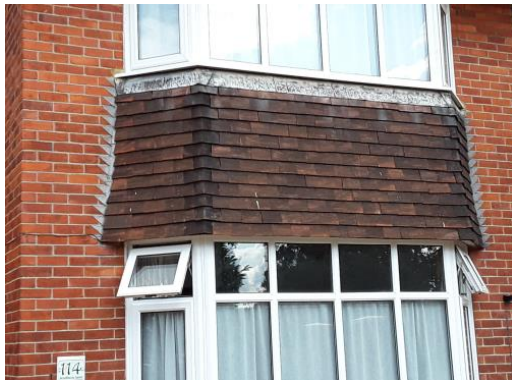
| Location | Feature | Confirmed Presence or Potential |
|---|---|---|
| Walls | Brick, hanging tiles and pebble blast | Brick walls in a good state of repair, as is the pebble blast area. The hanging tiles within the front elevation had some notable gaps, however no stains, droppings or debris noted on closer inspection. The underlay appears tight and intact, reducing overall movement and space available for potential roosting bats OVERALL: Limited Potential for Access and Crevice Space |

hanging tiled wall within front elevation

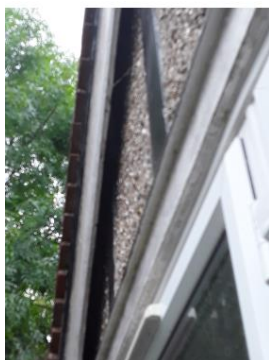
| Soffits/ barge boards | Wooden | <p>The majority of the dwelling has boxed soffits and barge boards that sit tight against the walls.</p> <p>The rear single storey extension is not boxed but rather opened, allowing for potential access and crevice space.</p> <p>OVERALL: Potential for Access and Crevice Space</p> |

open soffits on the rear elevation providing potential access and crevice spaces

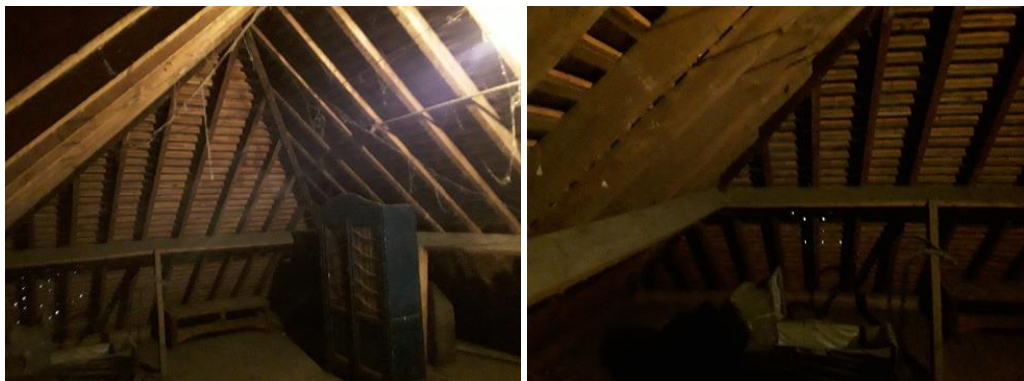
6.3.3. The exposed roof space presented noticeable light with gaps noted within the roof slopes. Wooden beams, supports and battens were in good state of repair, with no signs of rot, cracks, gaps or holes. Notable cobwebs were located though out the roof space including the ridge space. The brick chimney is enclosed by timber boarding and no notable gaps or areas of visible light was noted. The flooring comprised timber boarding and insulation. No signs of roosting bats in the form of marks, stains, droppings and/ or debris were found in the loft space. No signs of active or remnant bird nests or use by birds were found inside the loft space.

7.1. The loft space noted areas of potential access within the lifts and gaps within the exposed tiled roof. The internal inspection found no signs of bats in the form of droppings, debris, marks and or stains. No signs of use by nesting birds were noticed during the time of the survey. The external inspection of the building found potential access points and crevice roosting opportunities within the roof space and rear soffit boards. No signs of active or remnant nesting birds were noticed during the time of the survey.

internal loft space – visible light noted within the exposed tiles
