## BAT SURVEY AT 239 HEMDEAN ROAD CAVERSHAM

Prepared for:  
Mr G Coale  
239 Hemdean Road  
Caversham  
Reading  
RG4 7QX

3<sup>rd</sup> September 2015

Ref: SPH/PBS-01/03.09

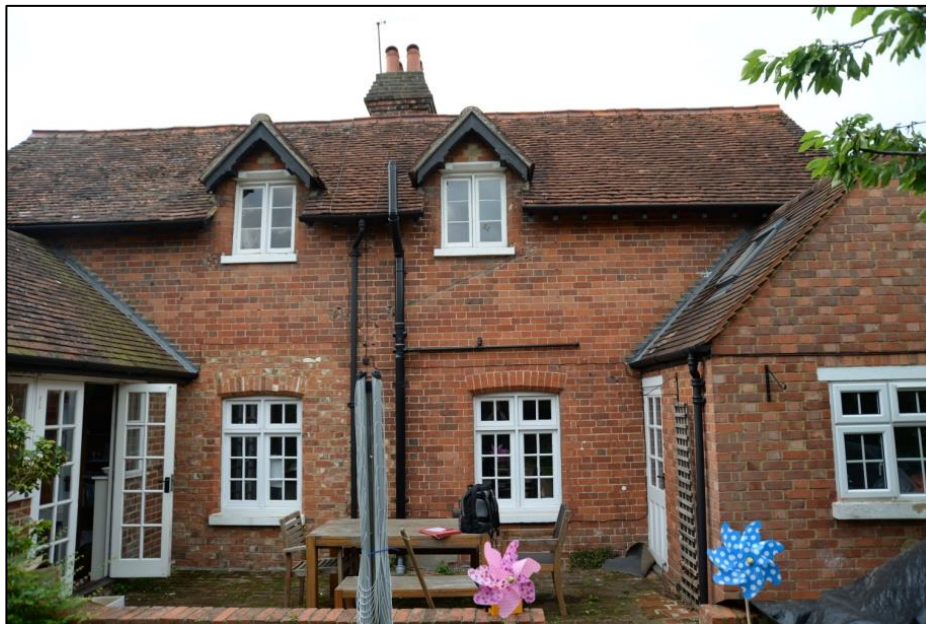
The application site contains a two storey detached house - formerly two semis that have been combined. It is occupied and in good condition, see Figure 3. The rest of the application site comprises enclosed gardens, with a brick built outbuilding, lawns, fruit trees and occasional herbaceous shrubs.

Figure 3. Rear aspect of 239 Hemdean Road. 03.09.2015.

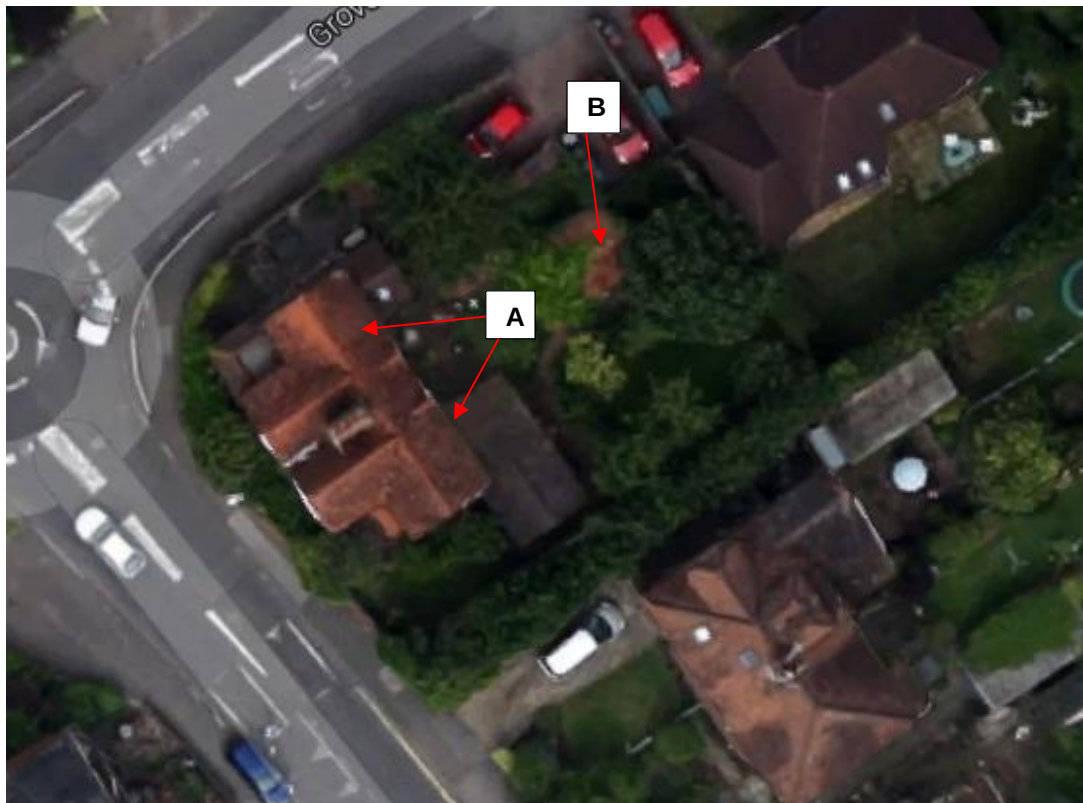
The surveyors were stationed as indicated in Figure 4 on the next page, to ensure that possible emergence areas (areas of concern) could be observed.

Figure 4 – 239 Hemdean Road. Surveyor locations during the emergence survey.

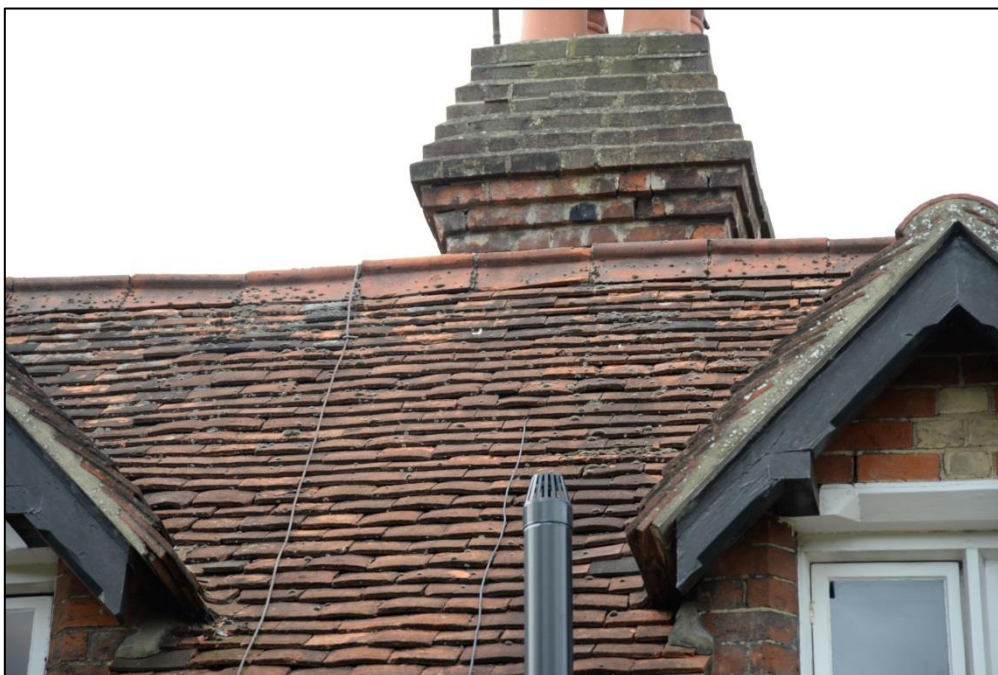
The buildings inspected are of standard brick construction with pitched, clay tiled roofs. The house has a complex roof alignment, the dominant alignment is mainly north to south. Various gaps in the tiles were observed on the rear pitch between the dormers, see image at Figure 5.

Figure 5. 239 Hemdean Road, gaps between tiles on the rear roof between the dormers 03.09.15.

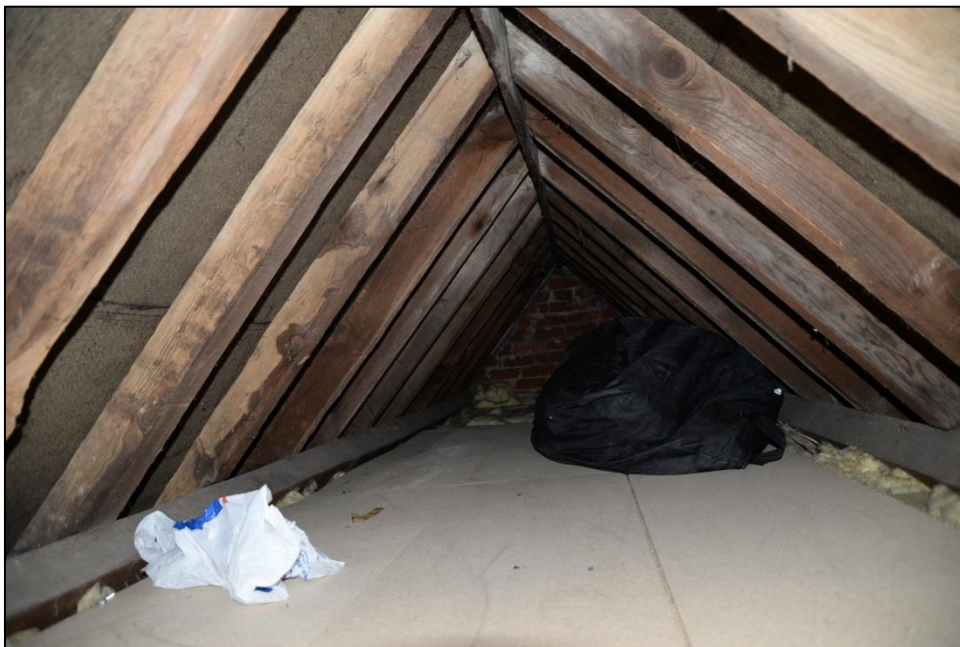
An internal inspection of the main roof void was carried out. It was accessed from the first floor landing. The roof consisted of a series of voids beneath the main ridge, with voids over the dormer windows and the spaces were accessible, see Figure 6 on the next page.

Figure 6. 239 Hemdean Road, main boarded loft section, 03.09.15.

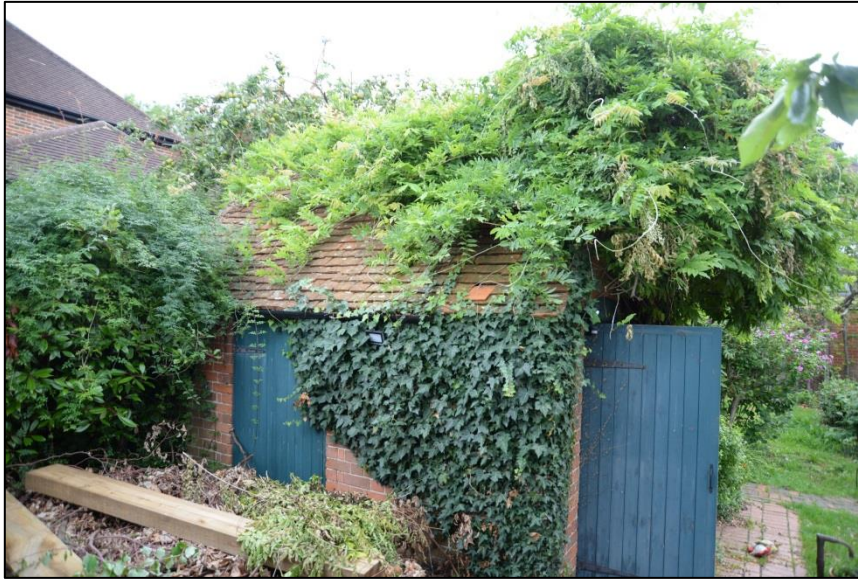
The brick outbuilding was examined for any signs of bats (as described in section 4.2). The outbuilding is almost totally covered in wisteria and ivy, see Figure 8. The condition of it indicated that it had not been cleaned or tidied recently. No signs of bats were observed.

Figure 8. 239 Hemdean Road, Brick outbuilding, 03.09.15.

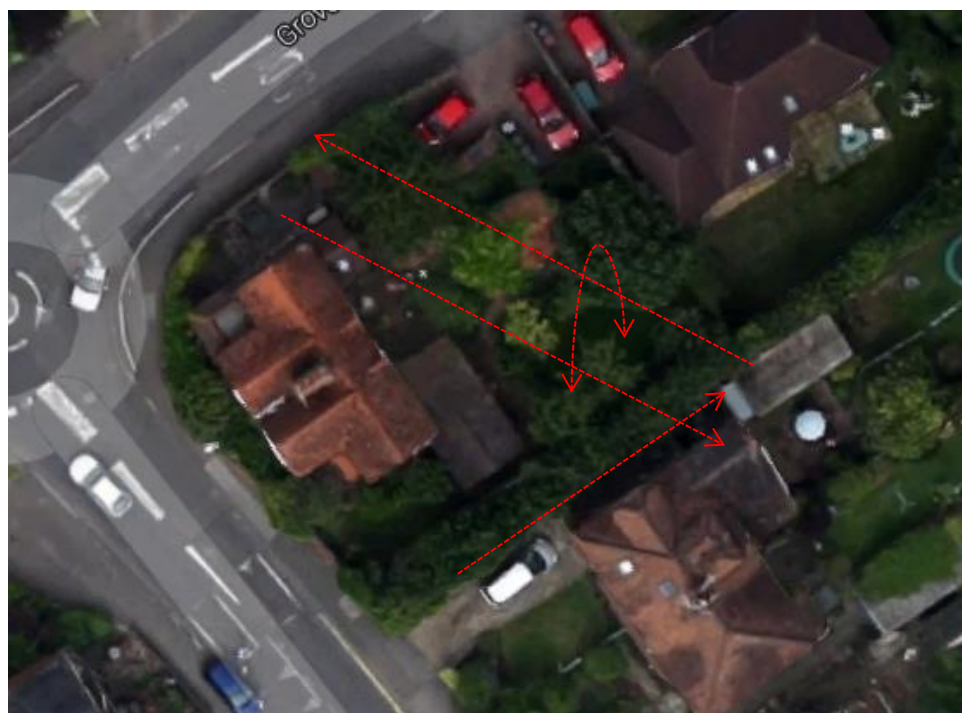
During the dusk survey no bats were seen emerging from or returning to the house or outbuilding to roost. In total three different species were recorded foraging within the vicinity of the building and commuting across the site. Bat passes were low around the property, a simple summary of the bat recorded can be seen in Table 2 on the next page and the most frequently used flight paths are shown in Figure 9 on the next page.

**Figure 9.** Commonly used bat flight paths at 239 Hemdean Road. 08.09.15.

The bats could be seen foraging over fruit trees in the rear garden and heading back and forth between the site and the adjacent Balmore Park.
