# DESK STUDY & GROUND INVESTIGATION REPORT

Royal Heights  
Queen's Road  
Reading

J18003

March 2018

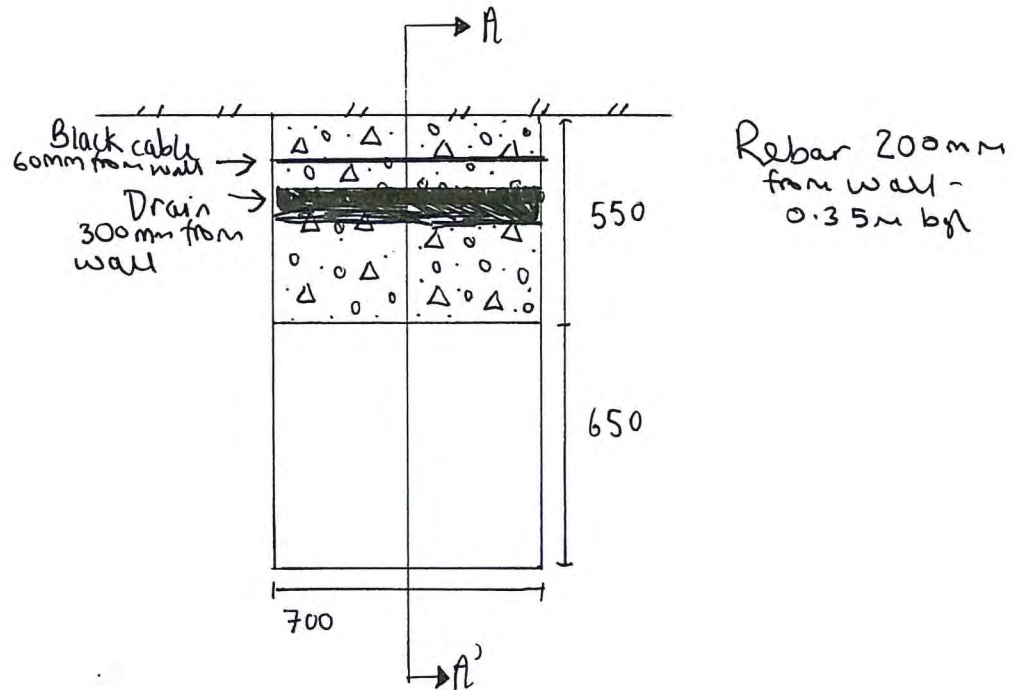
PLAN

A total of two trial pits were excavated to expose the foundations of the existing buildings and the findings are summarised in the table below. Trial pit records are included within the appendix.

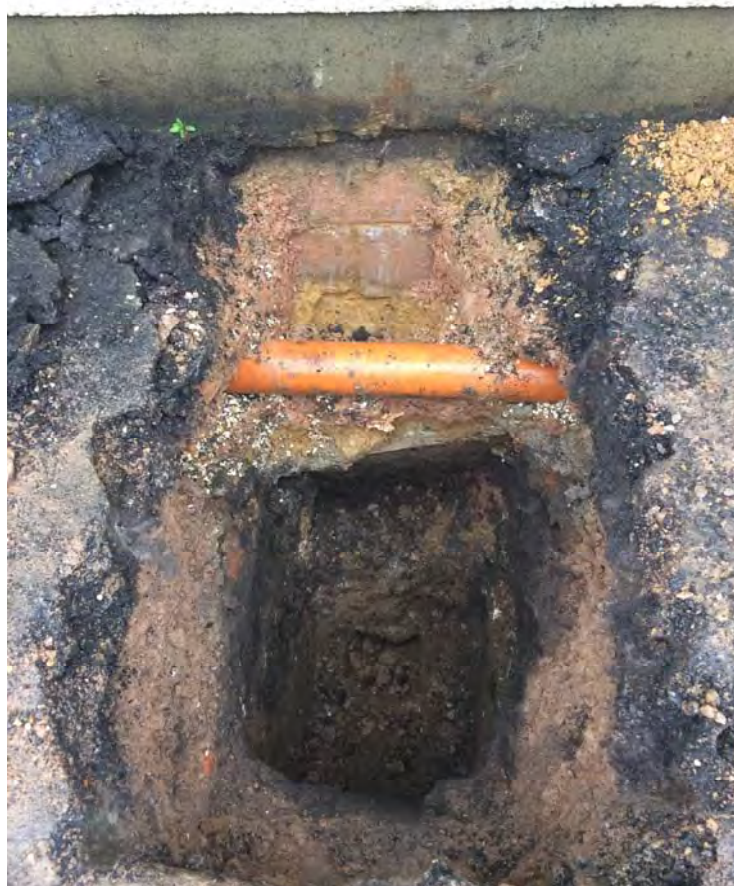
View of foundations and services encountered in Trial Pit No 1

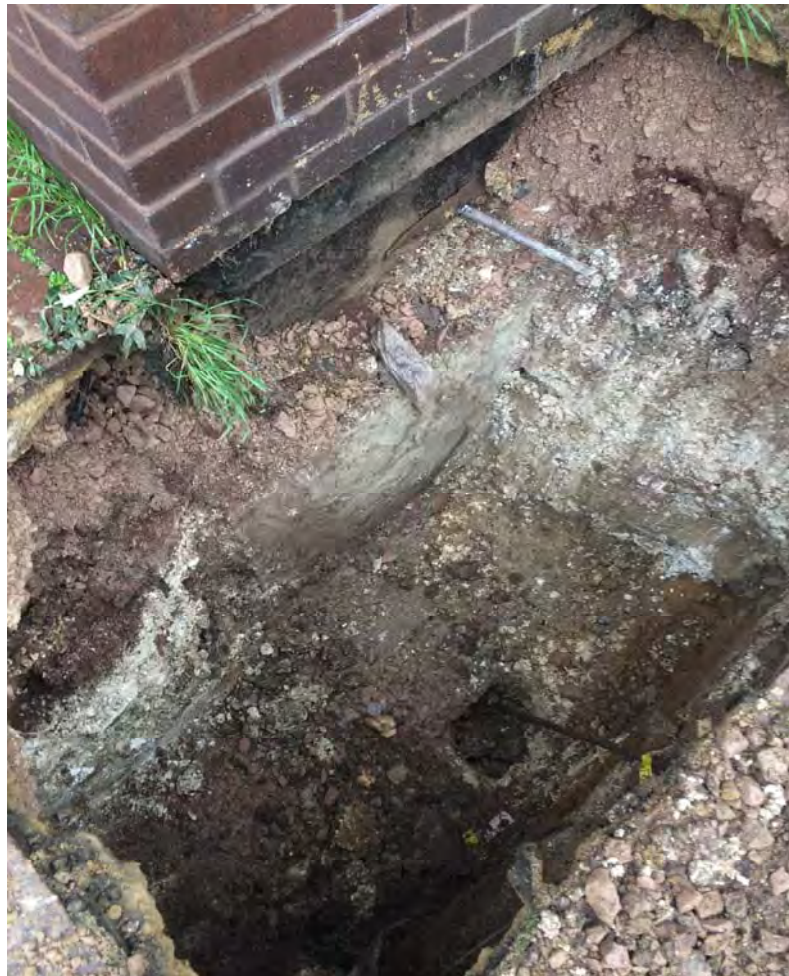
View of foundations and services encountered in Trial Pit No 2

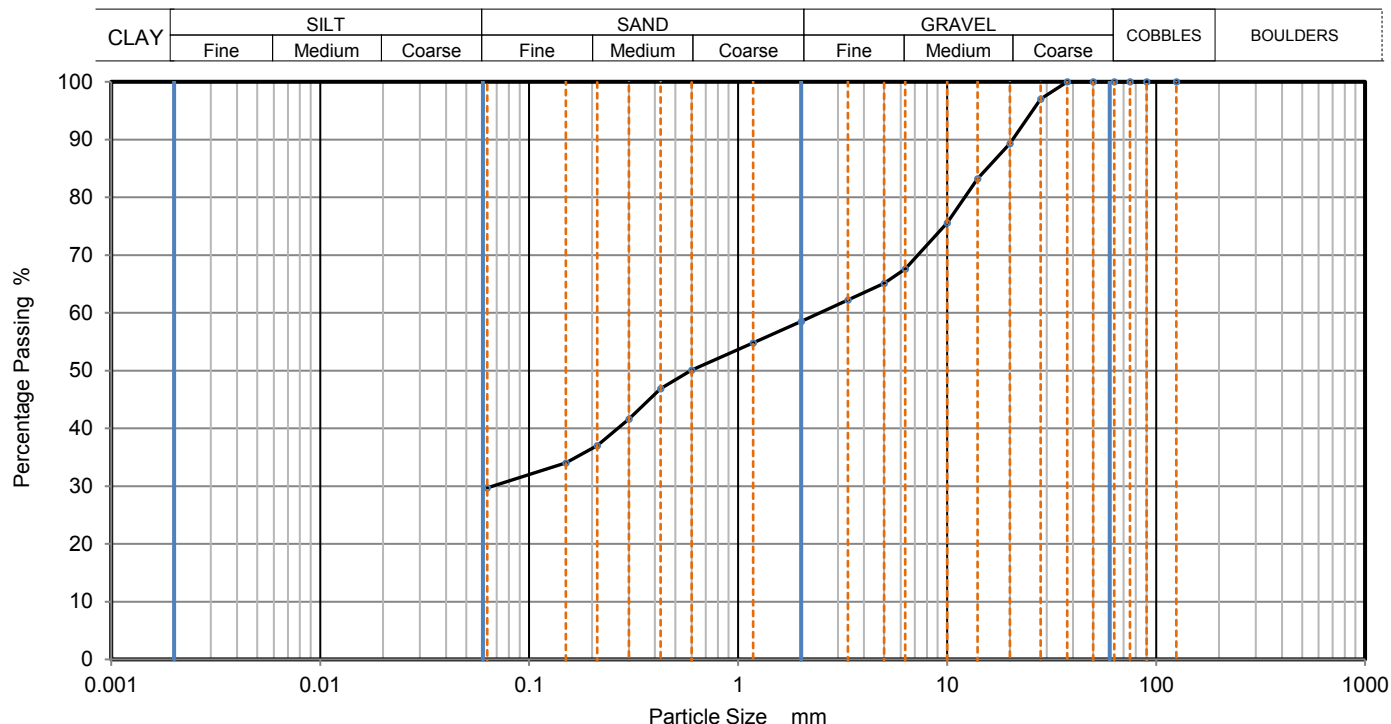
| Soil Description | Brown very clayey very sandy GRAVEL with occasional putty chalk pockets and fm intact chalk fragments (gravel is fmc and angular to rounded) | | |
| Test Method | BS1377:Part 2: 1990, clause 9.0 | | |

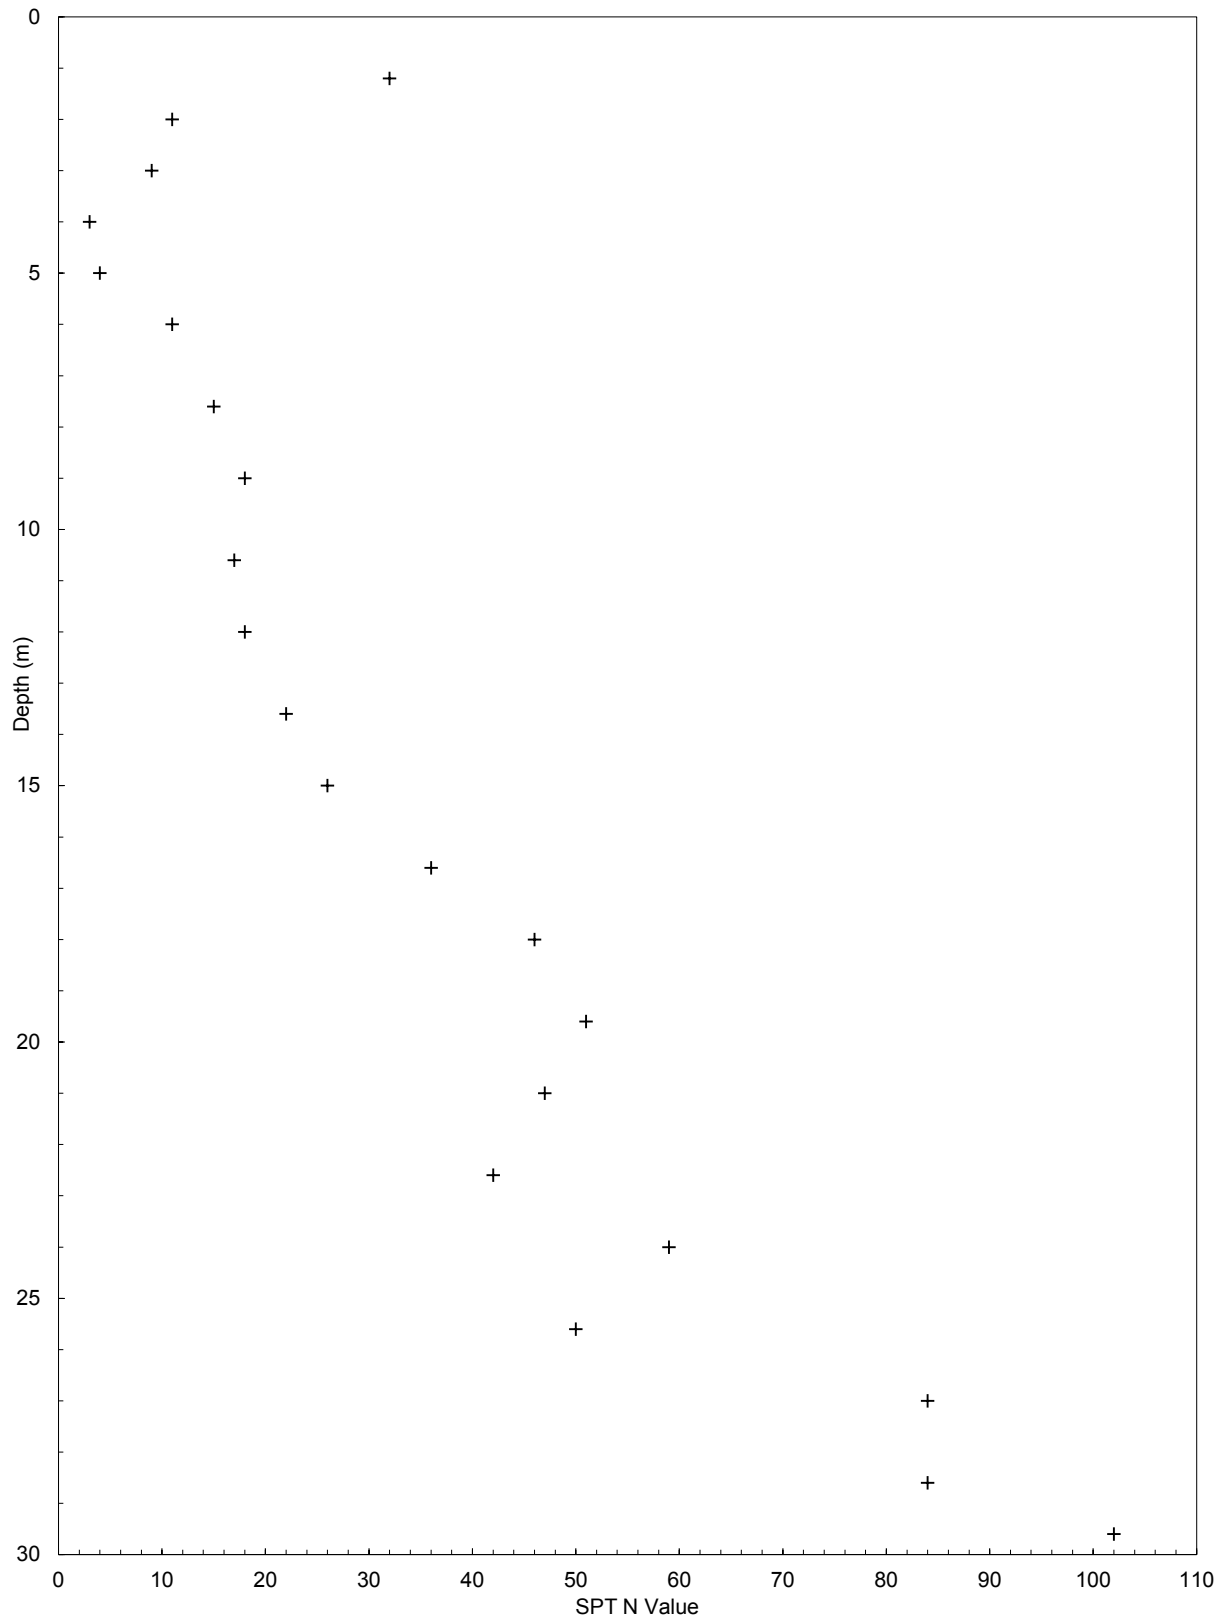
In situ testing from the boreholes has indicated either zero or low blow counts to depths of between 5 m and 6 m in the chalk and poor or no recovery of the chalk was noted in the open-drive sampler boreholes from depths of 2 m to 5 m. Further details on this are included on the borehole records in the appendix. Below a depth of about 6 m, the N values generally increase with depth and the N60 values in the cable percussion borehole range from 11 at a depth of 6.00 m to 102 at a depth of 29.50 m.

+ - SPT 'N' values
