# Bat Roost Assessment Report

Project: Swansea Road, Reading, Berkshire (1005765)

October 2019

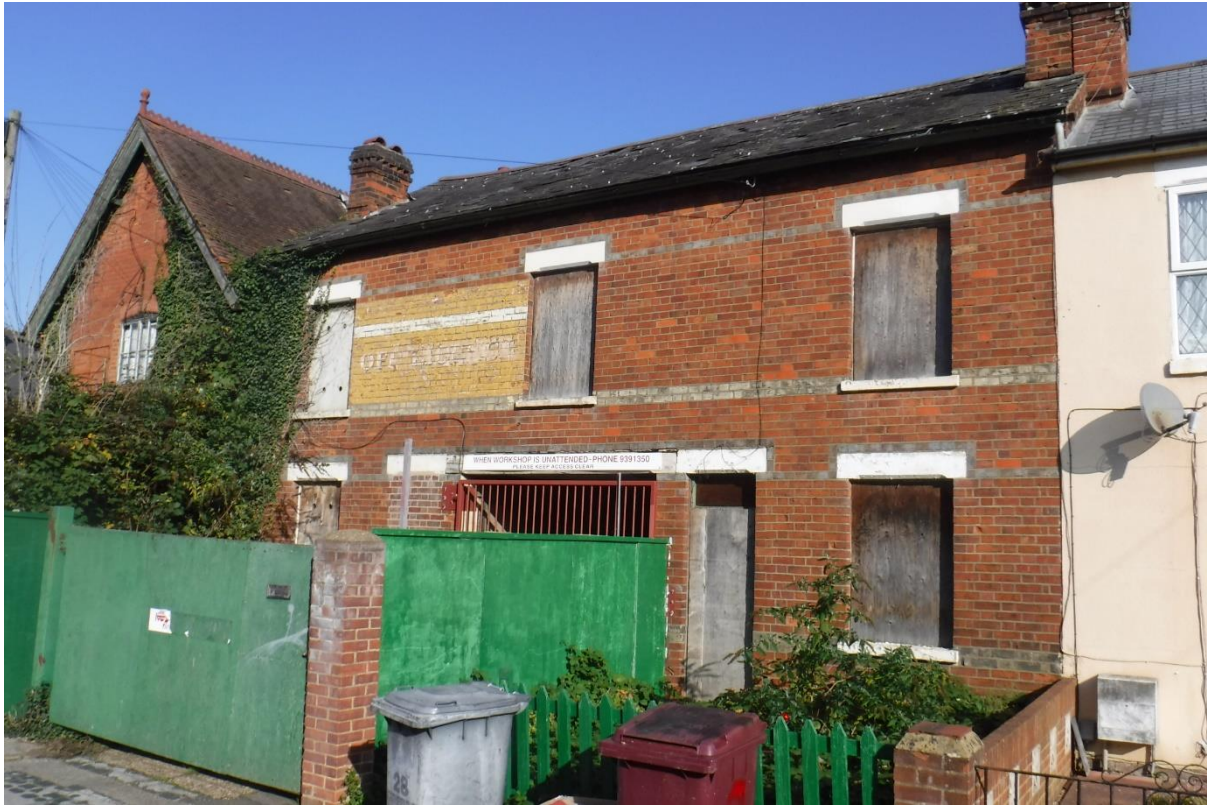
### B1a – External

- 3.3.1 Building **B1a** is a two-storey, unoccupied, residential building of brick construction with boarded up windows. Building **B1a** supports a pitched slate tile roof, with openings at the eaves recorded, with two chimney stacks and an associated lean-to structure located at the rear of the building. The exposed external walls are of a construction considered unlikely to support a notable cavity, and were recorded to be in a relatively good state of repair at the time of survey, although areas of mortar were recorded to be missing at the chimneys and above a lintel associated with the car port. Dormer windows are present within the roof and as such, it is considered unlikely that a separate / accessible loft void is present. Potential access features for bats include the areas of missing mortar, numerous lifted and missing tiles on the roof and areas of lifted lead flashing.

- 4.2.5 **MM2 – Precautionary Approach to Demolition Works.** Buildings **B1a**, **B1b** and **B2a** are considered to offer negligible to low bat roosting potential. However, as described above, bats

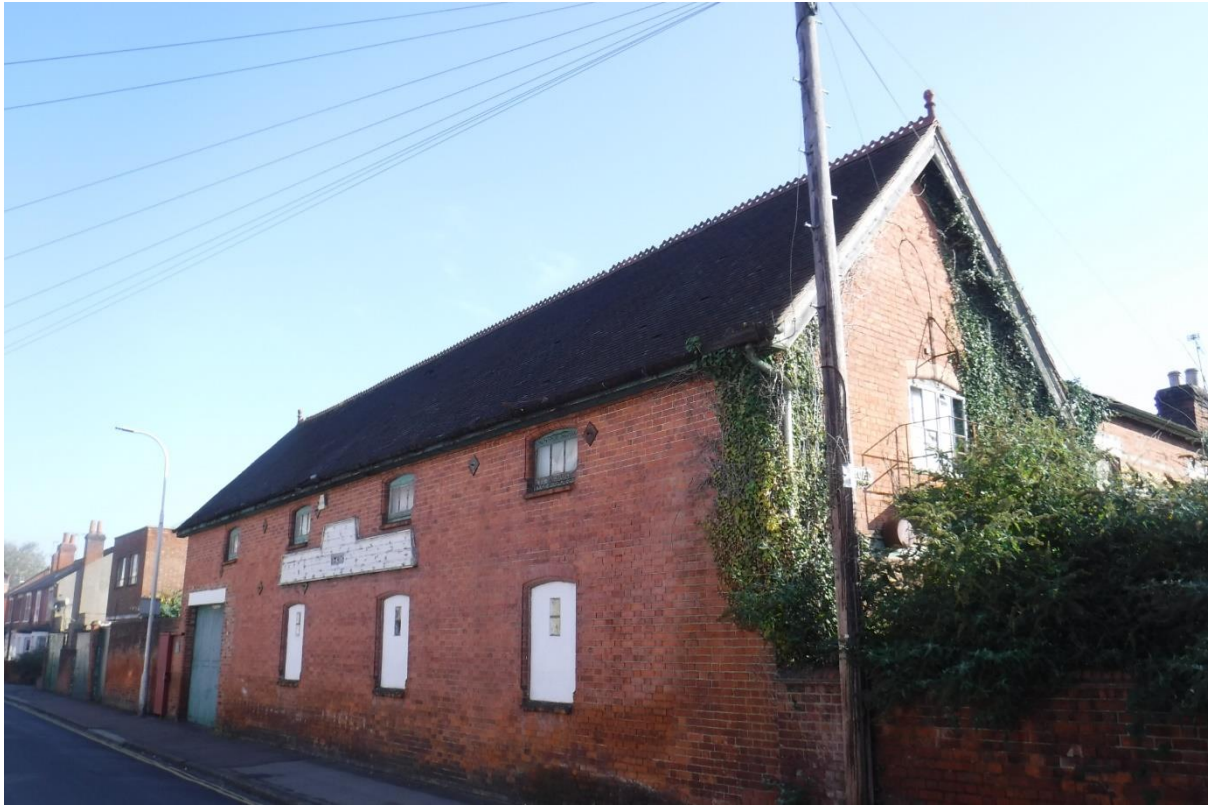
**B1b - External**

- 3.3.3 Building **B1b** is an unoccupied, two-storey warehouse / workshop space, of brick construction. Building **B1b** supports a pitched clay tile roof with soffit boxes recorded to be in poor condition, providing a gap of at least 2.5cm between the soffit boxes and the building. The external walls are of a construction considered unlikely to support a cavity and were recorded to be in a relatively good state of repair with Ivy *Hedera helix* present on the south-western aspect. The roof was recorded to be in a moderate state of repair with some missing tiles identified, in addition to missing mortar at the gable end rakes. The windows were recorded to be either boarded or cemented over. An old wooden sign is present on the eastern aspect of the building with gaps present between the sign and the brickwork, which could provide roosting opportunities to bats. A large garage door with gaps around the edges is also present on the eastern aspect of the building providing potential access opportunities to bats. A remnant wall, presumably from a previous lean-to building, is present along the western wall of building **B1b**, which provides large gaps and crevices.

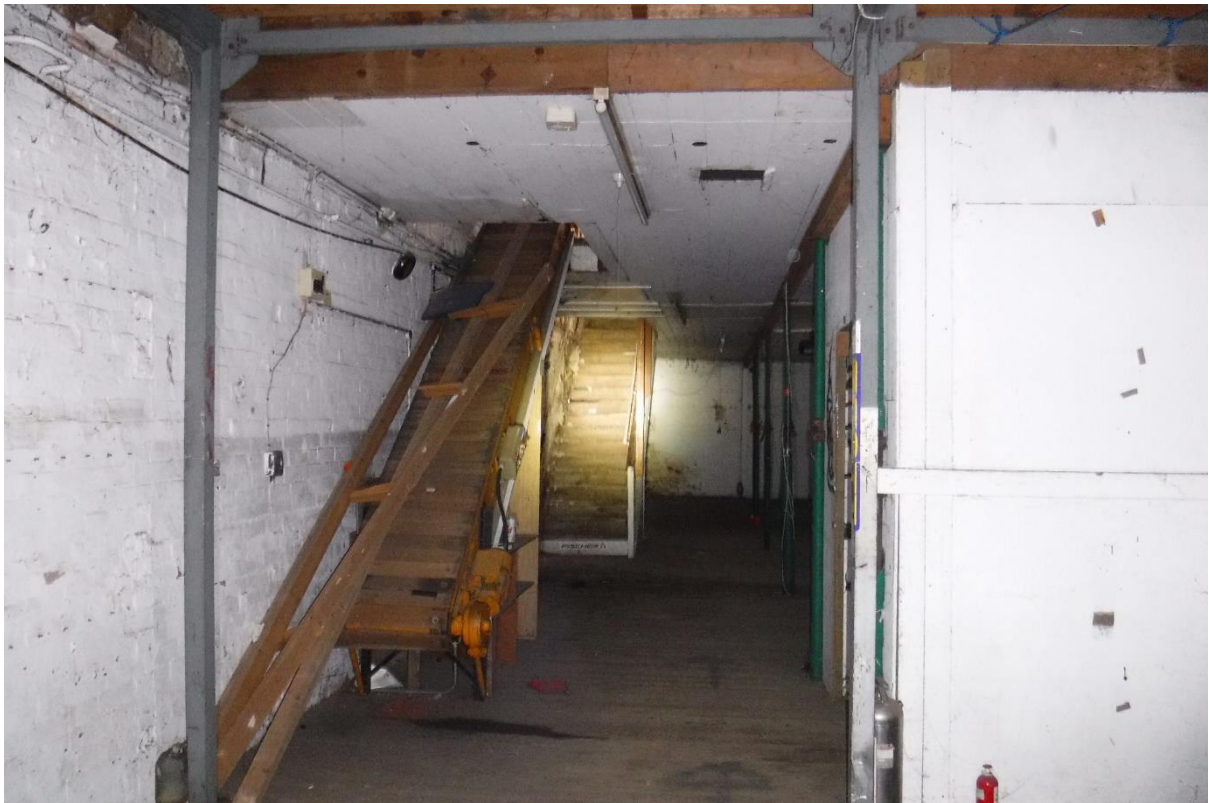
**B1b - Internal**

- 3.3.4 No access was possible to the second floor of the building due to health and safety concerns associated with the presence of rotting floorboards, which also prevented an exhaustive internal inspection of the ground floor from taking place. The interior of the building comprises exposed brickwork with wooden ceilings and was recorded to be in a poor state of repair.

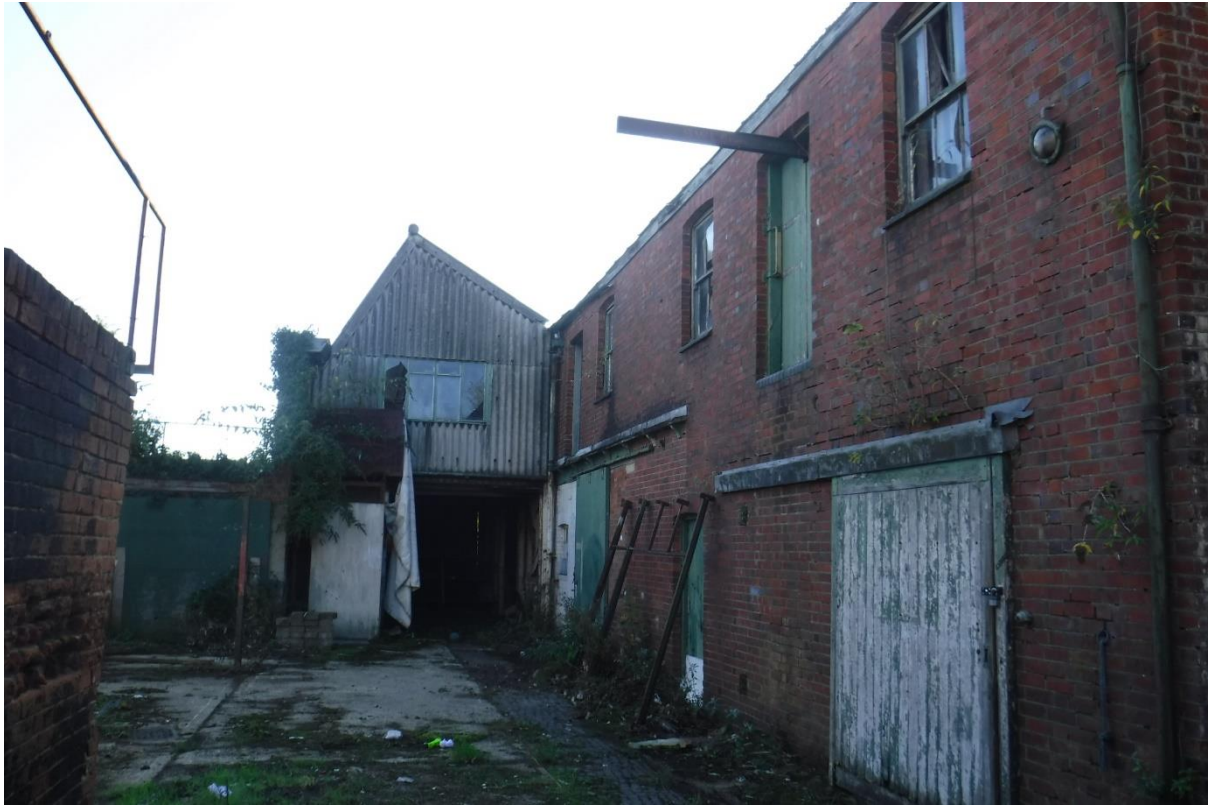
**B2a - External**

- 3.3.5 Building **B2a** is a two-storey warehouse / workshop space, of brick construction, currently being used as a storage area with evidence of rough sleeping also recorded. Building **B2a** supports a largely flat roof of bitumen felt and corrugated asbestos, with a section of pitched roof at the north-east of the building. Many of the windows were recorded to be open or broken with gaps also present beneath the corrugated asbestos. Large warehouse doors are present which were also recorded to have large gaps into the interior of the building.

- 3.3.7 Building **B2a** also supports a lean-to structure to the south of the building, comprising wooden beams supporting a sloping roof of corrugated plastic sheeting which is broken in places and in a poor state of repair.

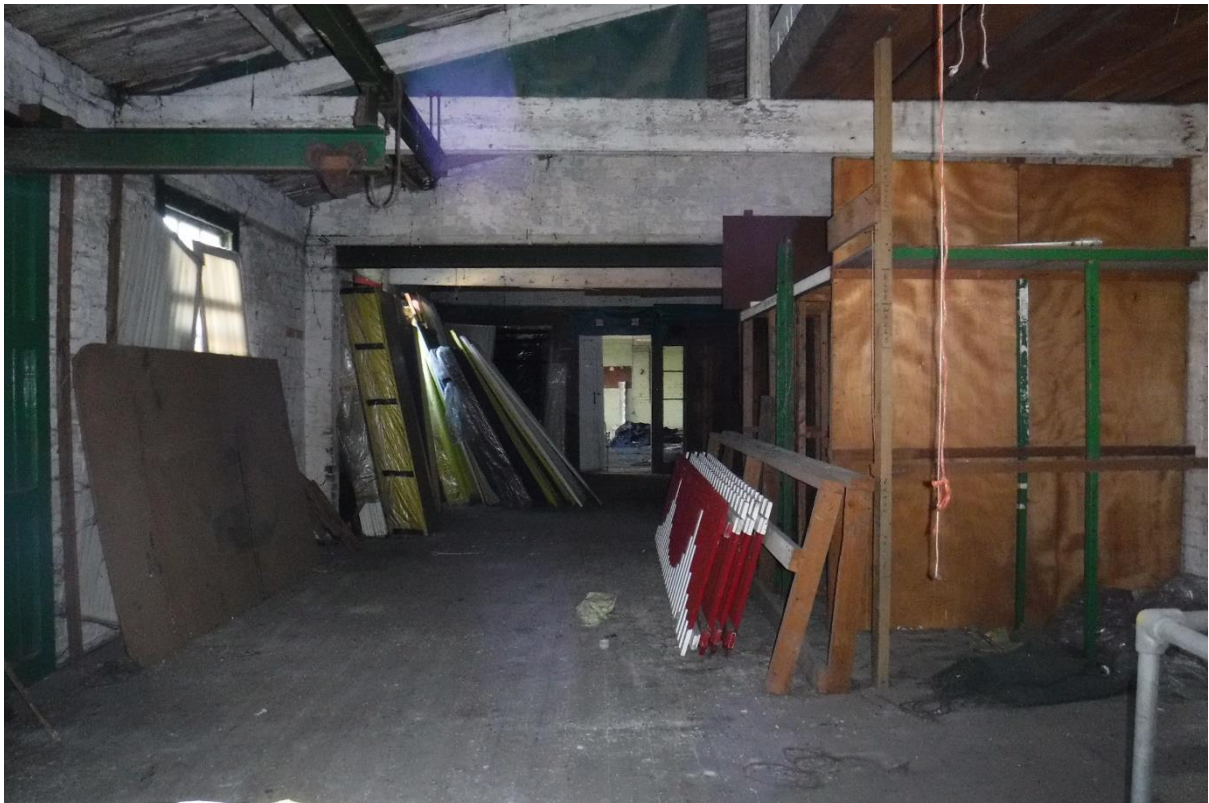
**B2a - Internal**

- 3.3.6 Due to health and safety concerns associated with the presence of rotting floorboards, an appraisal of the second floor was made from the stairway of the building only. No loft void is present, with the roof recorded to be backed with wooden sarking boards and support beams, which could provide potential crevices for bats to roost. The first floor was recorded to be light and breezy due to the number of broken and uncovered windows present.

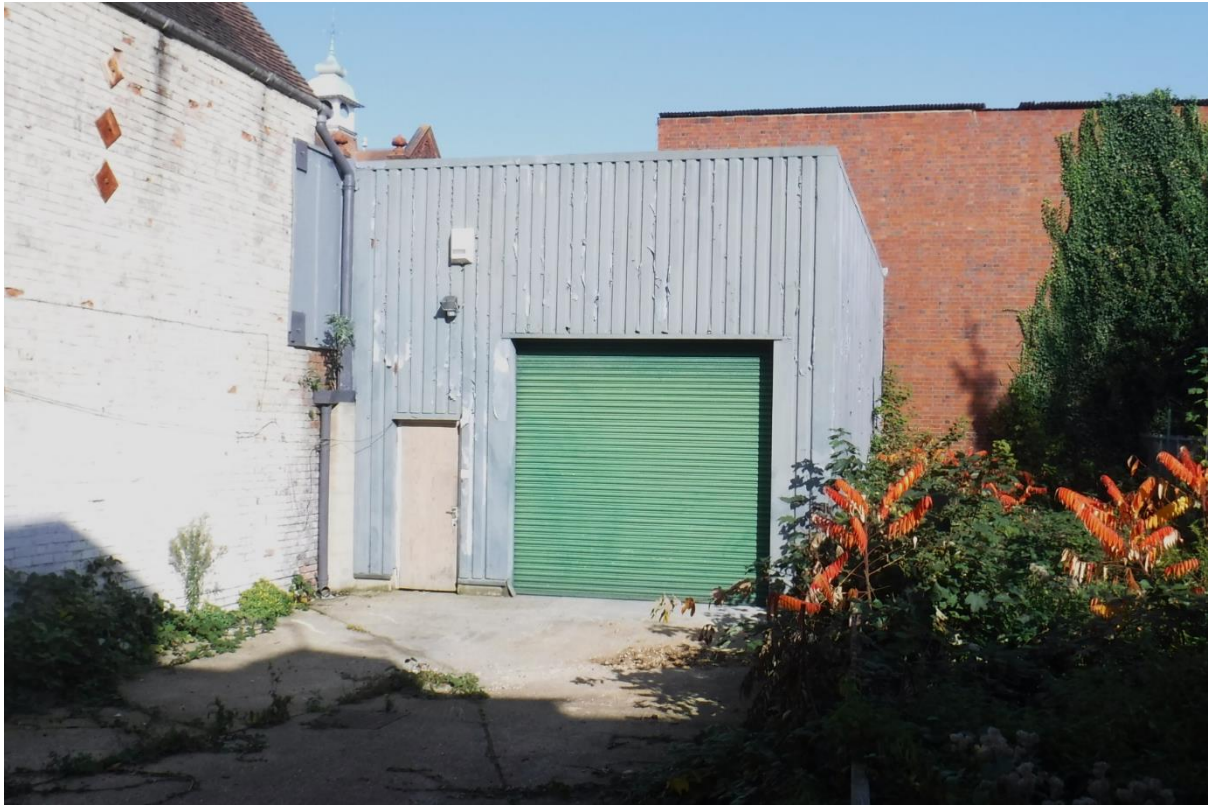
**B2b - External**

- 3.3.8 Building **B2b** is a two-storey warehouse of metal frame / clad construction, with a concrete base, supporting a flat roof. A large, metal roller door is present on the southern aspect of the building, with gaps present at the top that could allow access to bats. A security light is also present on the southern wall of the building, though it is not known whether it is still functional. No internal access was possible for this building.

- 3.4.3 A limited number of potential opportunities for roosting bats were recorded to be present across building **B2b**, restricted to external features such as the gaps above the roller door. This could potentially allow access into the building for individual opportunistic bats, however the building is unlikely to be suitable for maternity or hibernation roosts, with no evidence of bats recorded.
