## **Express Preliminary UXO Risk Assessment**

| <b>Project</b> | Royal Heights |
| <b>Site Address</b> | Grantley Heights, Kennet Side, Reading, RG1 3EG |
| <b>Report Reference</b> | EP5854-00 |

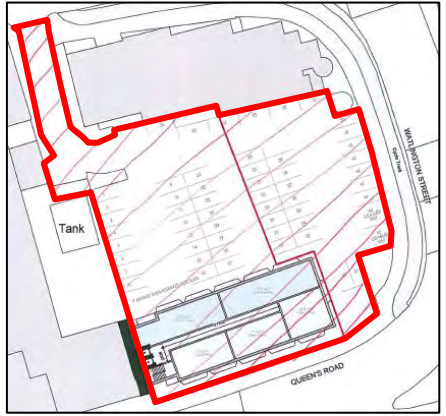
| Risk Assessment Considerations | |
|---|---|
| Site location and description/current use | <p>The site is located in the town of Reading, Berkshire.</p> <p>The site is occupied by a building recently in use as offices, a car park and access way. Commercial and civil properties surround the site on all sides. Wesley Methodist Church. Queens Road is south of the site, Watlington Street is east and Kennet Side is north.</p> <p>The site is approximately centred on the OS grid reference: <b>SU 7219473280</b>.</p> |
