## Preliminary Roost Assessment Westfield Road, Caversham

ADAS was commissioned by Avalon Construction and Design Ltd to conduct a Preliminary Roost Assessment (PEA) on four buildings at 106-116 Westfield Road, Caversham, Reading, Berkshire, RG4 8HL (grid reference: SU 7163 7494). The proposed works are to convert the loft spaces and extend the rear of the buildings to enlarge the existing dwellings and create three additional flats.

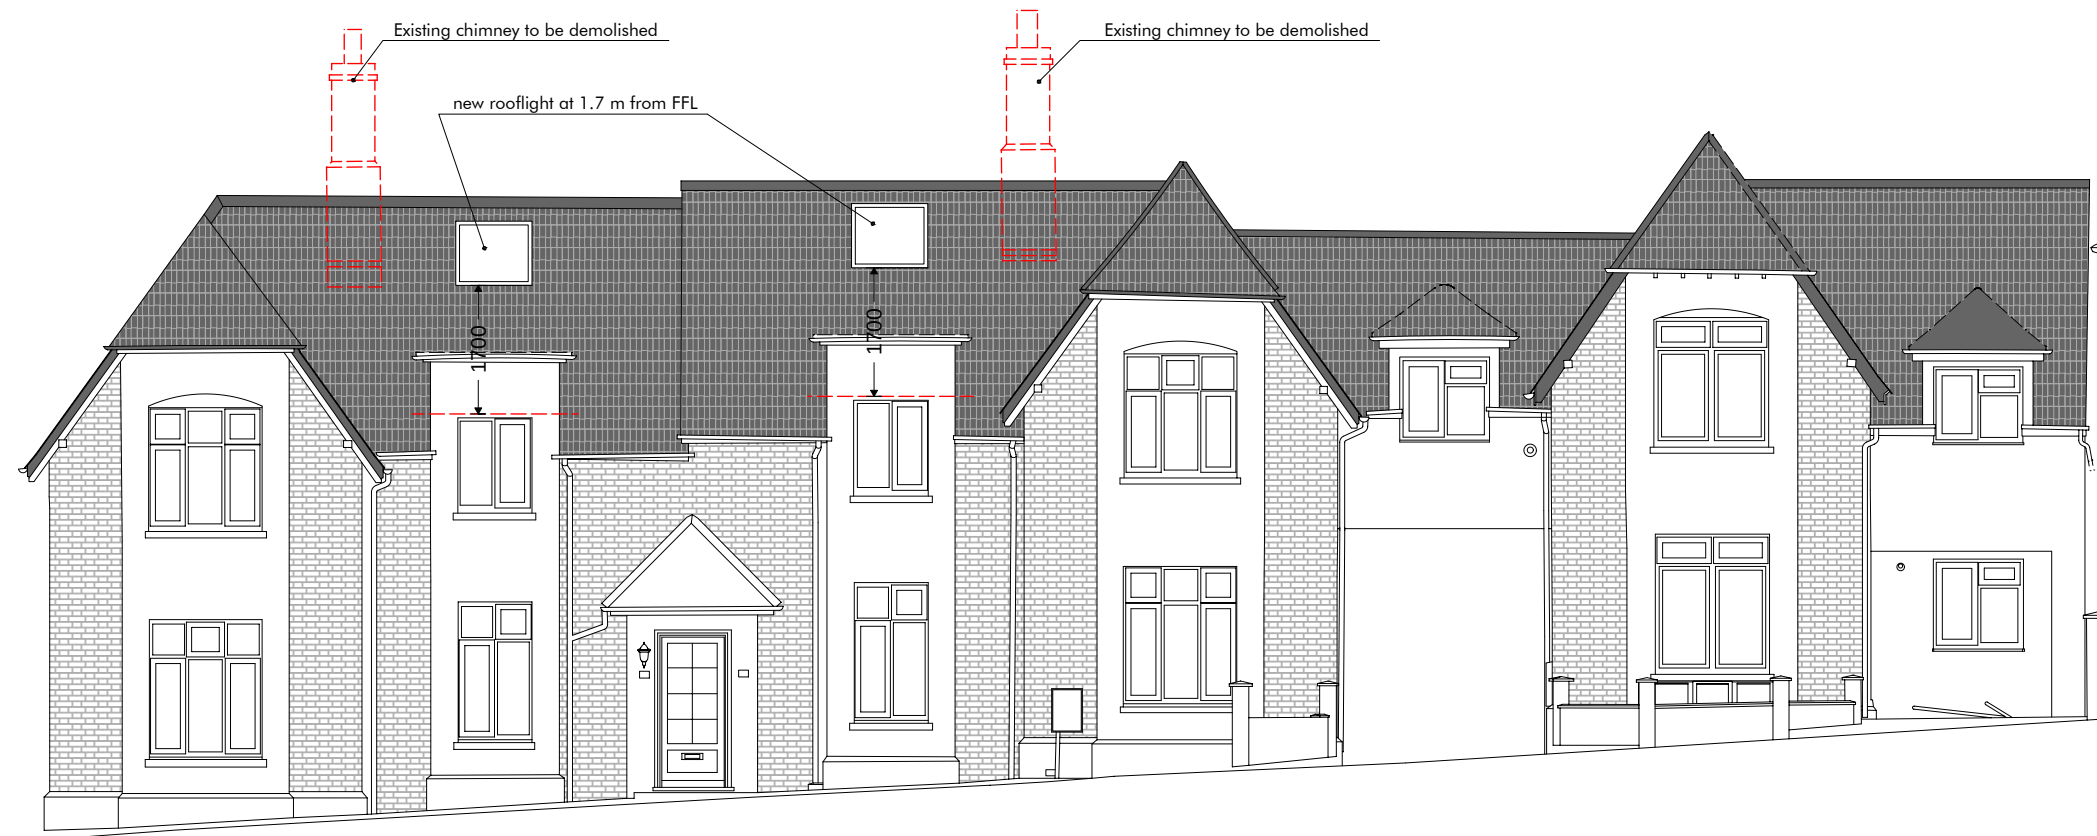
NOTE:  
the only intervention to the main  
facade consist of the new rooflight  
and demolition of existing chimney

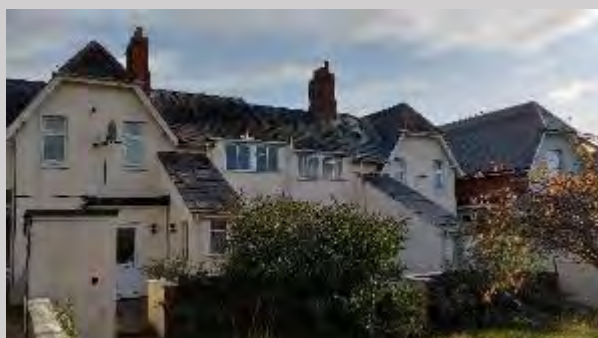
Photograph 1: Building 1, Sections A and B – west elevation.

| Building | Features observed | Potential roosting points | Suitability |
|---|---|---|---|
| 1 | <p><b>External:</b> Building 1 was comprised of rendered brick with a slate roof and modern UPVC windows. Sections A and B had two red brick chimneys with lead flashing. There was evidence in some sections of the eaves of anti-bird netting and spikes.</p> <p><b>Internal:</b></p> <ul style="list-style-type: none"> <li>Sections A and B - The void space had a height of approximately 1.7m and a combined floor area of approximately 90m<sup>2</sup>. The loft space was comprised of a wooden frame, wooden sarking with a bitumen felt liner behind. There was a red brick chimney in the middle of the space and a red brick gable end. Daylight could be seen where the chimney joined the roof on the eastern elevation, gaps along the eaves on both the eastern and western elevations and at the southern gable at the apex of the void. A plasterboard false wall separated Sections A and B. The insulation was comprised of woodchip/cork. A wasp's nest was on the western eaves of Section A. Mouse (<i>Mus musculus</i>) droppings were found but no bat droppings were found. The loft space extended beyond the chimney to the south, but this could not be accessed safely.</li> <li>Section C - The void space had a height of approximately 1.7m and a floor area of 44m<sup>2</sup>. The loft space was comprised of a wooden frame, wooden sarking with a bitumen liner behind. There was a red brick gable end, no daylight could be seen, however, there was a slight draft. There was a missing section of sarking that lead into another void which could not be accessed safely which was comprised of bitumen liner only, no sarking, and</li> </ul> | <p>Features that were suitable for bats included: holes in the soffits, lifted lead flashing around the chimneys, gaps under ridge and hip tiles, slipped and broken slates, gaps between the soffits and the walls and gaps under the eaves.</p> | Moderate |

To conclude, Buildings 1 and 4 offered moderate and low suitability, respectively, for crevice dwelling bats. It is therefore recommended that two emergence/re-entry bat surveys are undertaken on Building 1 which would involve four surveyors and one emergence/re-entry bat survey is undertaken on Building 4 which would involve two surveyors. The surveys should be undertaken between May and August and will involve surveyors using bat recording equipment to record bat activity at the site during one dusk survey and one dawn survey.

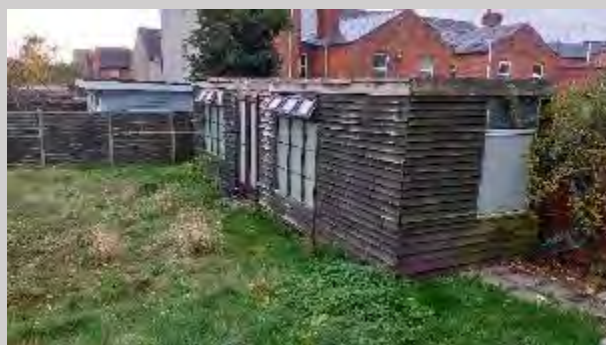
Photograph 4: Building 2 – east and north elevations.

| 2 | <p><b>External:</b> Building 2 was comprised of wooden cladding with a flat bitumen felt roof. Large areas of bitumen felt were missing from the roof and it was very damp and light inside. Parts of the top timbers on the walls were rotten.</p> <p><b>Internal:</b> There was no loft space. Internally, the building was used to store household items limiting access to complete a full internal inspection.</p> | None. | Negligible |

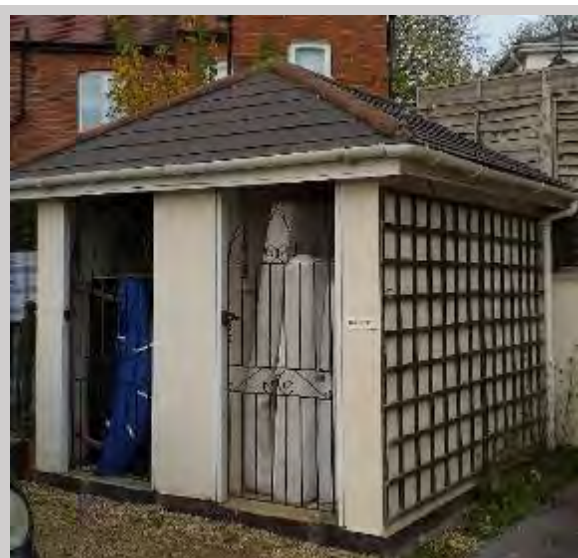
Photograph 6: Building 4 – east and south elevations.

| 4 | <p><b>External:</b> Building 4 was comprised of rendered brick with a slate roof and red clay ridge tiles. The building was open to the north and south and an ornamental climbing plant grew within the building from the west.</p> <p><b>Internal:</b> The roof was comprised of wooden sarking and the building was being used for storage, limiting internal access.</p> | Features for bats included a missing apex ridge tile on the northern elevation, lifted tiles, and gaps between the eaves and wooden boarding on the southern elevation. | Low |

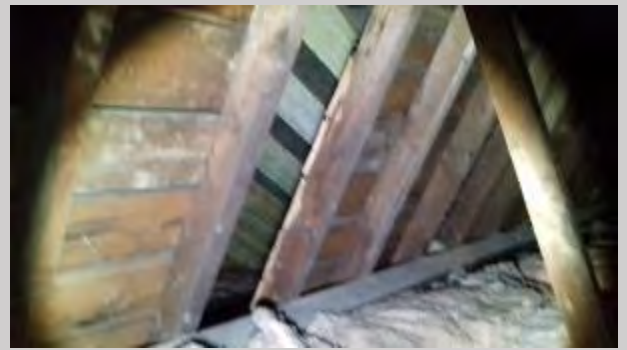
During the Preliminary Roost Assessment survey, no evidence of bats was found internally or externally, however, there were multiple features suitable for crevice dwelling bats on Buildings 1 and 4 (see Appendix 1). The far north and far south of the loft spaces beyond the chimneys could not be fully accessed safely, therefore, a full internal inspection could not be completed. Given the features on these buildings and the suitable foraging and commuting habitat, including Balmore Walk and the River Thames, Buildings 1 and 4 were classed as having moderate and low potential, respectively, to support roosting bats. Buildings 2 and 3 had no features and were classed as having negligible potential to support roosting bats.

Photograph 10: Building 1 – loft space in Section C facing northeast with missing panel leading into additional void that could not be accessed.
