# **36 LIEBENROOD RD, READING, BERKS, RG30 2EB**

## **Phase 1 Daytime Bat Assessment**

**14<sup>th</sup> May 2019**

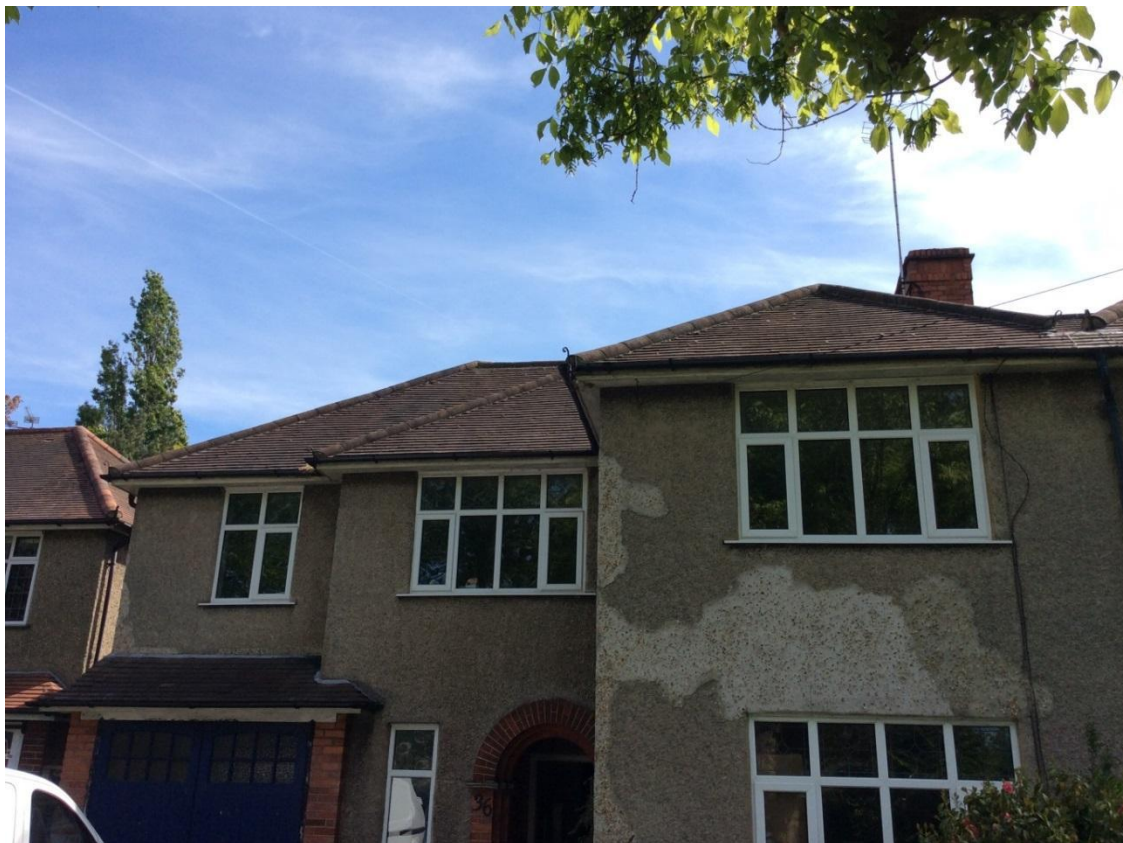
**Fig 2.** Front (western elevation of house).

**Exterior assessment:** The residential dwelling within the site comprises a two-storey semi-detached structure. The dwelling dates to 1930s. The exterior walls are brick built with a clay tiled roof (see fig.2). At the rear there is an old wooden framed conservatory in poor repair which has no potential for bats (See fig 3.). There is an extension at the NE corner (see fig. 4) with a cat-slide roof, with an inaccessible void above the cloakroom area. However the roof /fascias were in excellent order with no potential access points.

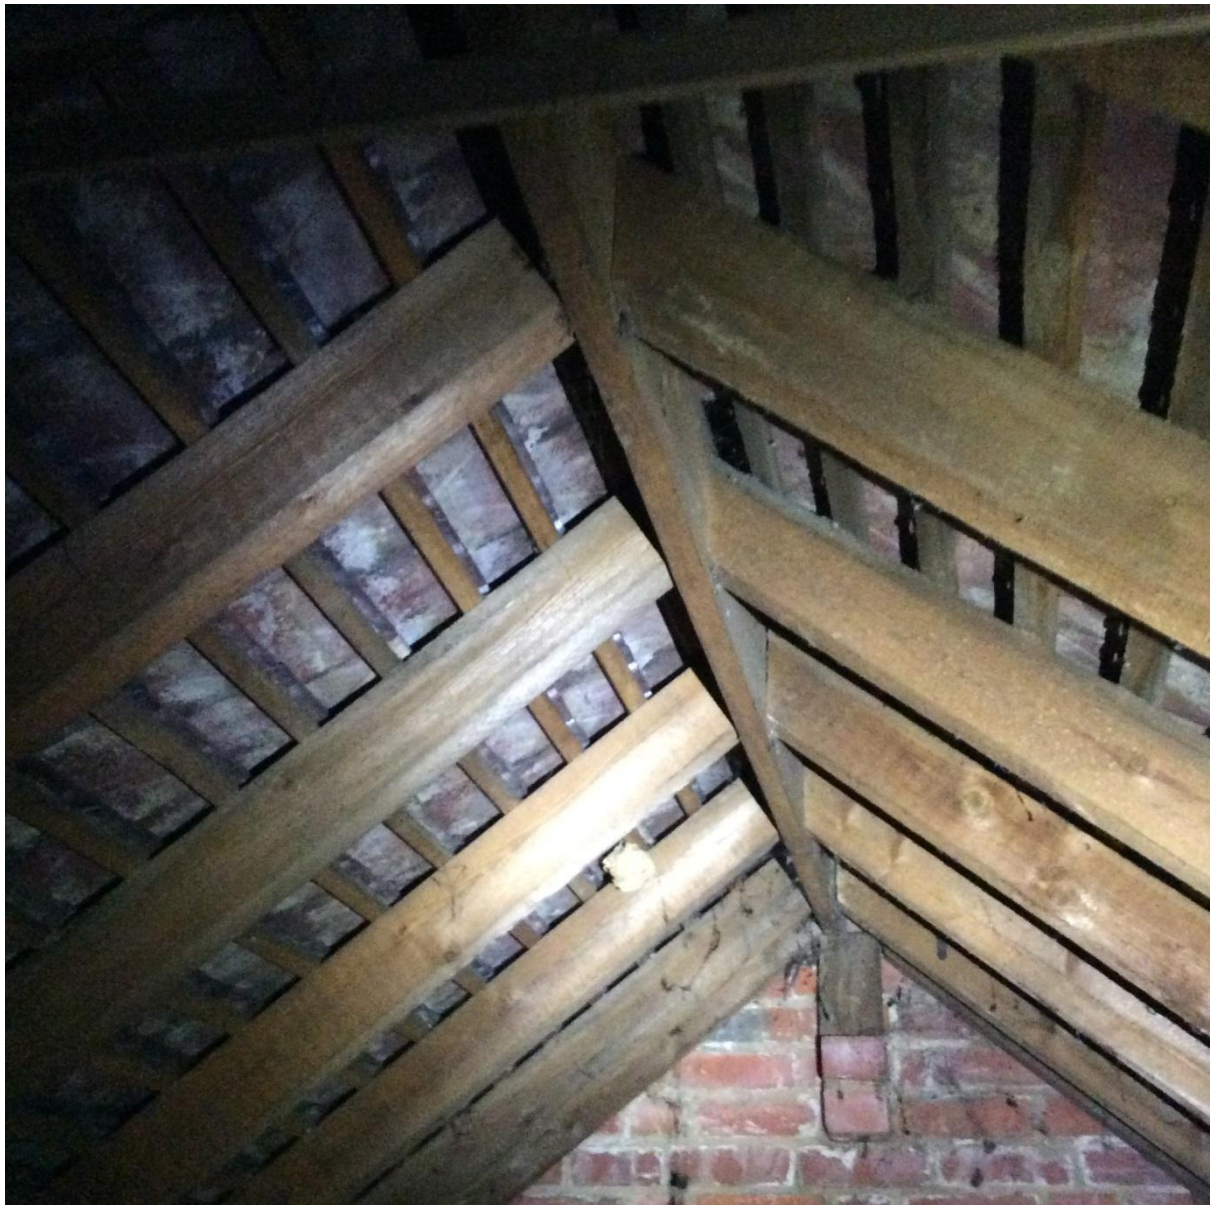
**Fig 5. Interior of main loft looking north**

**Interior assessment:** The main loft void was accessed via a hatch on the landing. The loft has a pitched roof with soft-wood timber frame. The roof is *unlined* and the undersides of the tiles are visible throughout. There is a small window in the roof which illuminates the void throughout. The loft partially boarded out with the remainder insulated with fibre glass. There was no sign of bat or rodent droppings.

The loft void along the entire apex had been filled with the scaffold webs of a *Steatoda spp.* Two halogen strip lights had been added to illuminate the space.

Several old nests made by Common Wasp *Vespula vulgaris* were present.

There was no evidence of any bat activity within the loft void, and no hidden voids or under tile spaces (as the loft is not lined with felting etc.). Externally the house has low potential for bats with no obvious access point could be seen from the exterior.

The lack of any evidence of bats in a loft of such an age was surprising but the presence of a skylight window which permanently illuminates the loft void by day is unusual and may well be a contributory factor.

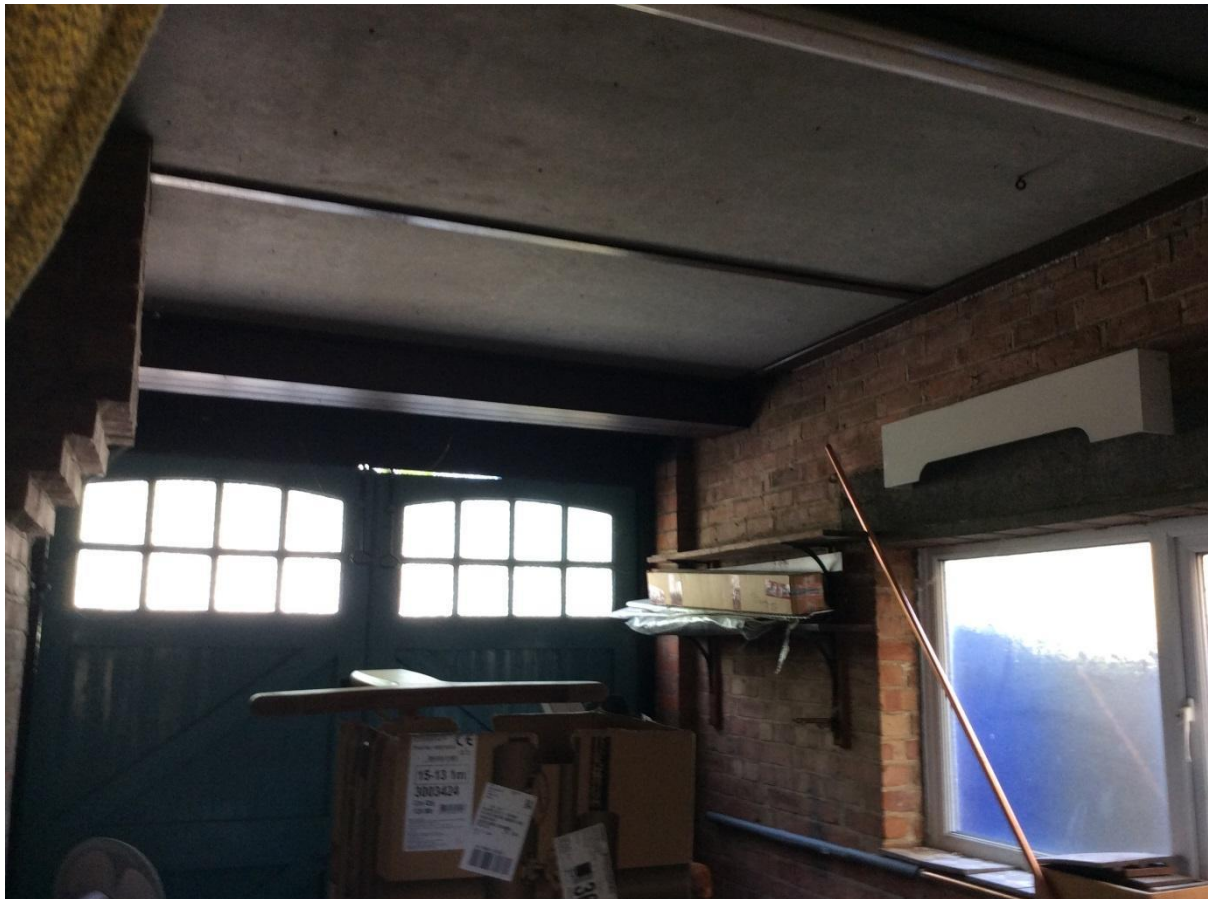
**Fig 6. Interior of garage.**

The tiles, soffits etc. were all in excellent order with no obvious access points. The tiled roof over the garage had a couple of broken tiles but the stubs were still *in situ* so no access point had been created.
