# Bat Survey Report – Preliminary Roost Assessment

78 Tilehurst Road, Reading RG30 2LU

February 2019

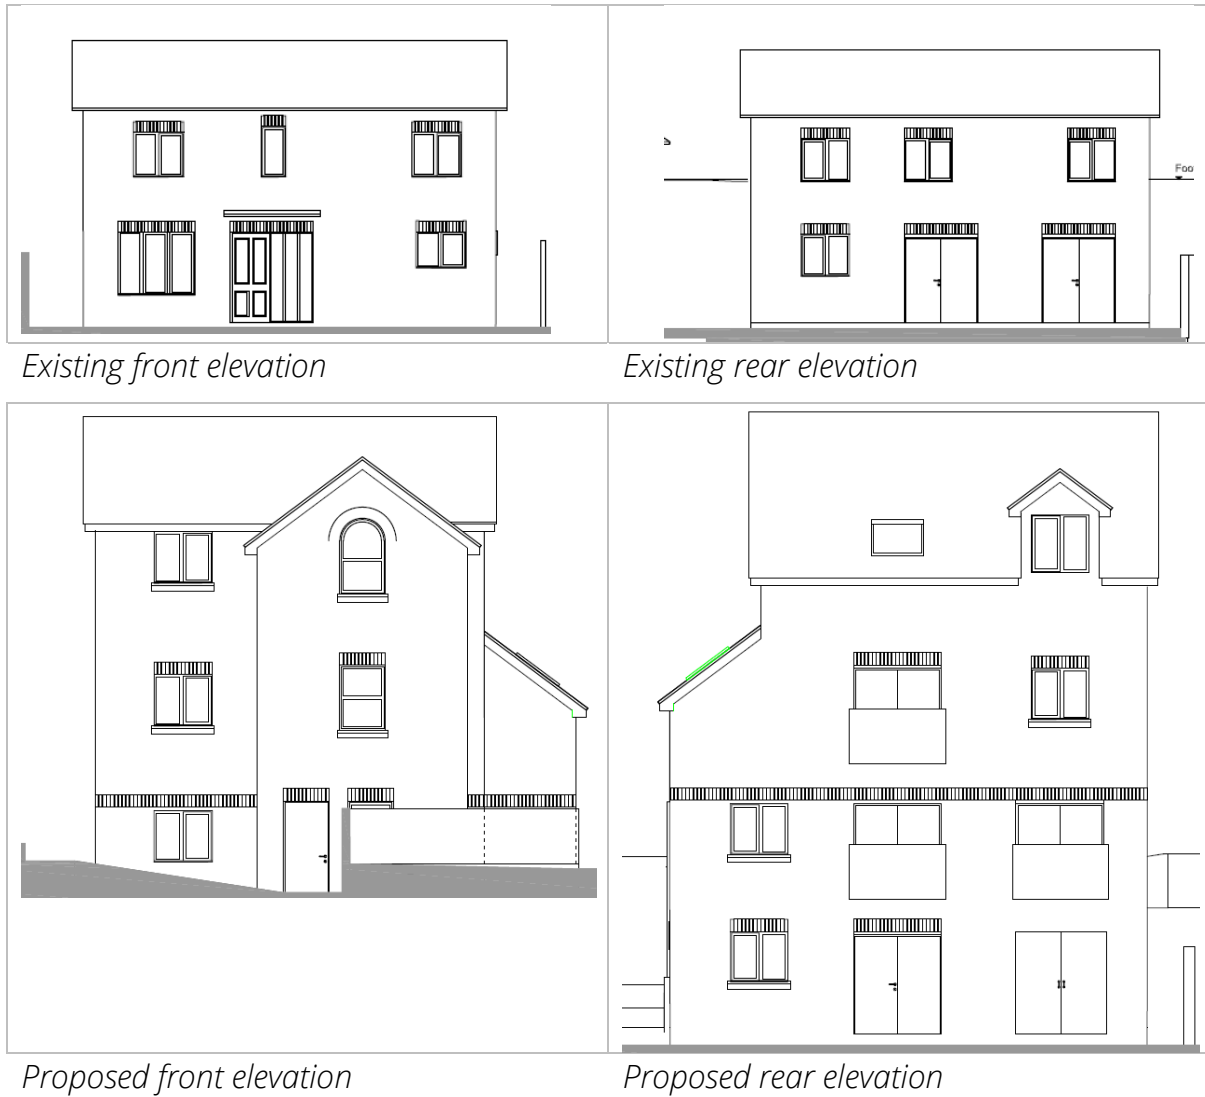
- 1.6. The development is for the extension to the property to create further floors above the existing first floor, and subsequent conversion into flats as shown in Figure 1. This will require the existing roof to be removed.

Figure 1 – Existing and proposed elevations<sup>1</sup>

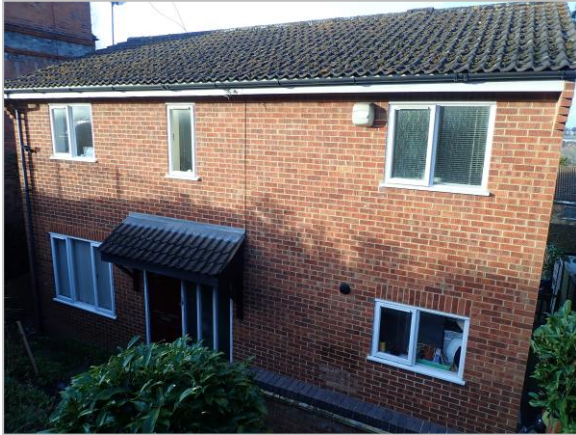
- 1.2. 78 Tilehurst Road is a relatively modern detached house, believed to date from the later part of the 20<sup>th</sup> Century.
- 1.3. It is set within an extensive mature residential area towards the west of Reading, on the north-facing slope of the valley of the River Thames. The house faces south onto Tilehurst Road, with the main ridge running east-west. See Photo 1 in the photo sheet in Appendix 1.

*Photo 1 Front (south) elevation*

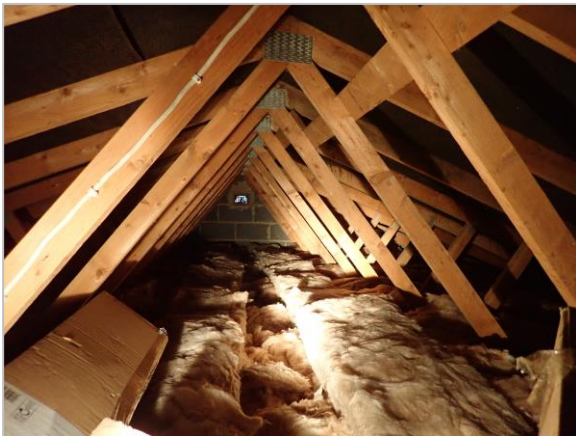
- 3.6. Internally, the loft was readily accessible. A detailed examination of all surfaces, including internal timbers, floors, insulation, walls, and stored items was carried out. Particular attention was paid to features such as the ridge apex at either end of the loft and joints in the timber work. Photos 3 and 4 show the general internal conditions of the loft.

*Photo 3 General conditions in loft*

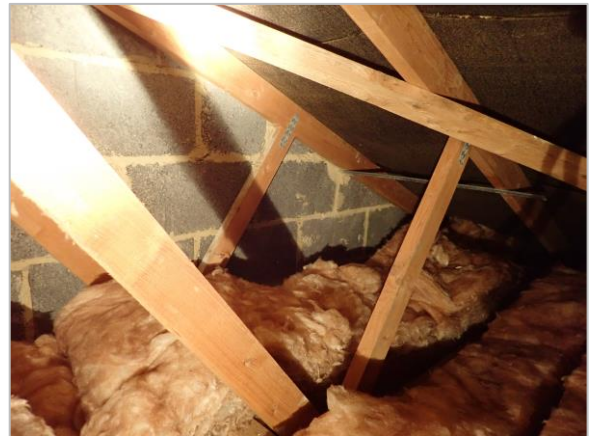
*Photo 4 General conditions in loft*

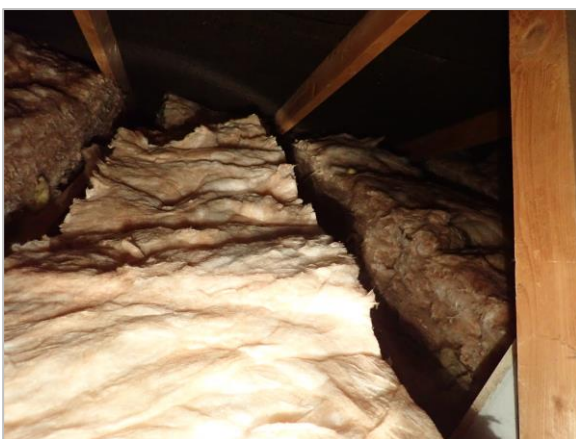
- 3.7. No droppings were noted on any of the floor areas, either the boarding or the top of the insulation (Photos 5 and 6). There is a deep layer of newer insulation laid over an older layer. Spot checks under both layers of insulation found no recent or historic evidence of bat presence.

*Photo 5 Insulation in loft*

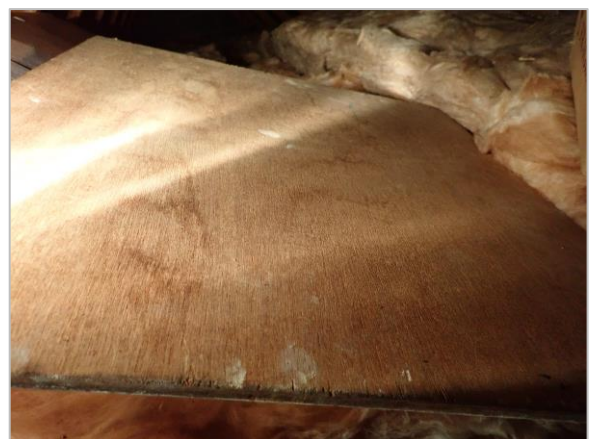
*Photo 6 Boarding in loft*

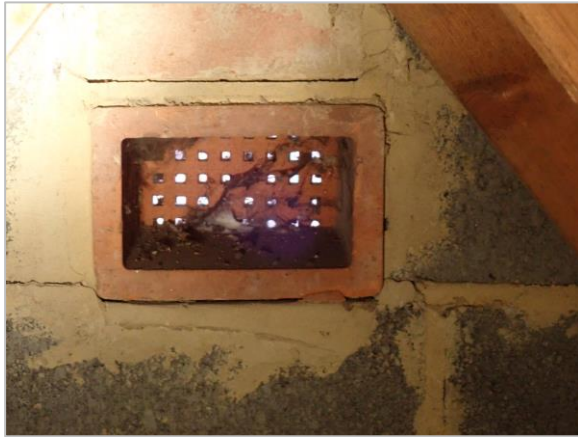
- 3.8. The gable apexes were carefully examined, along with the floor areas beneath these. No evidence of bat activity was noted. There is an airbrick to the western end (Photos 7 and 8); the holes in this are too small to allow bat access.

*Photo 7 Airbrick to western gable*

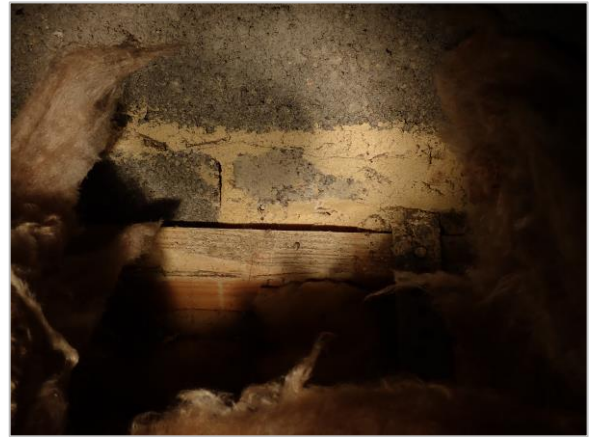
*Photo 8 Floor beneath gable apex*

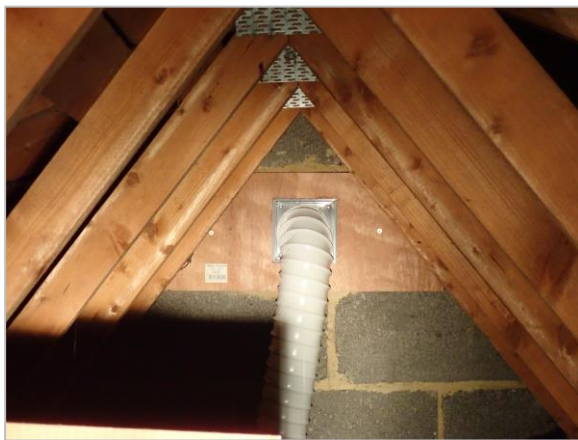
- 3.9. There is a vent pipe to the east end (Photo 9), and no gaps were noted around this and no bat evidence noted. There is also a vent to the ridge towards the eastern end (Photo 10). This is capped with a vented ridge tile (see Photo 12) and the vent itself inside the loft is smooth circular metal. Although there was a small amount of windblown debris and dust on the insulation below this, careful inspection found no bat evidence (Photo 11).

*Photo 9 Vent pipe to eastern gable end*

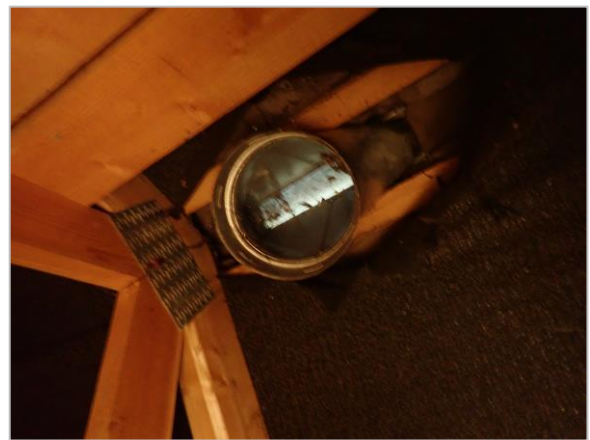
*Photo 10 Ridge vent*

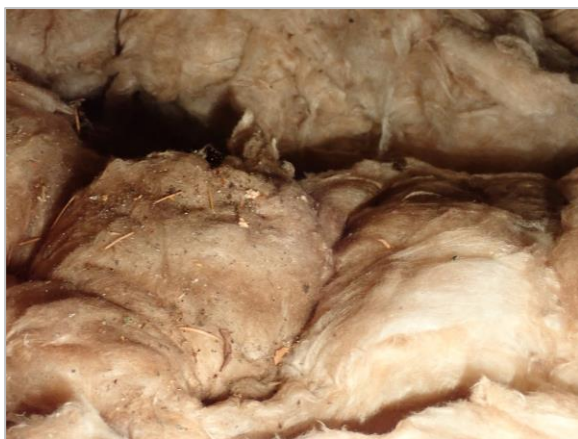
*Photo 11 Insulation beneath ridge vent*

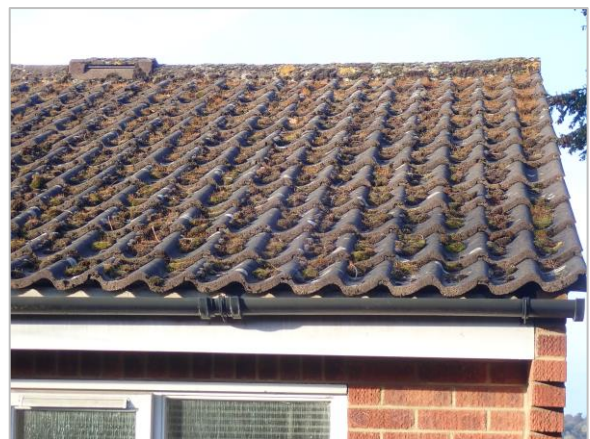
3.11. Externally, the concrete pantiles across the front and rear faces of the roof were found to be in good condition with no areas of slipped, missing, or damaged tiles (Photos 12 and 13). Heavy moss was noted in many areas.

*Photo 12 Roof tiles, front elevation*

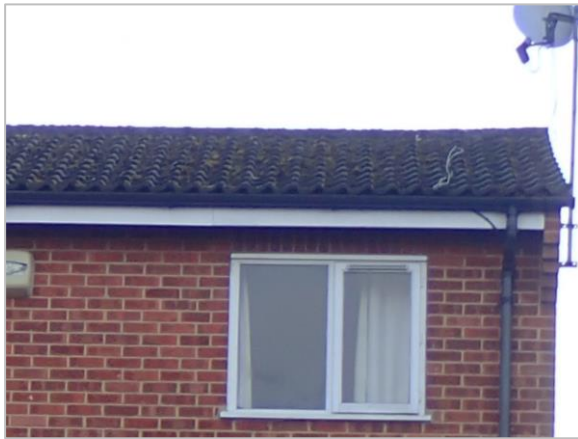
*Photo 13 Tiles to rear elevation*

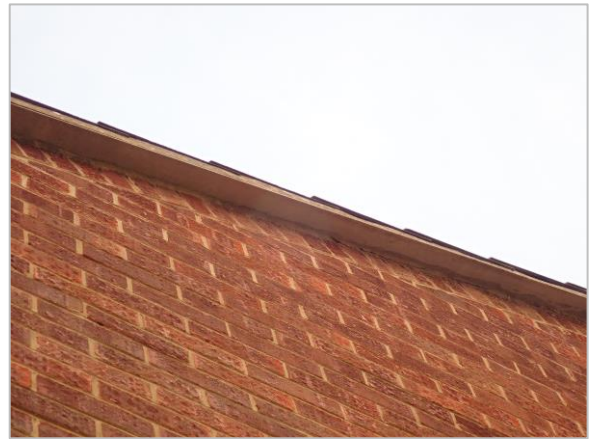
3.12. The ridge tiles were well mortared in and the verge mortar was in good condition with no apparent deterioration that might allow bat access (Photo 14). Soffits were found to be tight to the external walls with no gaps present of sufficient size to allow bat access (Photo 15).

*Photo 14 Verge in good condition*

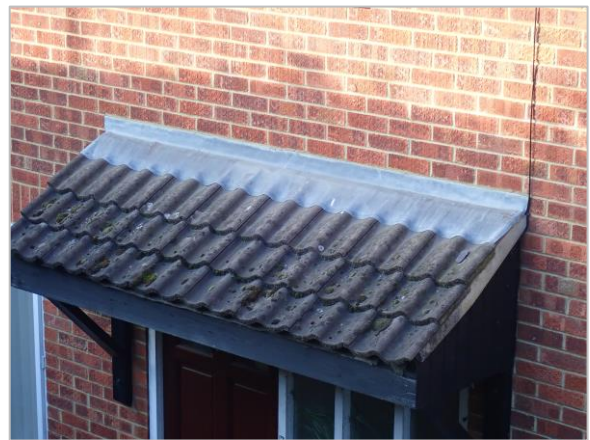
3.13. There is a small open porch to the front of the house. The tiles on this were in good condition, as was the flashing around the top with the external wall. No potential roost locations or roost access points were noted (Photo 16).

*Photo 16 Porch roof in good condition;  
no gaps to flashing*

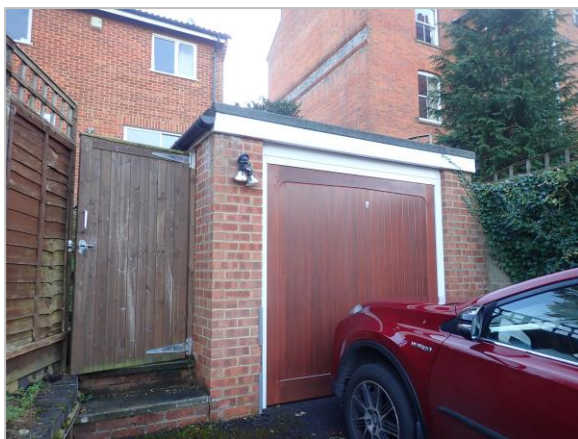
3.14. The garage is a simple flat-roofed structure with no internal void. The plastic fascia boards around the edge of the flat roof were tight to the external brickwork. There were no potential roost locations noted to the externals of the garage (Photo 17).

*Photo 17 Garage*
