**Project:** 108 London Street, Reading RG1 4SJ  
**Client:** Aspire 108 London Street Limited

**Date:** 10/07/2018  
**Reference:** 20180710\_4184\_GBV\_001.docx

| <b>Report Title:</b> | Groundborne Vibration Assessment | | | |

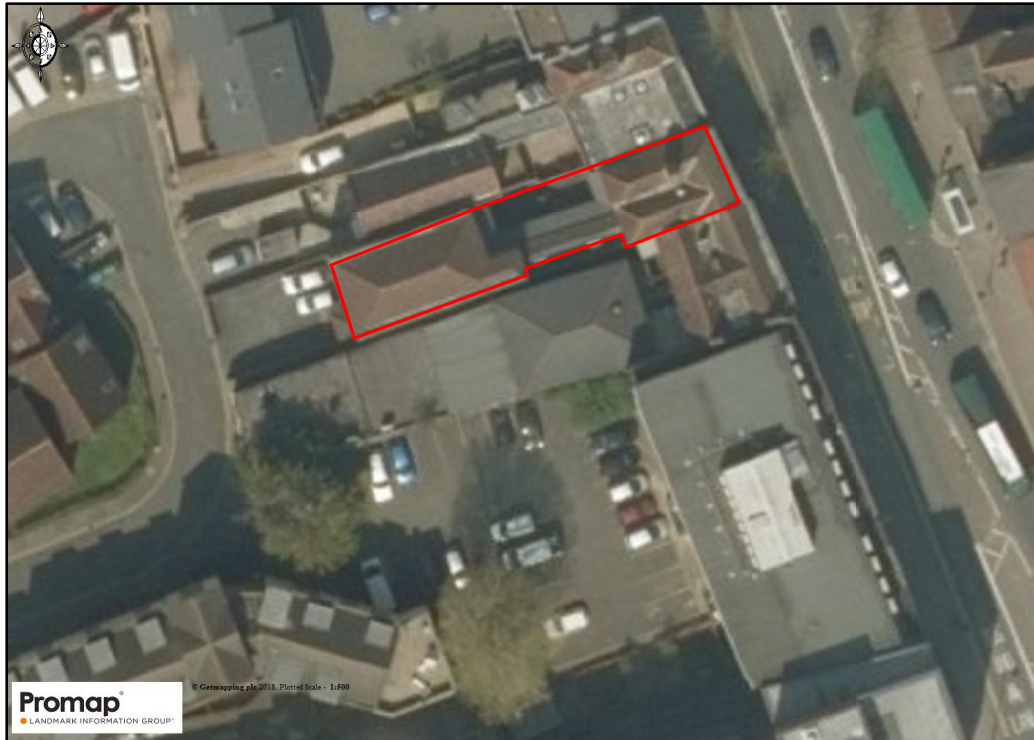
The site and adjoining land uses is illustrated in Figure 1 below.

Figure 1: Site location

The site lies in an area which is characterised by mix of residential, commercial and retail premises. The eastern elevation of the scheme overlooks London Street, a moderately trafficked one-way route having a junction with London Road/Crown Street to the south and the A329 to the north.

The After Dark Club flanks the scheme to the south, with residential premises being evident to the north.

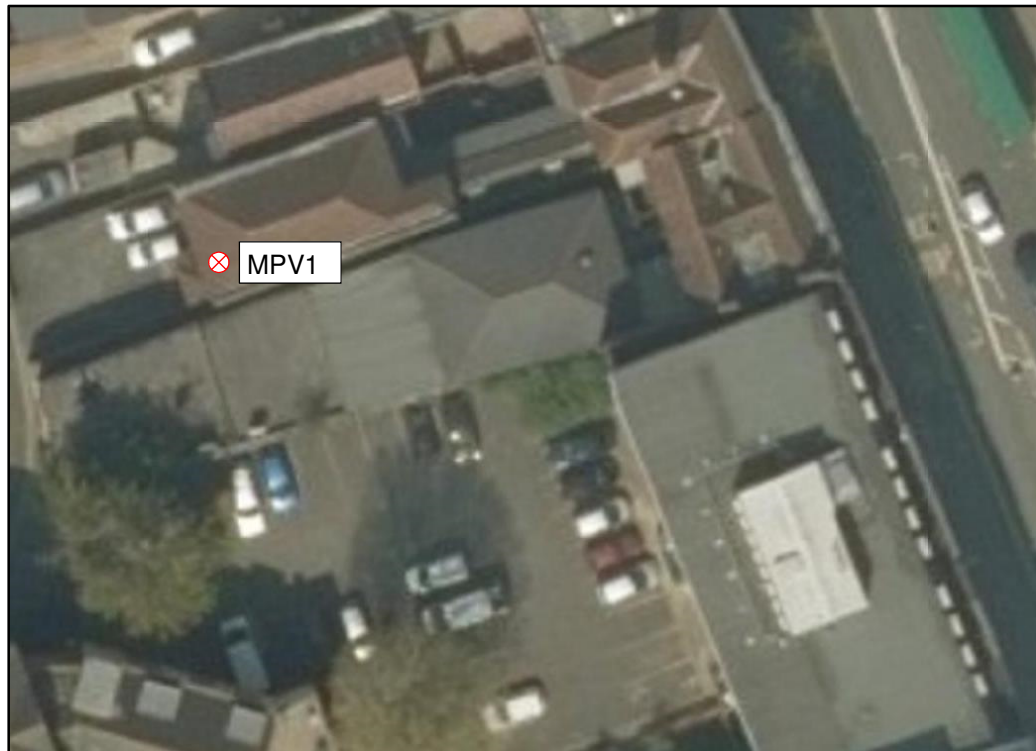
A vibration survey was carried out over the 14<sup>th</sup> to 19<sup>th</sup> March 2018 at the location illustrated by Figure 2 and described below. The survey period encompassed a Friday and Saturday night and thus included two nights of activity within the After Dark Club.

- **MPV1:** Prince Regent House, southeast corner of ground floor level slab

Figure 2: Vibration monitoring location

The monitoring location was selected to be as close as possible to the boundary with the After Dark Club, with a view to quantifying worst case vibration exposure.
