# **HERITAGE STATEMENT**

**11 Friar Street, Reading**

EH1904-1

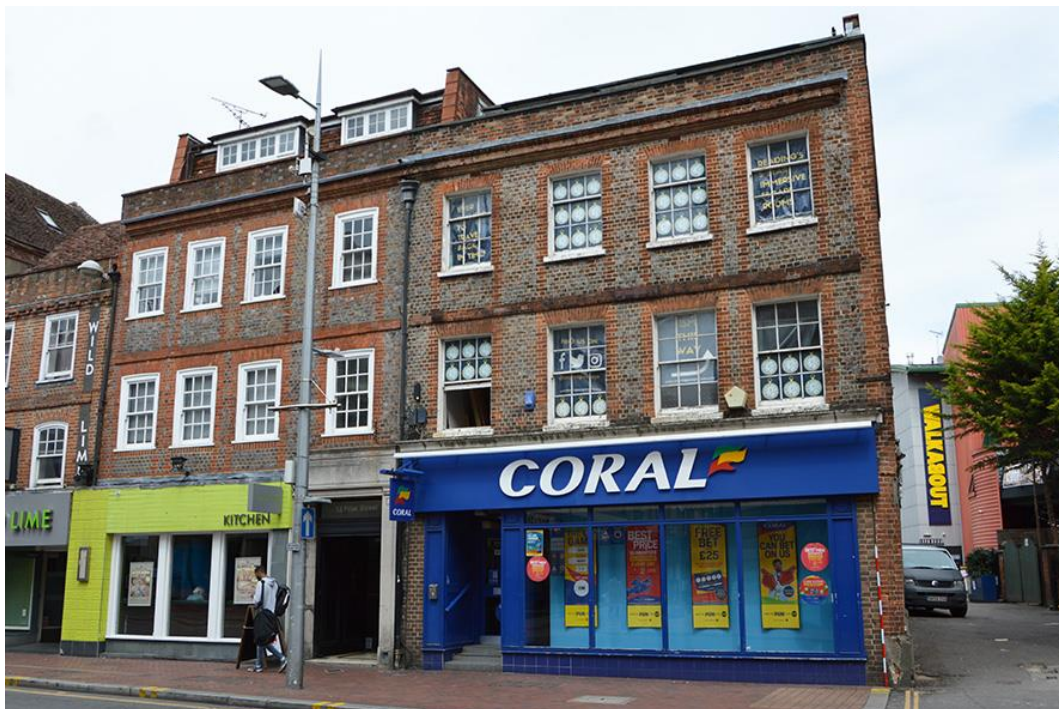
Plate 1: Friar Street elevation of 11 (right) and 12 (left) Friar Street from the south east

The frontage of the building faces on to Friar Street. It is a three-storey building with attic space that is matched by the adjoining structure (Plate 1). The ground floor of number 11 (Plate 2) has a large modern shop front with its entrance situated to the left-hand side. The first and second floors each have four multi-pane sash windows in flat-arched openings. There is a raised brick string band between the first and second floors. Above the second-floor windows is a moulded brick cornice which is topped with a brick parapet. The attic space is not visible from the Friar Street elevation.

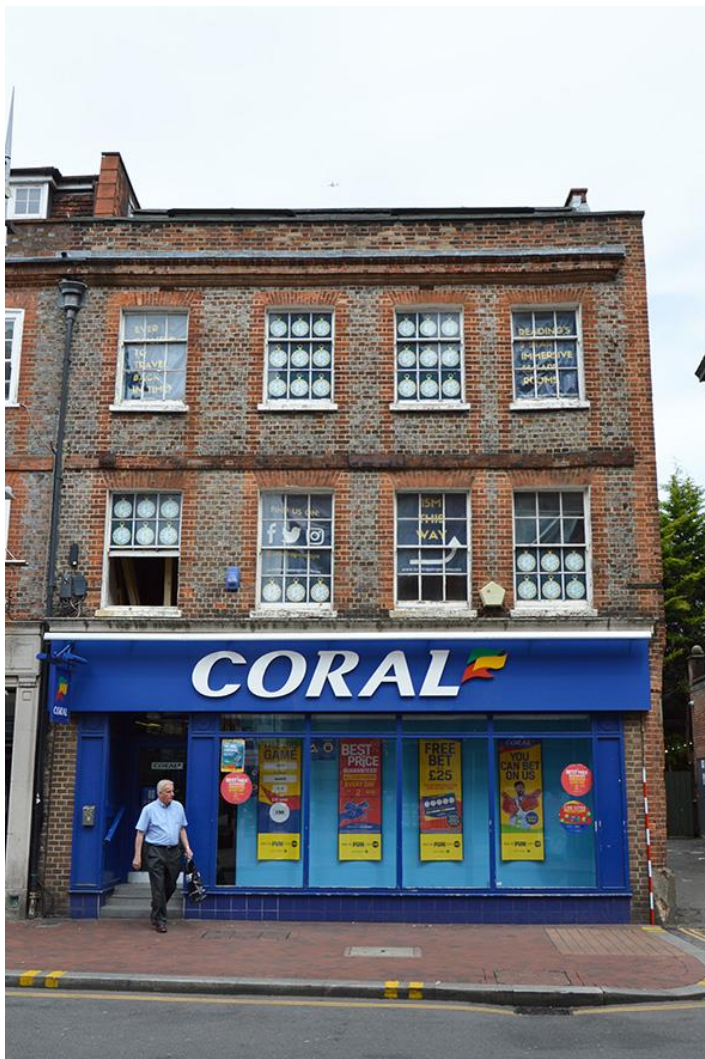
Plate 2: 11 Friar Street elevation from the south

The brickwork is an unusual silver grey in colour with red window surrounds, and lintels. The brick string band and cornice are also of red brick along with the quoins down the right corner. The parapet is also mostly red brick.

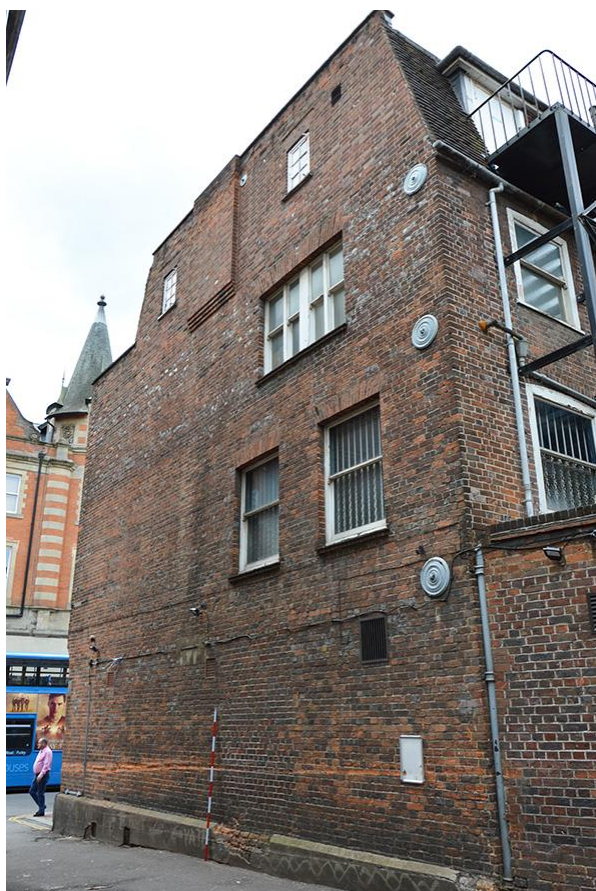
The eastern elevation of the building is on Wiston Terrace. The main part of the building is at the Friar Street end of the terrace (Plate 3) and is mainly red brick coursed in English Bond. There are

two flat-arched window openings containing sashes at first floor level with a large flat-arched opening above this containing four individual sashes. At third floor level are two small flat-arched openings with casements. These are either side of a chamfered chimney stack which has been capped.

Plate 3: Wiston Terrace elevation from north east

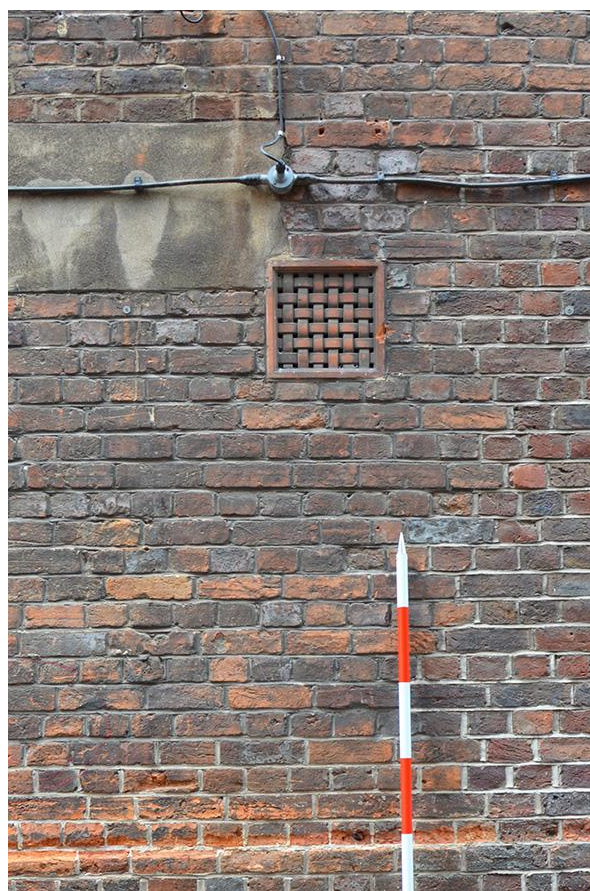
At ground level are two terracotta ventilation grills (Plate 4) in a woven design and a large metal ventilation grill. A bull's eye pattern plate (Plate 3) at each floor level shows the building has been tied to the adjoining structure.

Plate 4: Wiston Terrace elevation, woven terracotta ventilation grill

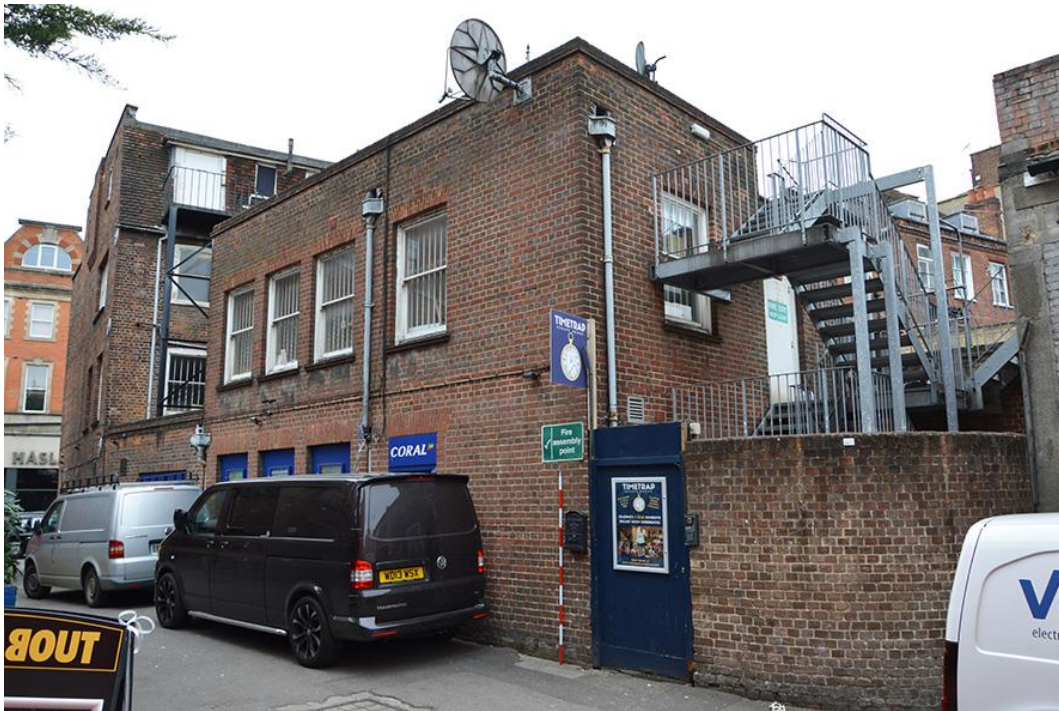
The rest of the Wiston Terrace elevation consists of the east walls of two extensions to the main building (Plate 5). The central section is of single-storey height with a flat roof. It has a large flat-arched opening which has been blocked and the brickwork is coursed in English Bond (Plate 6). There is a large metal ventilation grill within the elevation and a cornice is formed of three courses of terracotta tiles. This is topped with header bricks on their side to form a parapet.

Plate 5: Rear part of Wiston Terrace elevation from north east

As can be seen in Plate 5, the majority of the northern, rear, elevation of the building is hidden by extensions and fire escapes. The most northerly part of the building is the two-storey extension (Plate 7). The northern elevation of this contains a flat-arched opening with a sash window at first floor level and a doorway at ground floor level. A fire escape hides much of the elevation (Plate 5) and a doorway opens onto it at first floor level.

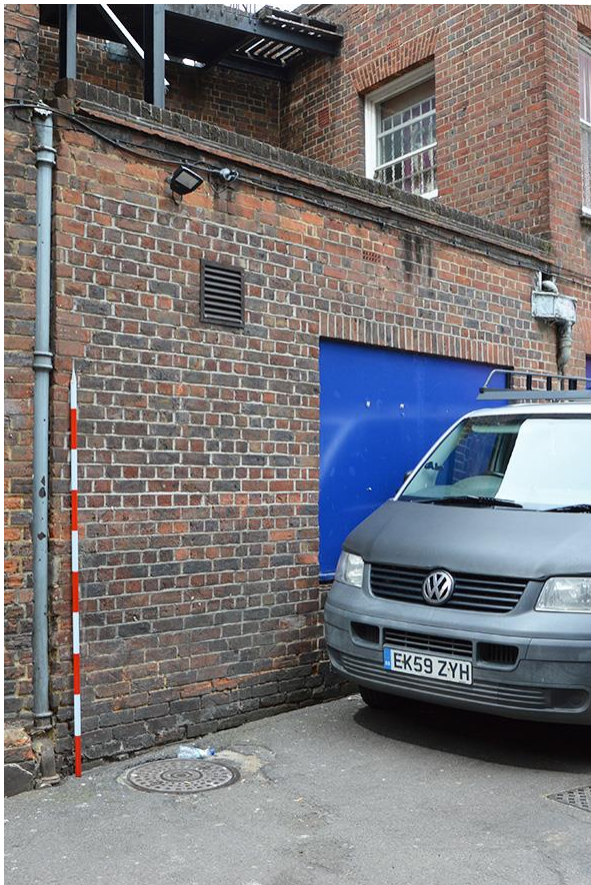
Plate 6: Wiston Terrace elevation central section

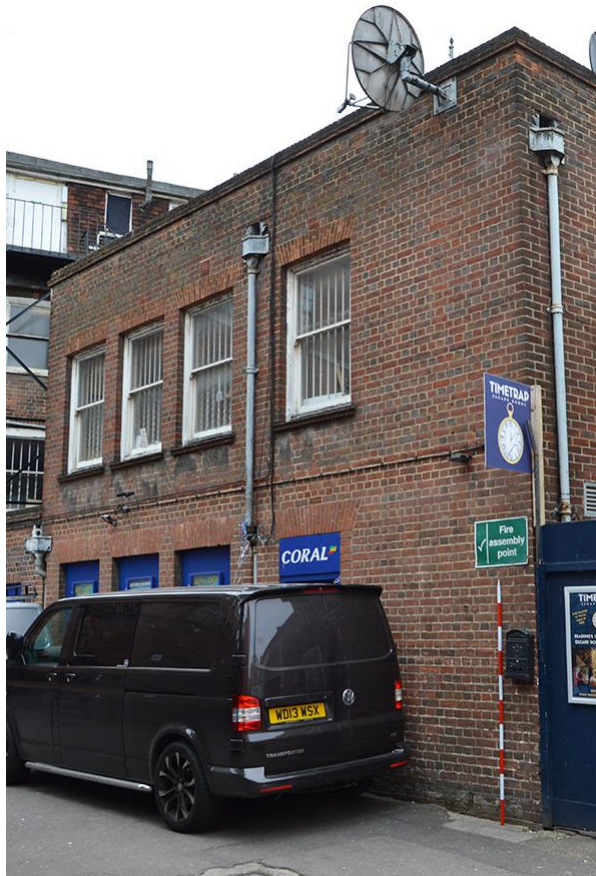
The section to the rear of this is two-storeys in height, also with a flat roof (Plate 7). It has three blocked flat-arched window openings on the ground floor along side a further opening now used as a door. On the first floor are four flat-arched window openings containing sash windows with moulded brick cills. A number of the openings have terracotta ventilation bricks over them. The brickwork is coursed in English Bond and is topped with the same cornice and parapet arrangement as the adjoining section of the building.

Plate 7: Wiston Terrace elevation back section

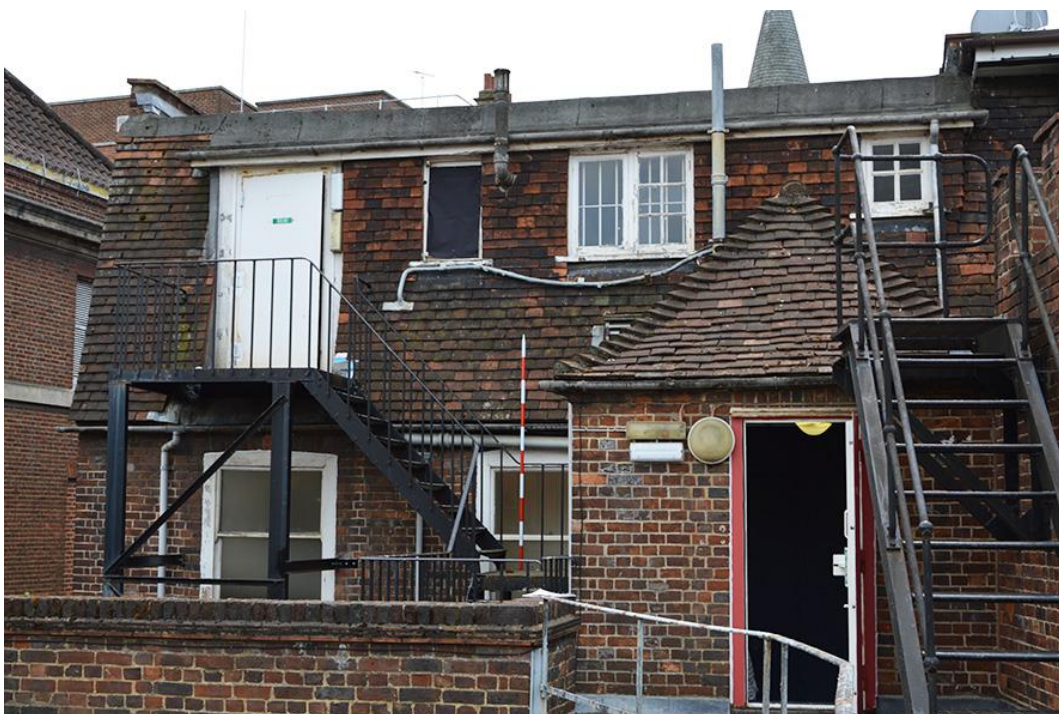
Only the upper floors of the northern elevation of the main building are visible (Plate 8) and these are again partially blocked by fire escapes. The top floor of the building has a terracotta tiled exterior with the third floor being brick, coursed in English Bond. The third floor also has two sash windows in segmental arched openings. The upper floor has three casement windows and a doorway opening on to one of the fire escapes. Attached to the elevation is a small extension with terracotta tile covered hipped roof and a flat-arched fire door.

Plate 8: Northern elevation of main building from north

The most visible change to the second floor of the building will be the proposed removal of the metal fire escapes (see Plate 8). These fire escapes are probably mid 20<sup>th</sup> century in date and clash significantly with the appearance and age of the listed building.

The mid 20<sup>th</sup> century metal fire escape do not blend with the early 18<sup>th</sup> century fabric of the listed building. They distract from its appearance and hide sections of the building. Removal of these will be an **improvement** to the fabric of the listed building and its setting.

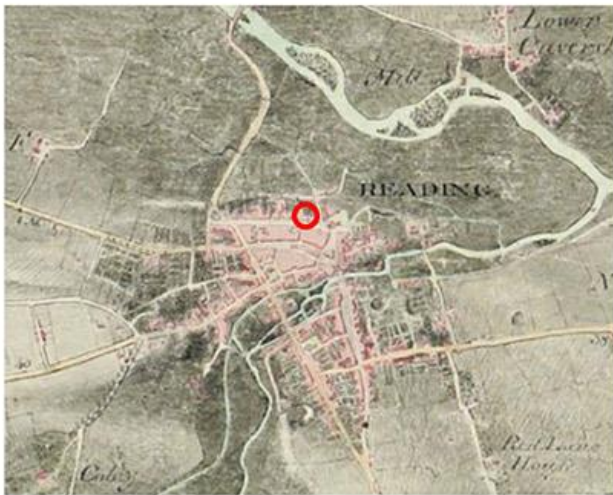
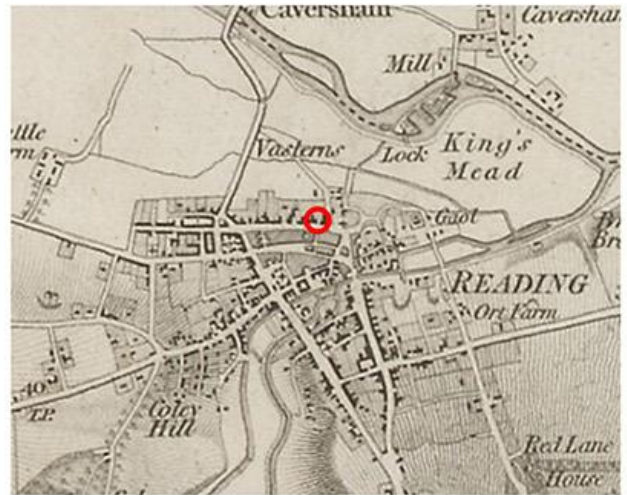
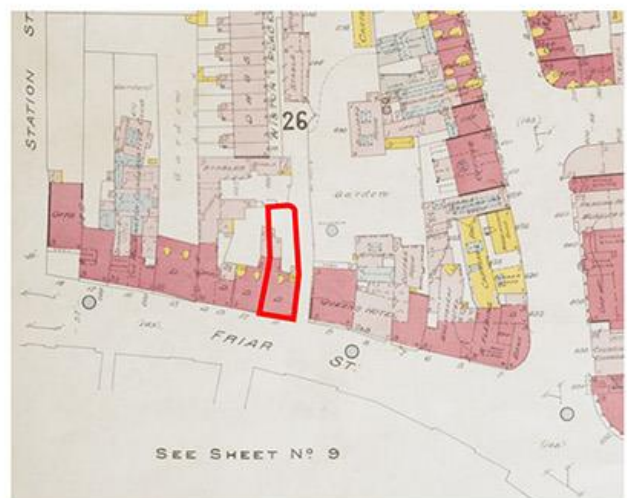
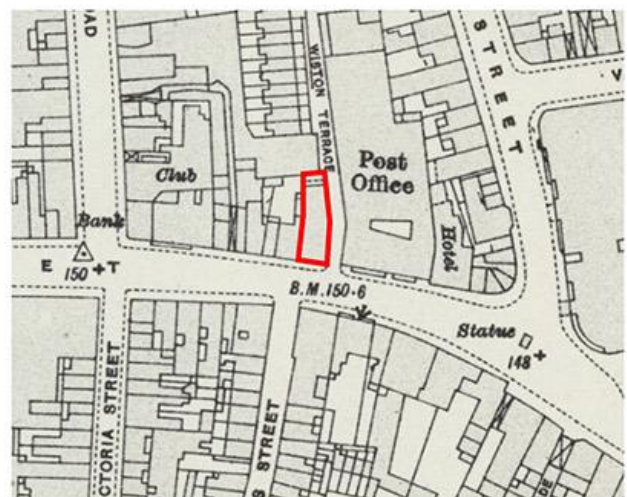
Figure 2 Historic mapping of the area of 11 Friar Street  
(with site marked)

Historic mapping of Reading goes back to the 16<sup>th</sup> and 17<sup>th</sup> centuries but shows little detail of the town and its layout. The first of the historic maps to show the layout of Reading is the 1809 Dawson plan (Fig 2). This map shows the area of 11 Friar Street but does not show individual building details. This is repeated on the 1830 Ordnance Survey first series (Fig 2).

The first map that shows any detail of the buildings within Reading is the 1875 Ordnance Survey (Fig 2). 11 Friar Street is shown on the corner of Wiston Terrace. The main part of the building fronts Friar Street. To the rear the main building projects along the boundary with 12 Friar Street and has two extensions along this boundary. These are mirrored on 12 Friar Street. To the right of the rear elevation is a small extension that has the boundary wall attached to it. The 1879 1:500 Ordnance Survey not only shows the buildings but walls, gateways, paths and items such as fountains. The rear garden of 11 Friar Street has a pathway with a circular flower bed in it and a gateway to Wiston Terrace is shown in the boundary wall. A front step is depicted on the Friar Street side of the building close to a coal cellar entrance.

The Goad 1895 fire insurance plans of Reading are useful for the detail they show (Fig 2). 11 Friar Street is shown as a three-storey dwelling with a timber skylight on the rear part of the roof and a lath and plaster skylight within the rear wall. The rear right extension is marked as being two-storeys in height and the Wiston Terrace elevation has a window at ground floor level and another on the first floor. The 1898, 1909 and 1912 (Fig 2) Ordnance Surveys show no change to the layout of the building which is depicted in the same way as it was on the 1875 Ordnance Survey.

The first map to show any alteration in the layout of 11 Friar Street is the 1931 Ordnance Survey (Fig 2). This shows that the building has been extended to cover most of open space at the rear of the plot. This layout remains unaltered to the present day.

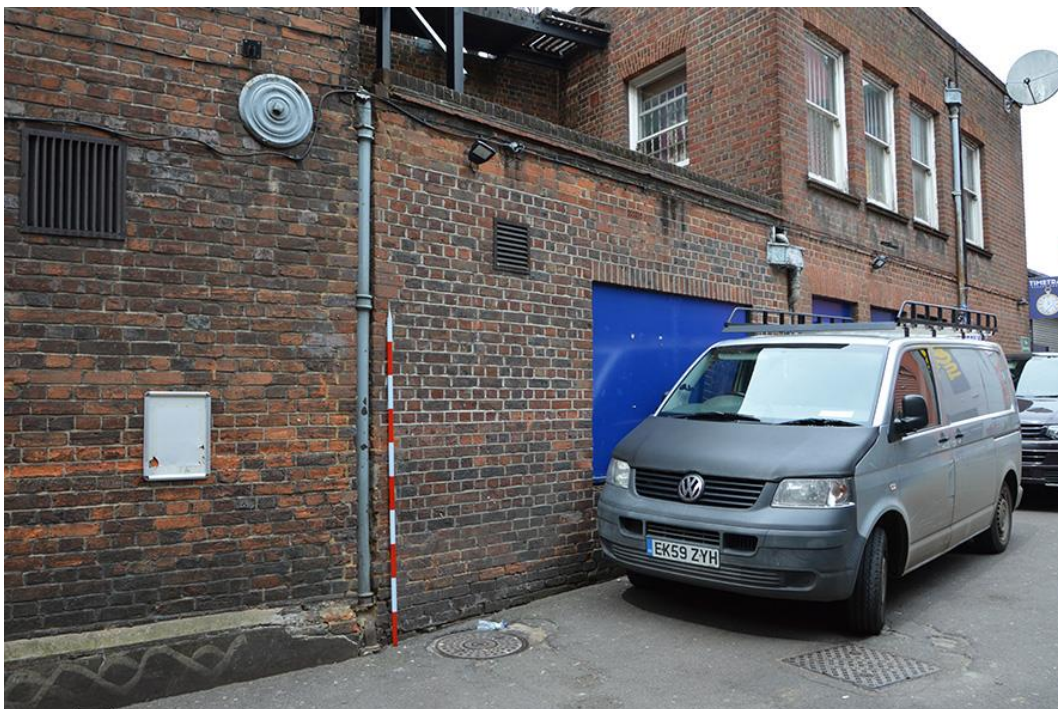
The plans (see Fig 3) show that a section of the Wiston Terrace wall, and its associated flat-roof structure, is proposed to be removed and new internal party walls would be constructed to house a new entrance lobby and stairs to the upper floors. The part of the building to be removed was added between 1912 and 1931, as shown by the historic maps included in Figure 2. The brickwork of the wall (Plate 9) can be seen as different to that of the main building (left in Plate 9) and matches that of the two-storey extension to the north (right in Plate 9) that was constructed at the same time. This brickwork is coursed in English Bond and measures 8 ¾" by 3 ½" by 2 ½".

Plate 9: Wall on Wiston Terrace proposed to be demolished

Whilst the wall and flat roof structure to be removed on the ground level are part of the listed building, and are therefore listed, they are around 200 years younger than the main building. The structure therefore only holds significance as part of the development of the listed building.

this part of the c1920s part of the building will cause **minor harm** to the listed building.

The setting of the listed building will be affected by the removal of the flat roofed structure and replacing it with, as is proposed, a glass fronted reception lobby and staircase. This will, however, improve the appearance of the Wiston Terrace elevation by causing the removal of the unsightly air-conditioning units, from the flat roof, and a metal fire escape. Therefore this will cause a **neutral** affect on the setting of the listed building.

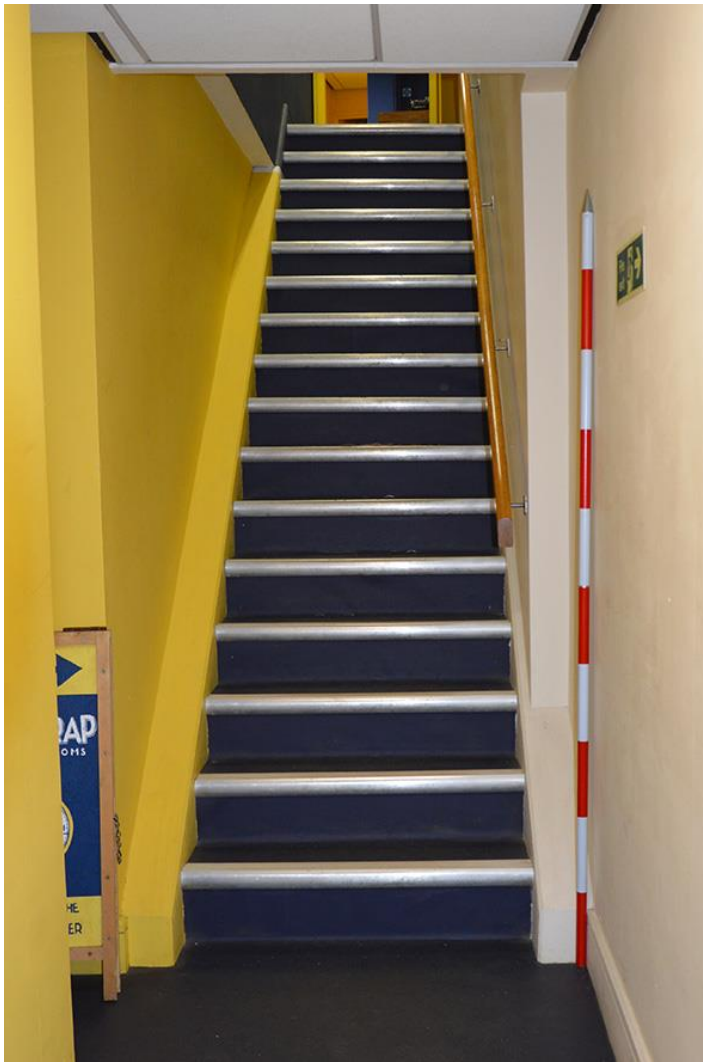
The plans for the first floor show that the staircase running from the ground to first floor is proposed to be removed with repairs made to floors, walls and ceiling following its removal. This staircase (Plate 10) is not very old and is a replacement for the ground to first floor staircase that was originally in the same position as the first and second floor staircases. The style of the staircase suggests that this replacement happened in the 1970s or 1980s.

Plate 10: Ground to first floor staircase in rear section of building

The ground to first floor staircase proposed to be removed holds little significance due to its age. It is also situated in a section of the building that was constructed in the 1920s, its removal will therefore not cause damage to the early 18<sup>th</sup> century structure.

The removal of the ground to first floor staircase will have little impact upon the building as it is a late 20<sup>th</sup> century addition into an early 20<sup>th</sup> century extension. Therefore, the removal of this staircase will cause **minor harm** to the building and its setting.

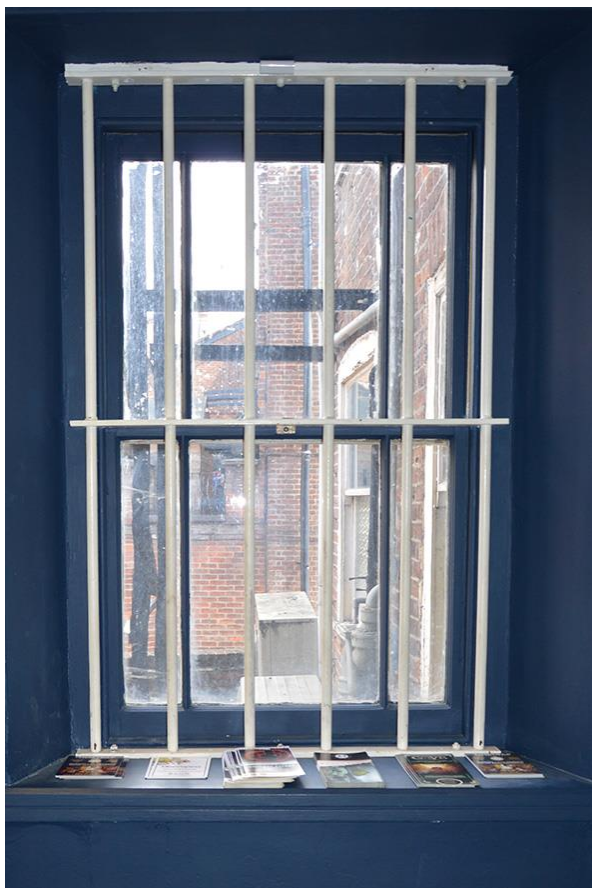
Plate 11: First floor window, identical to that proposed to be removed

The window opening to be altered in order to allow access into the new staircase and lobby has significance as part of the original structure of the listed building. The margin-light sash window that will be removed has less significance than the opening itself due the sash being a late 19<sup>th</sup> century replacement for earlier windows.

The removal of the window in order to provide access to the proposed new staircase and lobby will cause damage to the historic fabric of the building. The segmental head to the window will be retained with the margin-light sash window, the stone cill and brickwork beneath it being removed to create the doorway. This will cause **minor harm** to the fabric of the listed building.

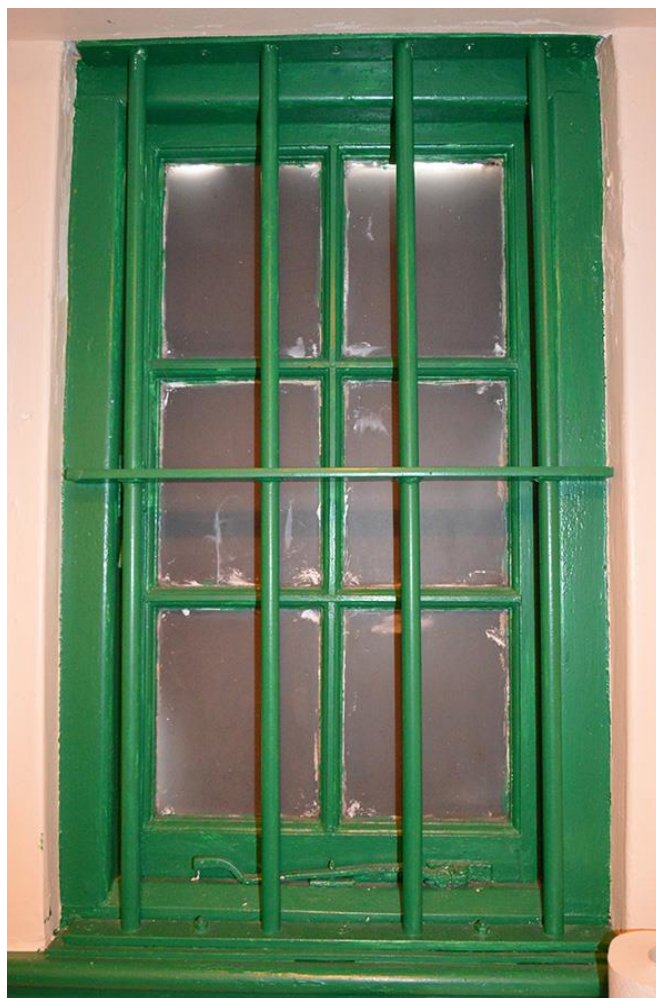
Plate 13: Original bathroom casement window on third floor

All of the third floor is proposed to be used as Flat 4. The layout of the floor is proposed to remain unchanged from the existing layout. Other than the usual redecoration, the only planned change is to remove the fire escape door, as the fire escape is being removed, and replace it with a new timber casement to match the adjacent windows which are to be retained (Plates 13 and 14).
