### **Phase 1 Preliminary Risk Assessment**

**READING METROPOLITAN  
CAVERSHAM ROAD, READING**

**PHASE 1 PRELIMINARY RISK ASSESSMENT**

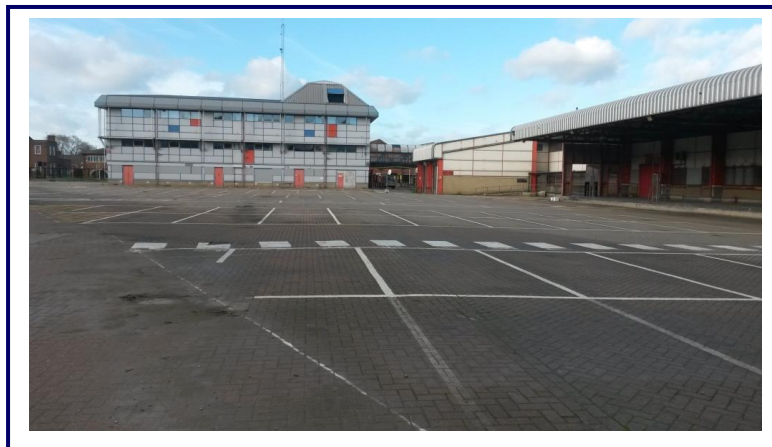
*General view of the site. For further photos see Appendix B.*

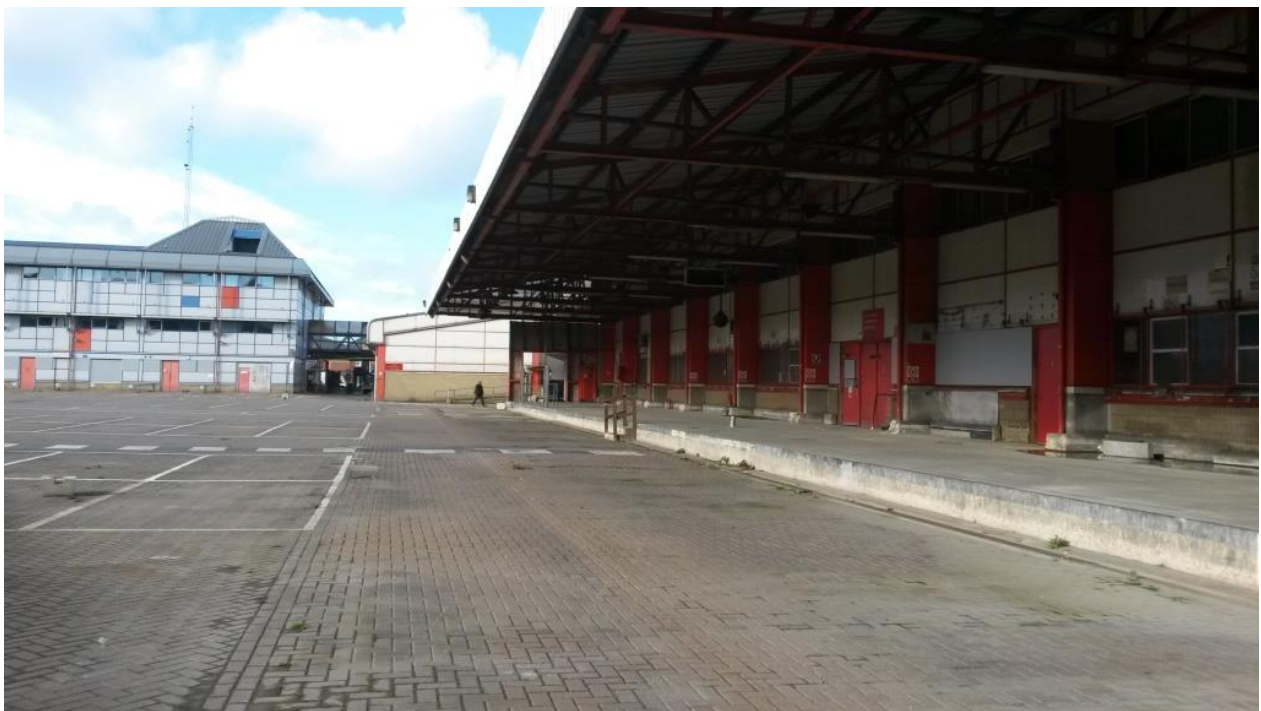
Photo 2: Raised concrete platform located to the south of the former sorting office.

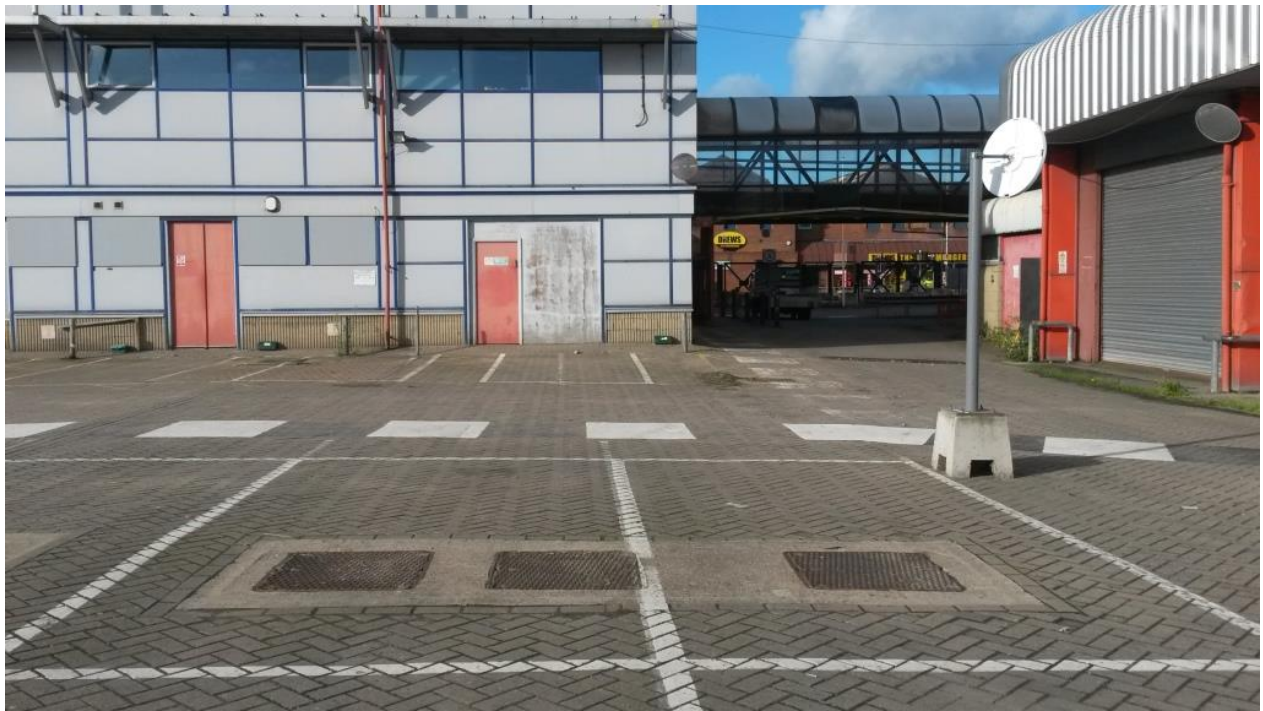
Photo 3: View of the office building to left with roller shutter doors of sorting office to right and walkway connected the two building in the background.

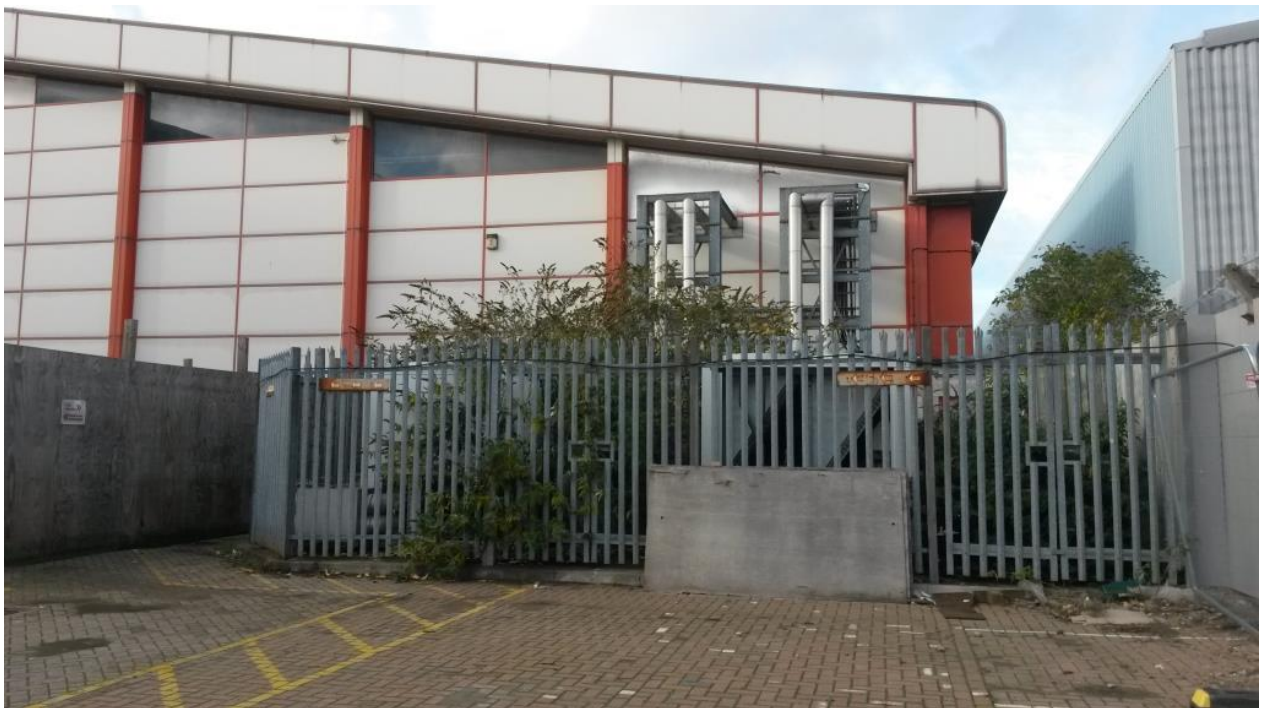
Photo 4: Overgrown likely former air handling equipment.

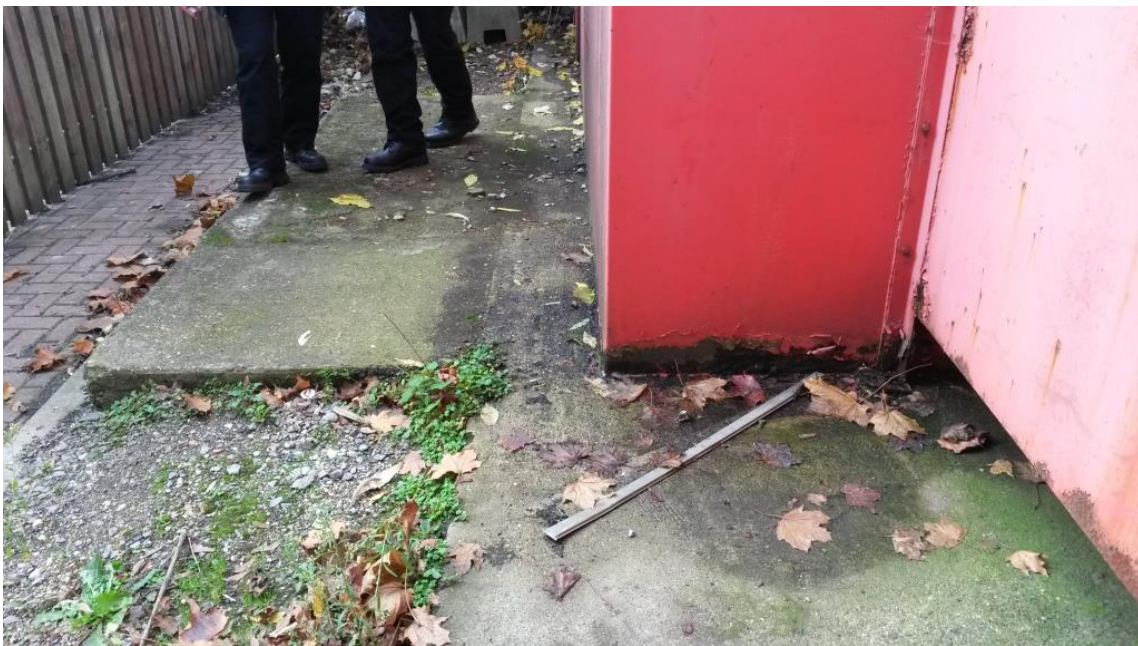
| <i>Bulk Storage / Tanks:</i> | A disused backup generator was observed in the northwest of the site. The generator was located within a metal unit on a concrete base. An approximately 200 litre capacity diesel storage tank was present within the generator unit. No other bulk fuel storage tanks were noted during the site walkover however it should be noted that areas to the east and north of the generator could not be accessed. Significant staining was observed internally to the generator unit (see Photo 7, Appendix B) with minor staining noted on the concrete base externally to the unit (see Photo 8, Appendix B). |

Photo 8: Minor staining noted on the concrete base externally to the generator unit.
