**GROUND INVESTIGATION REPORT**

**LAND TO THE REAR OF 36 - 46 MASON STREET, READING, BERKSHIRE RG1 7PD**

**LAUNCHPAD READING C/O POTTER WESTON ARCHITECTS**

| Report Reference: GWPR2040/GIR/JULY 2017 | | Status: FINAL |

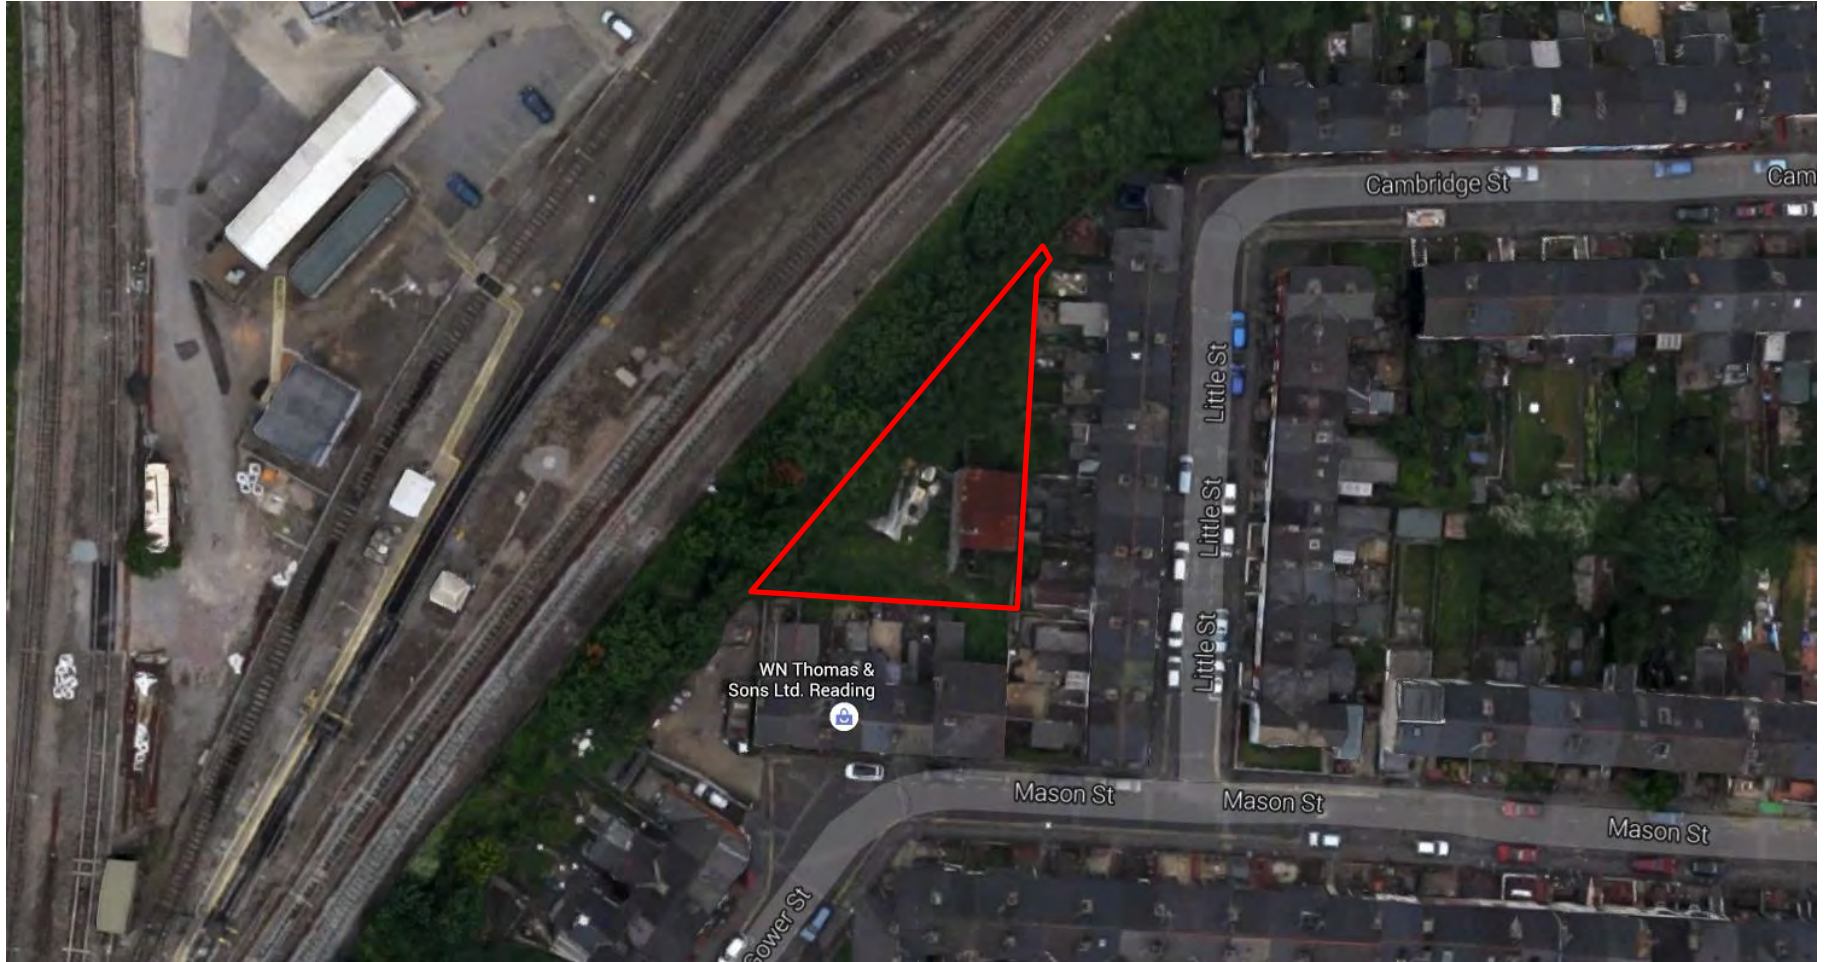
Figure 3

— APPROXIMATE SITE BOUNDARY

A Site Walkover was undertaken on the 5<sup>th</sup> November 2015. A description of the site, as noted during the Site Walkover, is tabulated below. An aerial view of the site showing an approximate site boundary, is given within Figure 3.

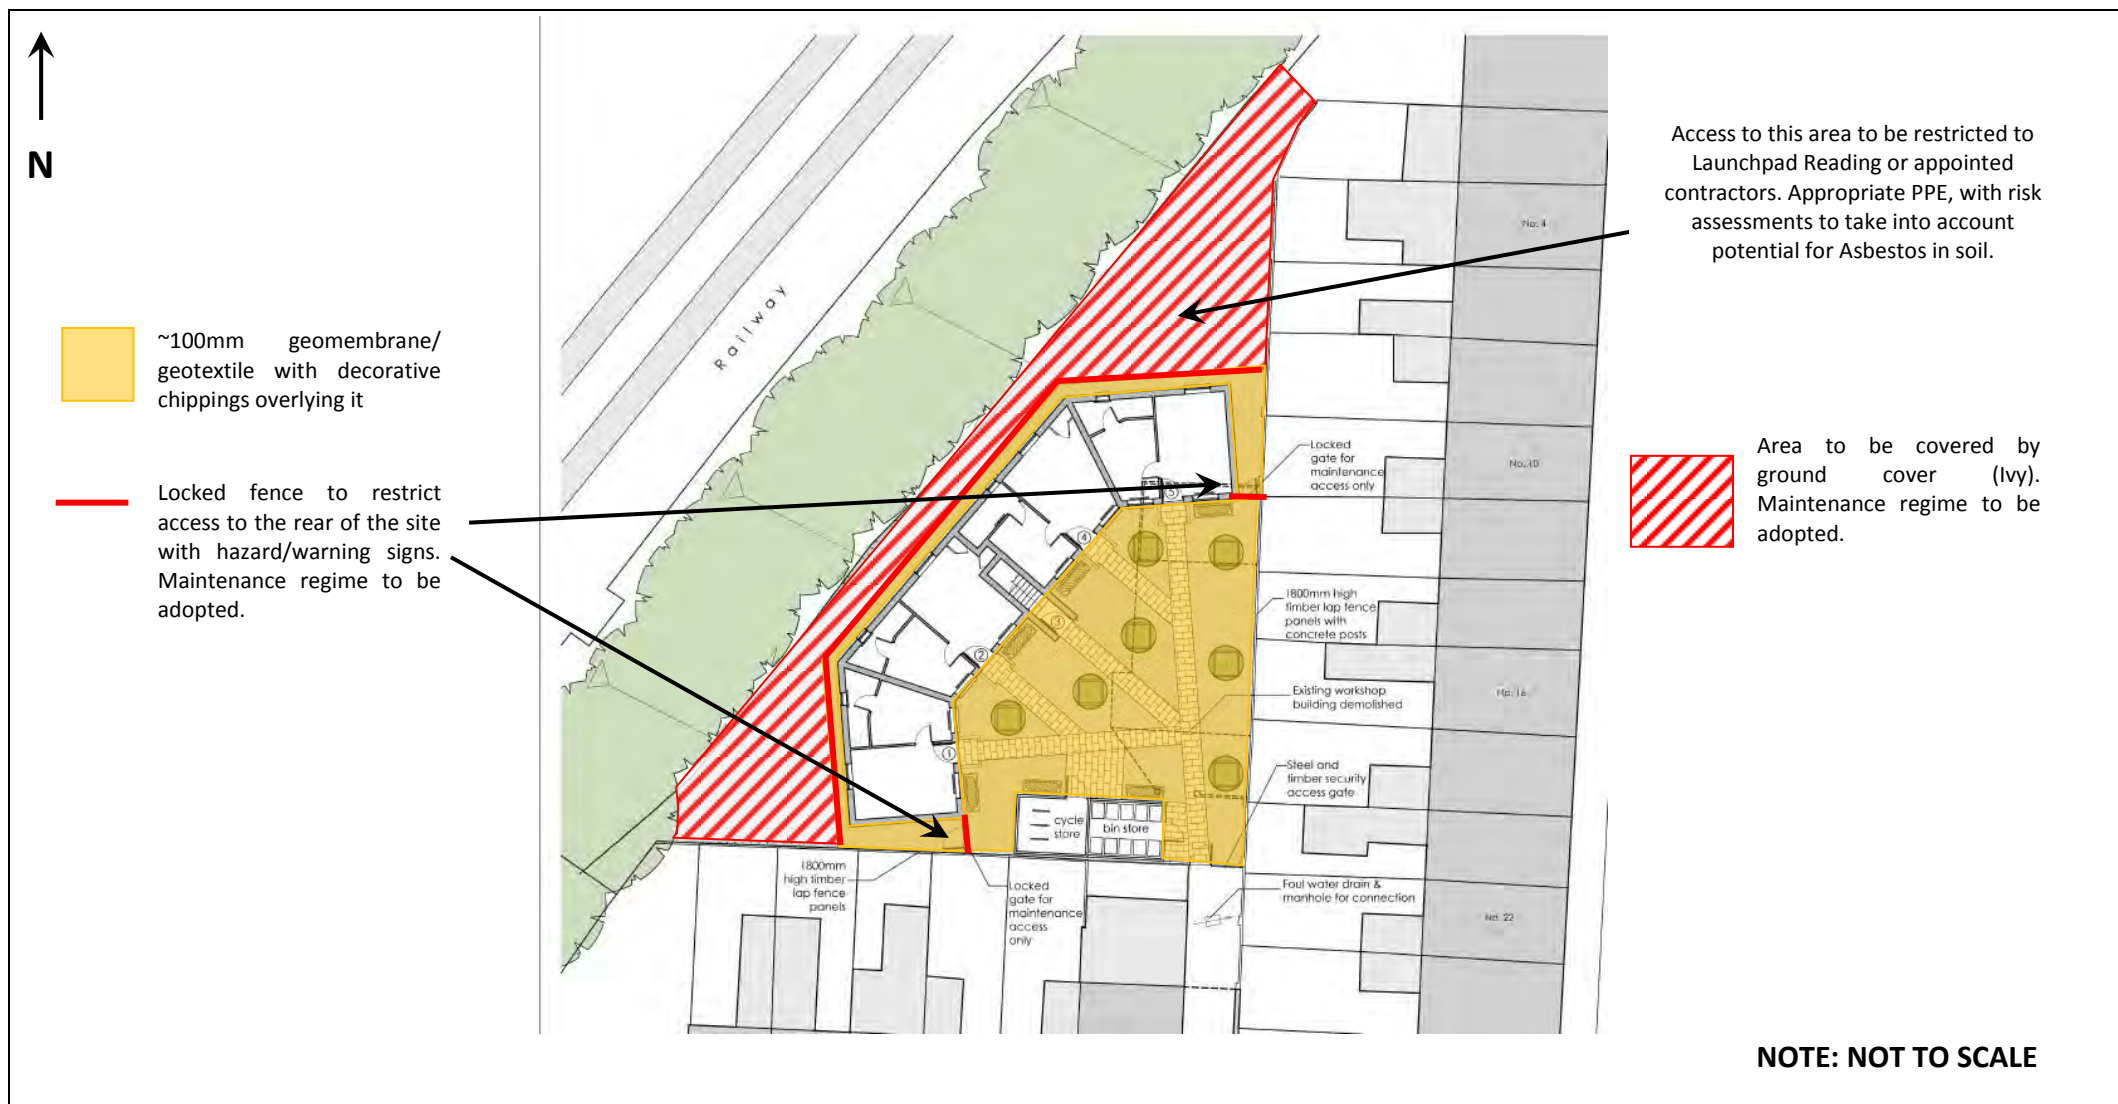
Figure 5

The approximate location of the trial holes can be seen within Figure 5.

The ground conditions encountered during the investigation are described in this section. The trial hole logs can be seen in Appendix B and the trial hole location plan can be viewed in Figure 5.

The methodology for sampling locations can be seen tabulated below. A trial hole location plan is given within Figure 5. A random sampling strategy was adopted.
