## **HIGHDOWN AVENUE**

### **PHASE 1 BAT SURVEY REPORT**

**HDA ref: 922.1**

**March 2019**

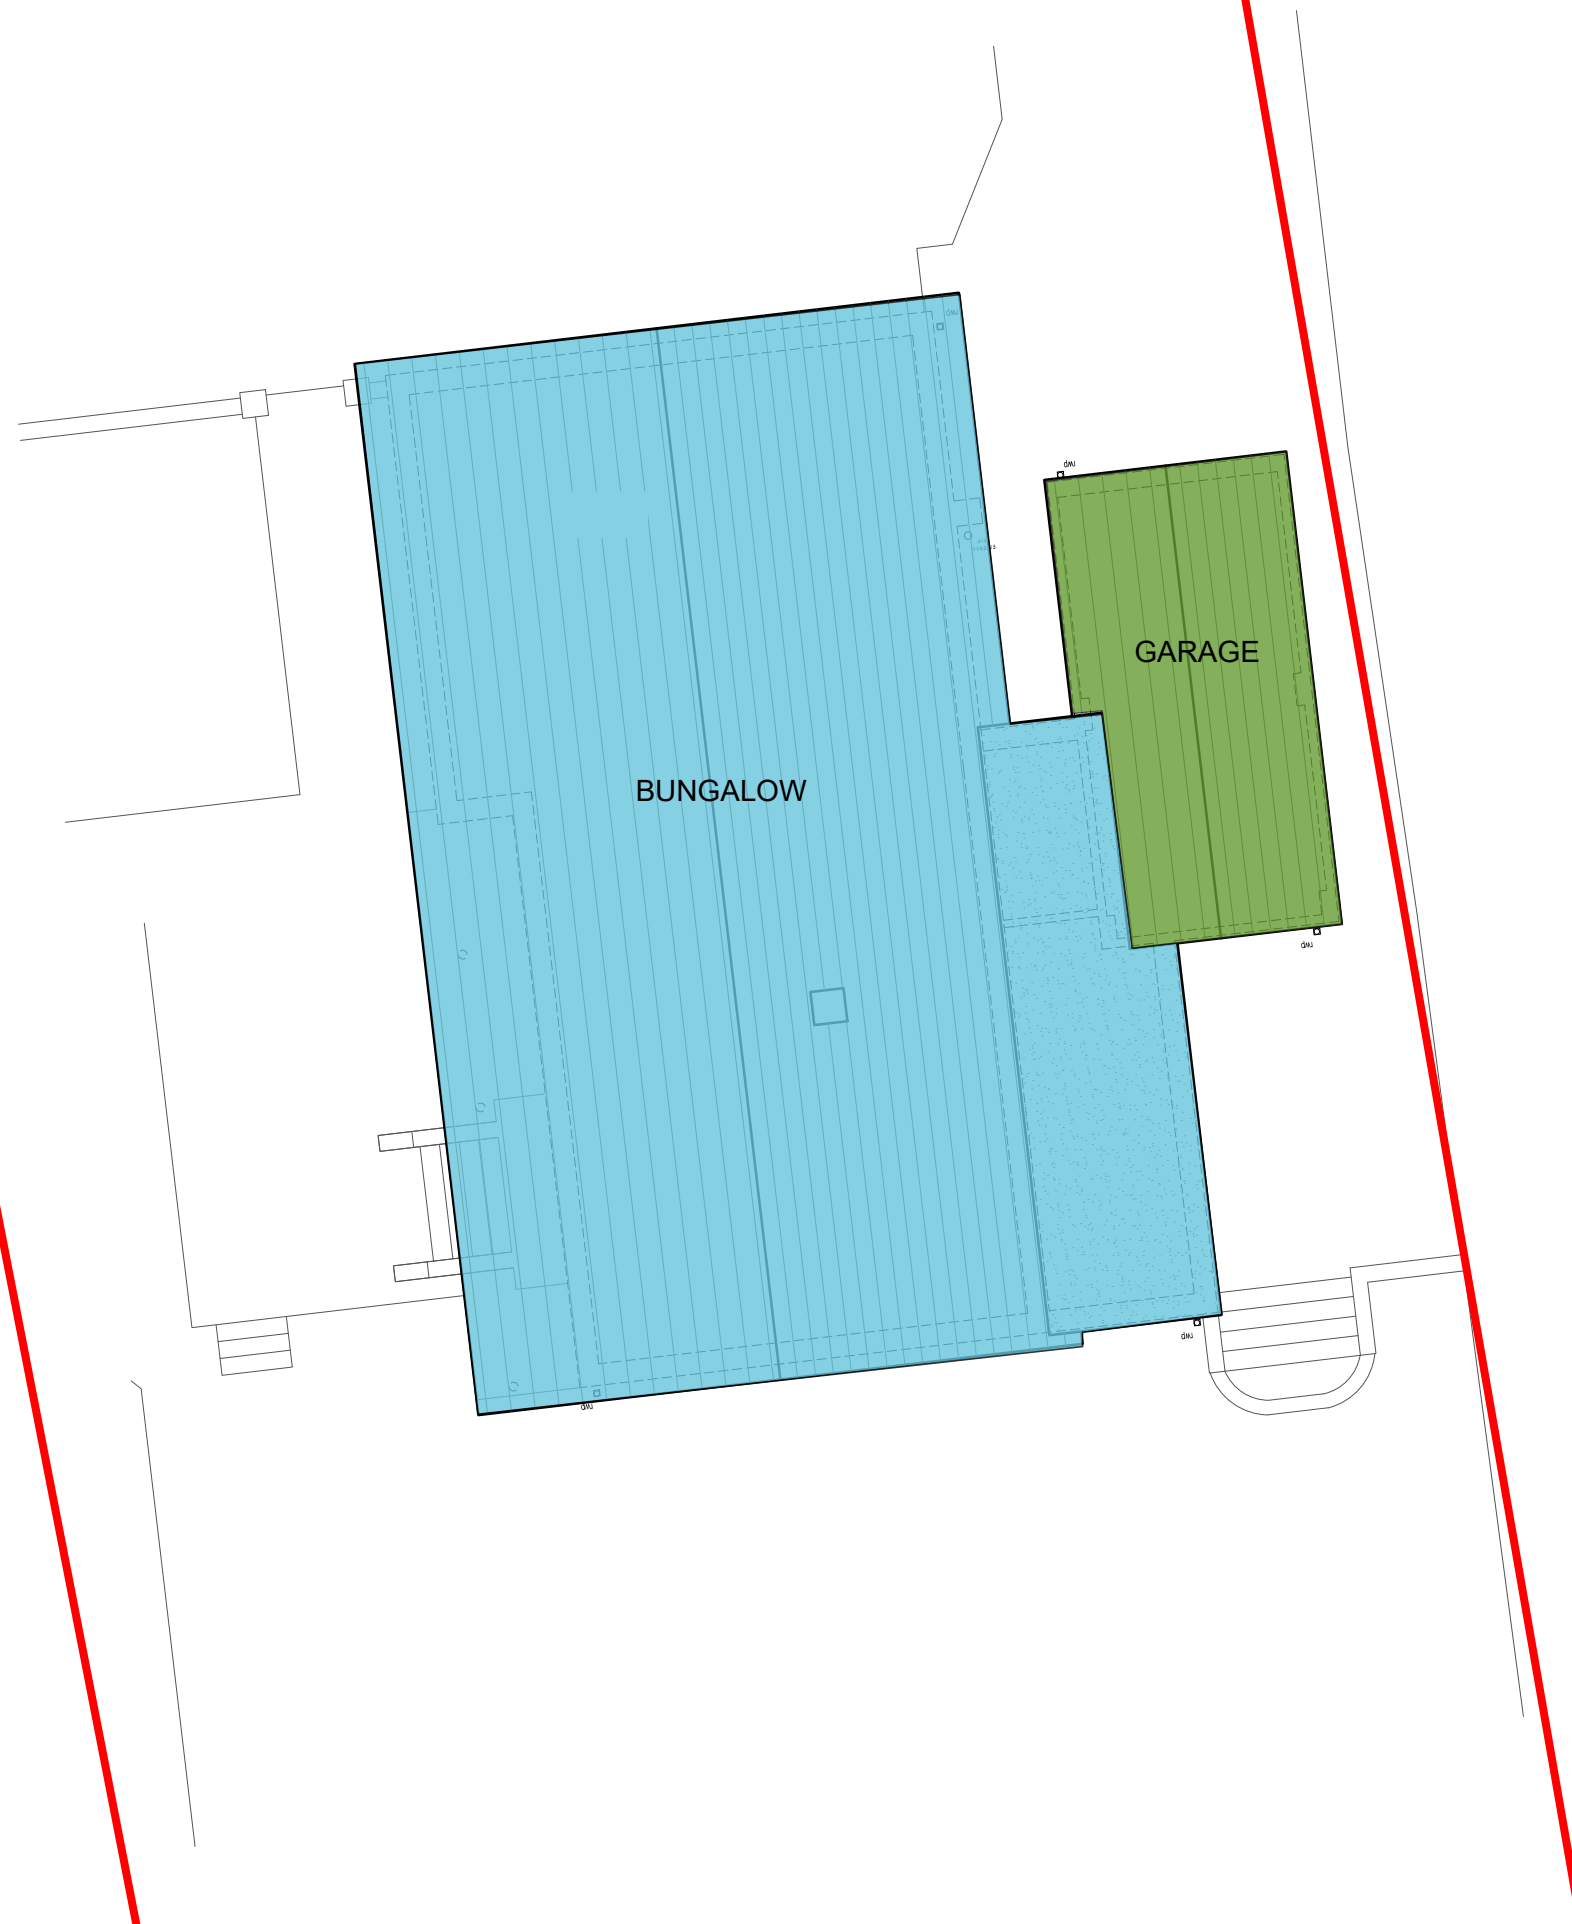
922.1/01

- 3.1.1 All buildings within the site were inspected during the Phase 1 bat scoping survey. The results of the Phase 1 building survey are summarised in *Table 1* below and the location of the buildings are shown in *Appendix A*. Photograph references relate to the photographs provided in *Appendix B*.

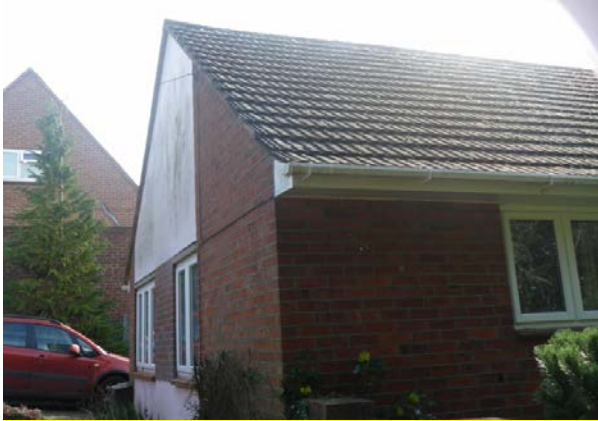
| Building | Description | Findings | Bat roost potential |
|---|---|---|---|
| <b>Bungalow (photos 1 to 3)</b> | Detached bungalow of brick and breeze block construction with a pitched concrete-tiled roof. A flat felt-covered roof section forms a link to the adjoining garage. | <p><b>External:</b> The exterior roof and walls of building are generally very well sealed. Very limited bat roosting opportunities for crevice-dwelling bats are available within a crack in the concrete apex ridge and cracks/gaps in the cement mortar at the end of the roof tiles at the north and south gable ends.</p> <p><b>Internal:</b> Single loft space present. The interior of the roof is very well sealed throughout with expanding insulation foam.</p> <p><b>No evidence of bats recorded.</b></p> | <b>Very low</b> bat roost potential |

**Photo 1:** Northern and eastern elevations of Bungalow

5.2.3 In view of the limited opportunities for roosting bats present within the Bungalow it is recommended that a Phase 2 bat roost survey of this building, comprising either a single emergence survey or an endoscope inspection of potentially suitable features, is carried out immediately in advance of works to this building commencing. This would avoid the need for supervised works assuming no bats are encountered (see below).

5.2.4 Alternatively, unless a future survey is carried out which confirms the absence of roosting bats as detailed above, all demolition or stripping works involving the removal of features with the potential to conceal roosting bats should be overseen by a licensed bat worker under an Ecological Watching Brief. Potential features at the site include gaps below the end of roof tiles on the north and south roof gable ends, and a crack at the northern end of the concrete roof ridge. These features should be inspected prior to demolition/stripping and a cautious approach should be employed, with features removed by hand, where appropriate.

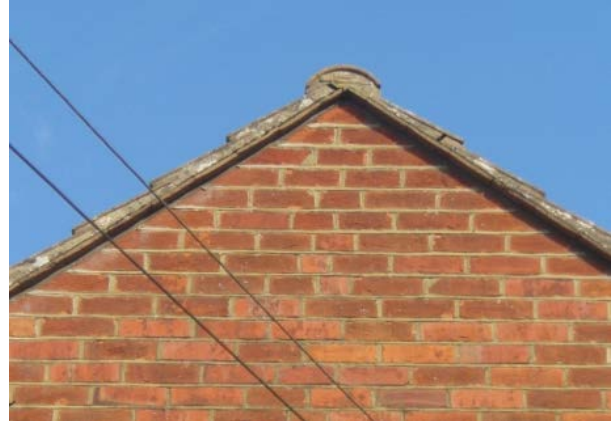
4.1 No evidence of bats was recorded within the Bungalow or Garage during the Phase 1 bat scoping survey. The Bungalow contains a small number of features on the exterior of the roof which have very limited potential to support individual/small numbers of crevice-dwelling bat species however no access is available for bats into the roof space and the building is considered overall to have 'very low' potential to support roosting bats.

**Photo 2:** Southern gable apex of Bungalow showing cracks in cement mortar

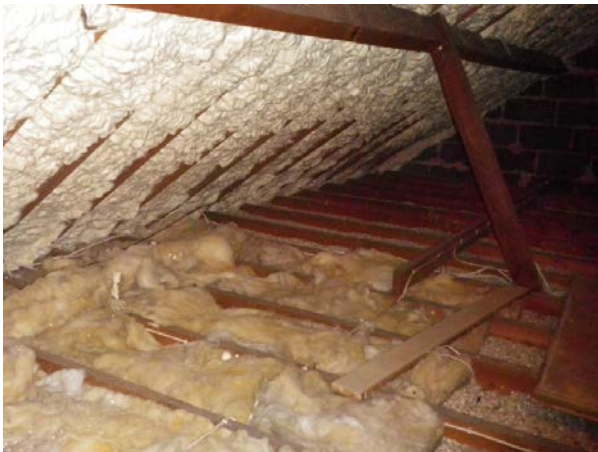
**Photo 3:** Interior of Bungalow roof space

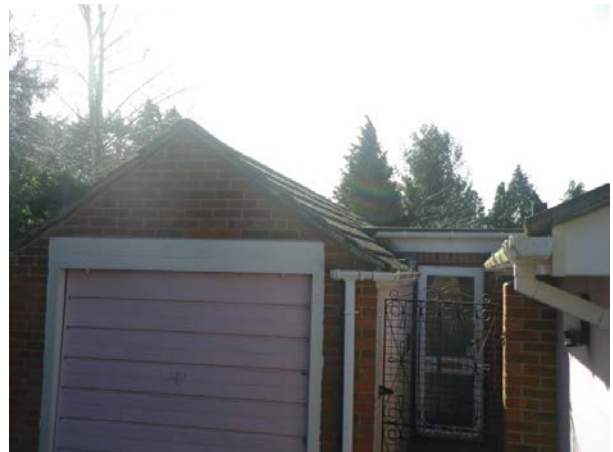
| Building | Description | Findings | Bat roost potential |
|---|---|---|---|
| <b>Adjoining garage (photos 4 and 5)</b> | Single storey garage of brick construction with a pitched concrete-tiled roof. | <p><b>External:</b> The roof and exterior walls are well sealed. No features of bat roosting potential were recorded.</p> <p><b>Internal:</b> The structure is open to the roof internally and the roof is lined with bitumen felt. The interior is lit by a window on the southern elevation.</p> <p><b>No evidence of bats recorded.</b></p> | <b>Negligible</b> bat roost potential |

4.2 No suitable bat roost features were identified within the Garage and in isolation this building is considered to have 'negligible' potential to support roosting bats.

**Photo 4:** Northern elevation of Garage

5.2.2 The Garage was identified as having negligible potential to support roosting bats and therefore no further precautions are required in relation to this building. No trees with potential to support roosting bats will be affected by the redevelopment proposals.

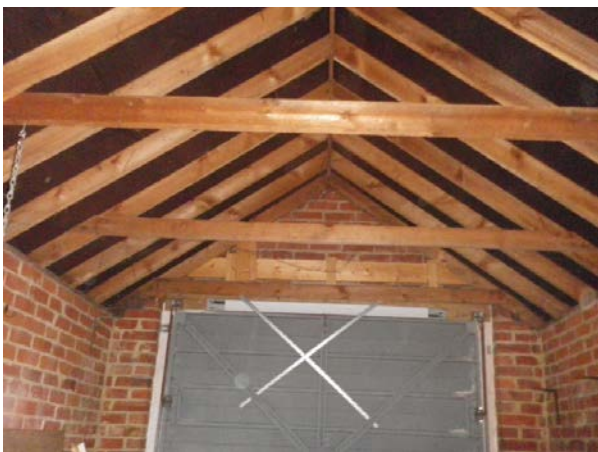
**Photo 5:** Interior of Garage
