Berkeley Homes (Western) Limited

## **Phase 6 – Green Park Village, Reading**

*Geoenvironmental Interpretative  
Report and Remediation Strategy*

August, 2018

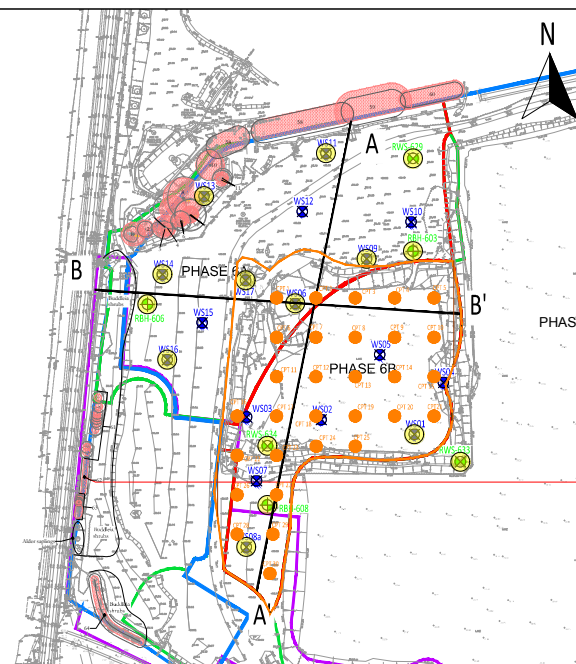
A

A'

? Inferred geology

— LIDAR elevation profile
