## **Reading, The Oracle Centre**

### **Parking Sign Safety Assessment**

16 July 2018

**Client Name:** Workman LLP  
**Document Reference:** WIE14360-100 R-1-1-3 Safety Assessment  
**Project Number:** WIE14360-100

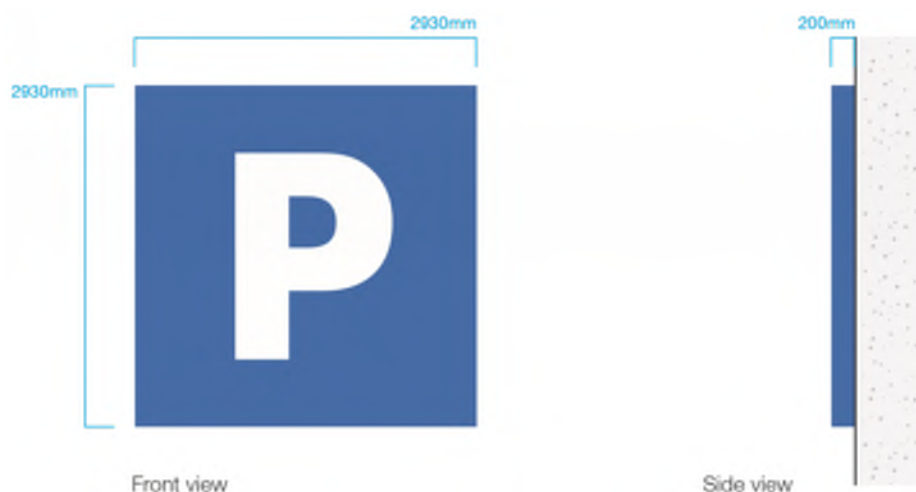
Figure 3: Details of Proposed Sign

- 2.6 The proposed Parking sign comprises a white letter 'P' in a square blue surround. The sign has overall dimensions of 2,930mm x 2,930mm. It will be formed using Opal acrylic graphics pushed through the aluminium face to finish flush.

- 2.7 Figure 3 below shows a diagram of the proposed sign.

- The sign has a simple and conventional design and will display only a white letter 'P' on a blue square in a similar style to sign 801 of the Traffic Signs Regulations and General Directions 2016. Therefore the sign would not be unusual nor would it be confusing to road users. Its information can be assimilated quickly by drivers seeking to access the car park and would be quickly disregarded by others.

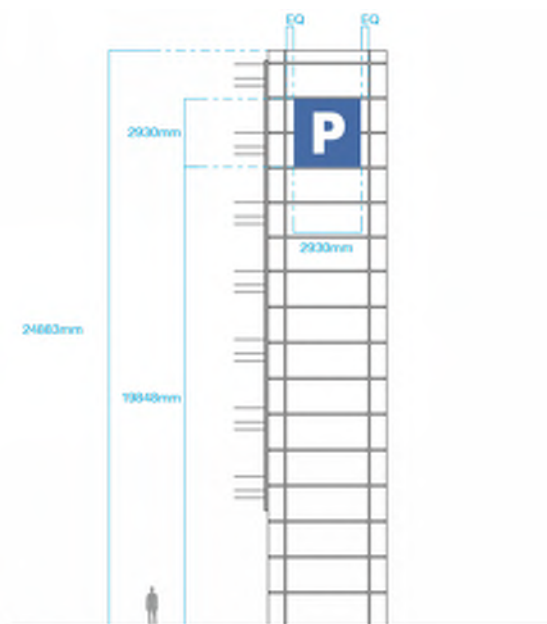
Figure 4: Proposed Sign Elevation

- The sign would be mounted in an elevated position on the car park's southwest facing façade. It would therefore not obstruct the visibility of any existing traffic sign or traffic signal.

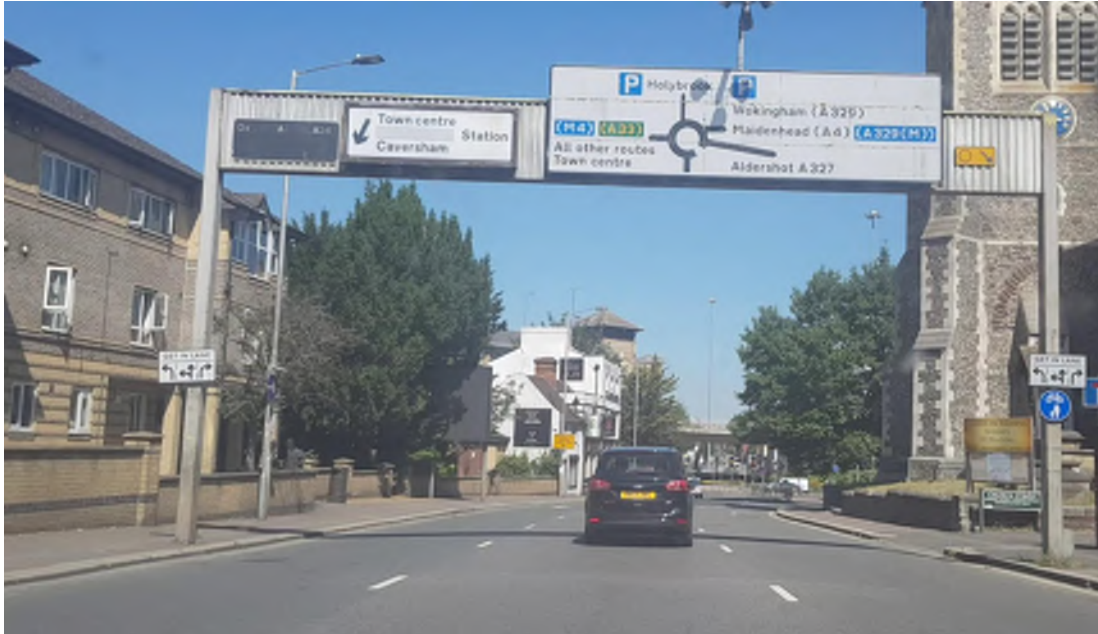
- 3.1 Images and photographs from the site visit are included at Appendix A.
- 3.2 When approaching the car park from Southampton Street, The Oracle car park was advertised on three separate boards along the route.

Southampton Street approaching The Oracle Centre

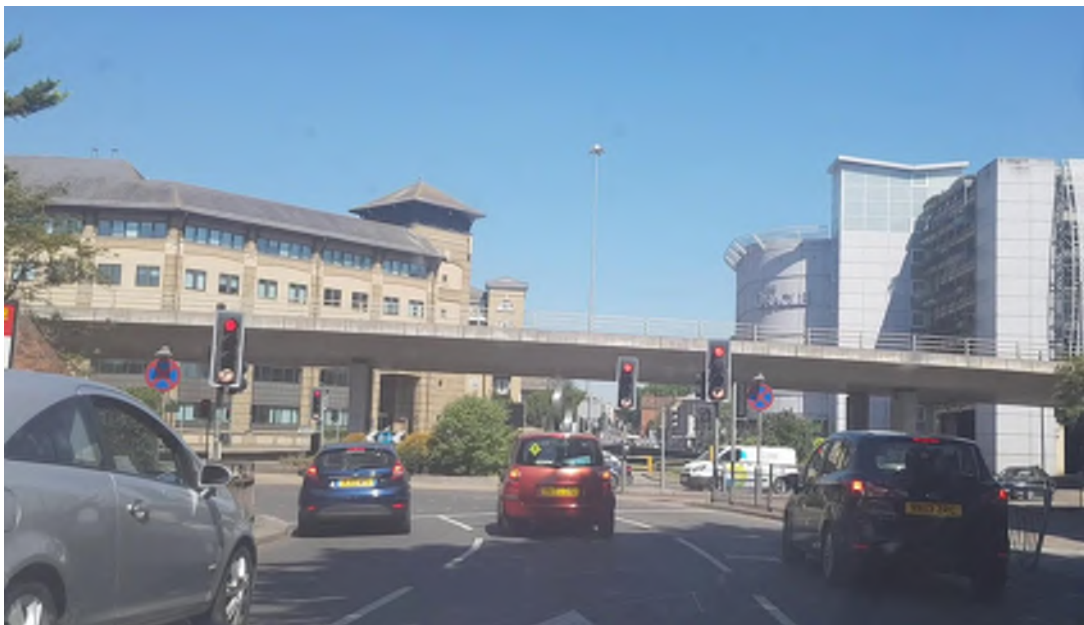
- 3.5 The proposed sign location is close to the A329 flyover. The proposed Parking sign would be visible to northeast-bound drivers using the flyover but not to southwest-bound drivers.

View from Southampton Street to A329 flyover and The Oracle Centre

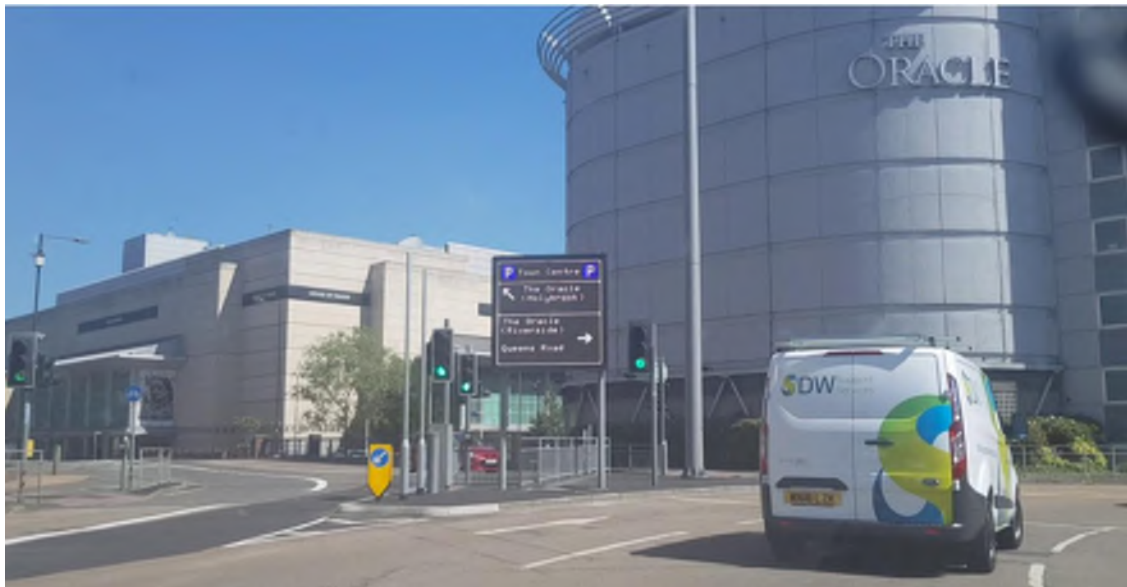
Bridge Street and signing to The Oracle car parks

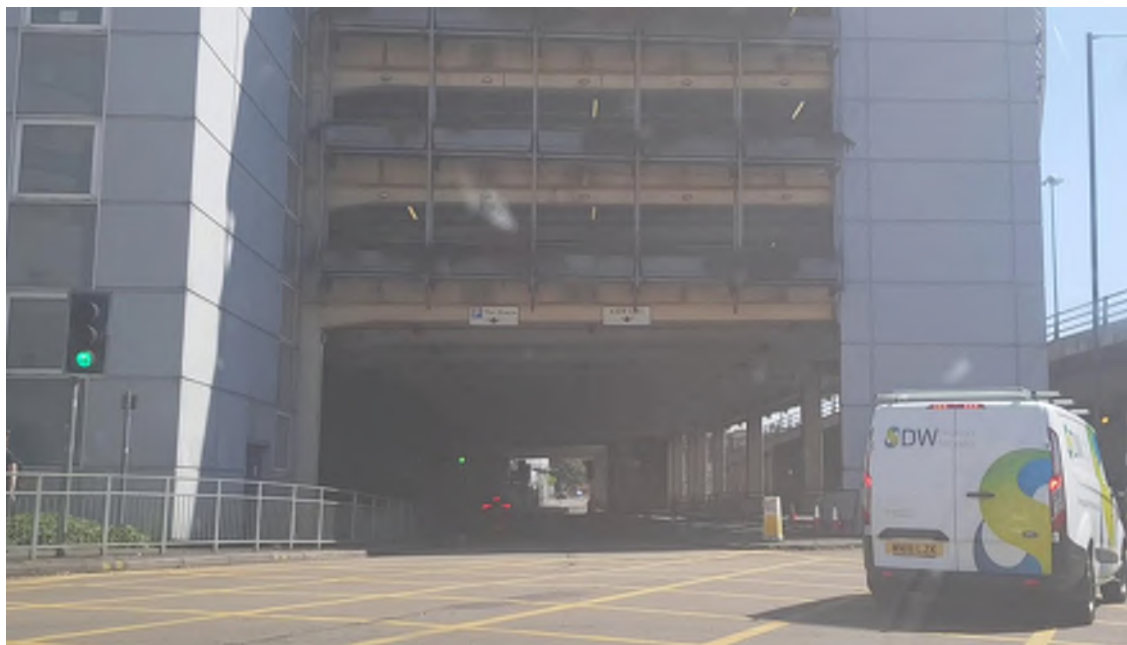
Lane guidance signs to The Oracle (Riverside) Car park Entrance and A329

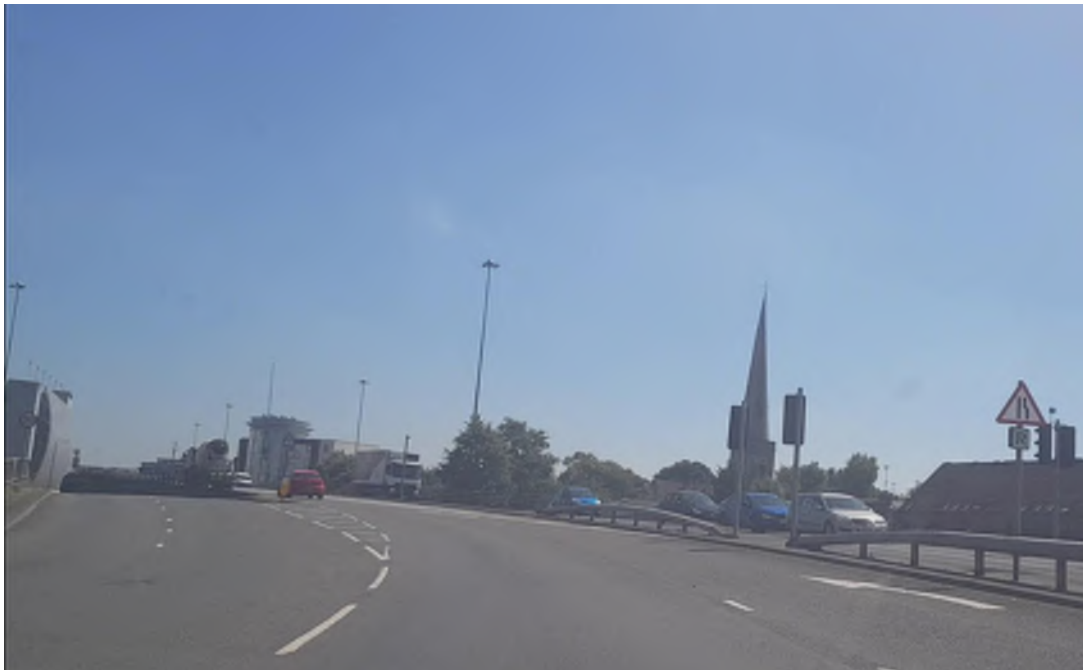
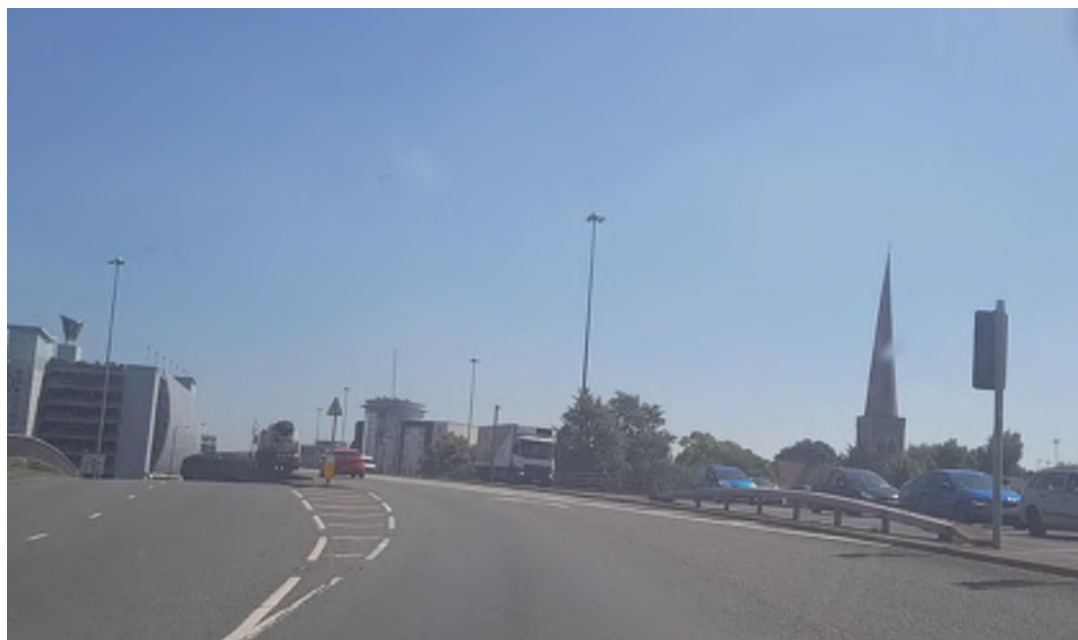
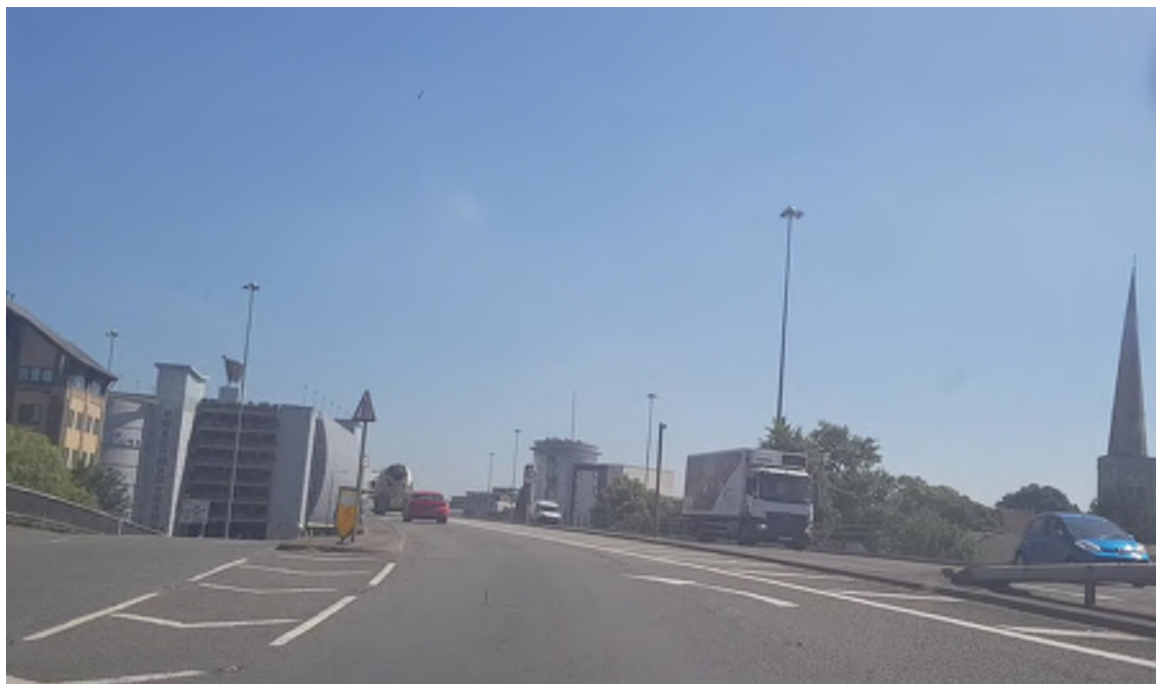
- 3.3 When approaching The Oracle from the northwest on the A329 southeast bound two signs for the car park are noted. One sign is on the overbridge of the A329/A4155 grade-separated roundabout and another sign is located by the exit slip from the A329 down to the A327 (roundabout) slip road. The proposed parking sign will become visible to drivers from this direction when they are on the off-slip approach lanes.

Off-slip from A329 towards The Oracle Centre.

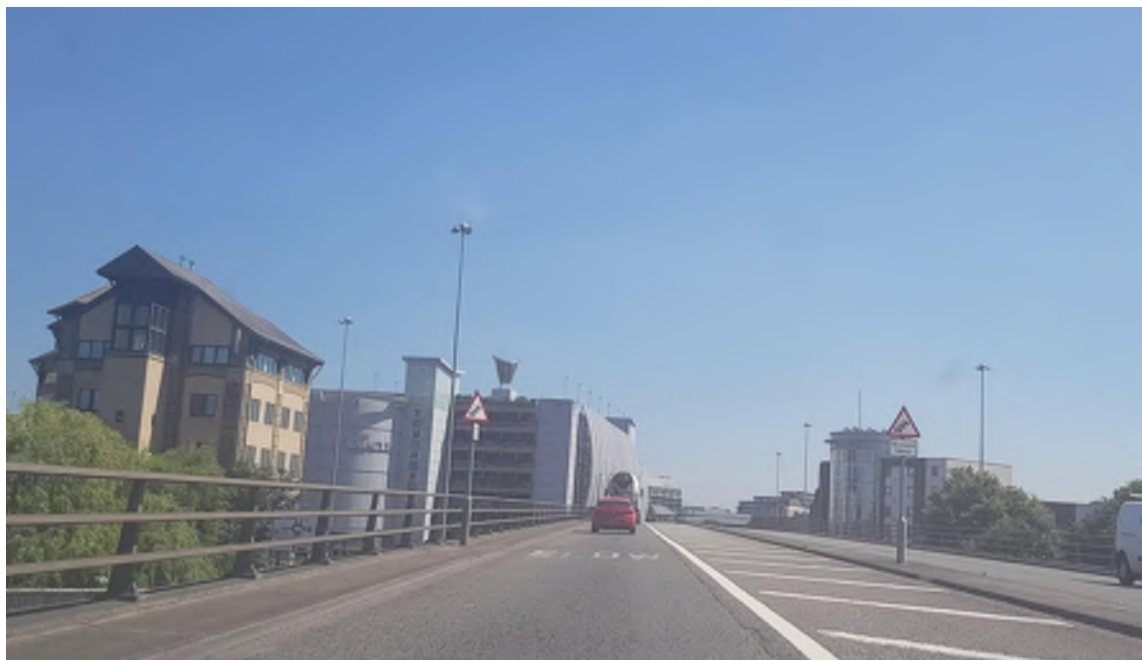
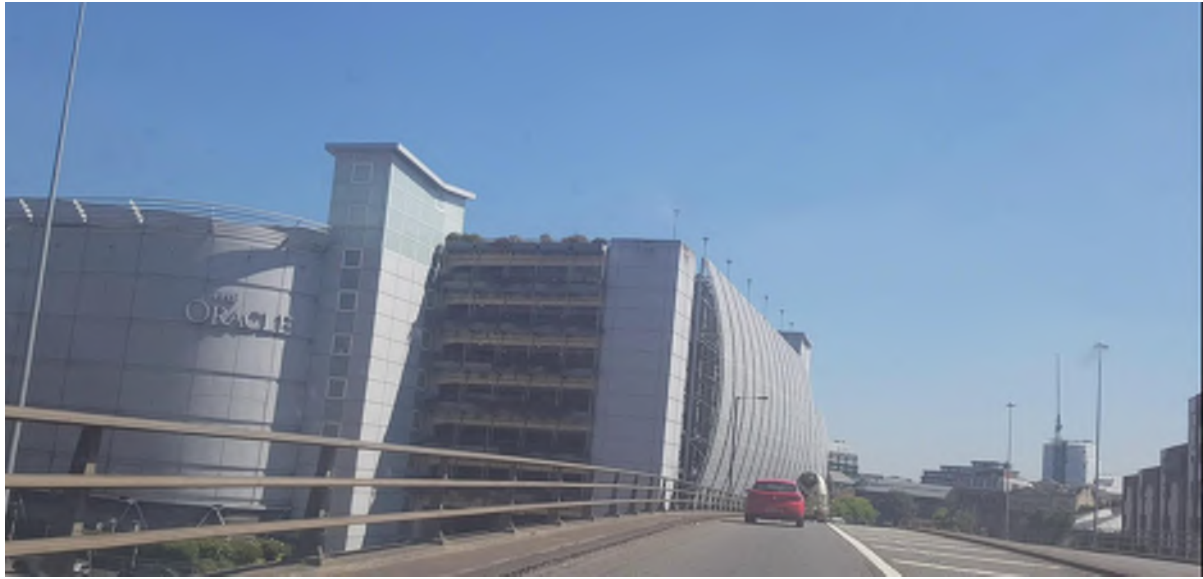
A329 flyover northeast-bound

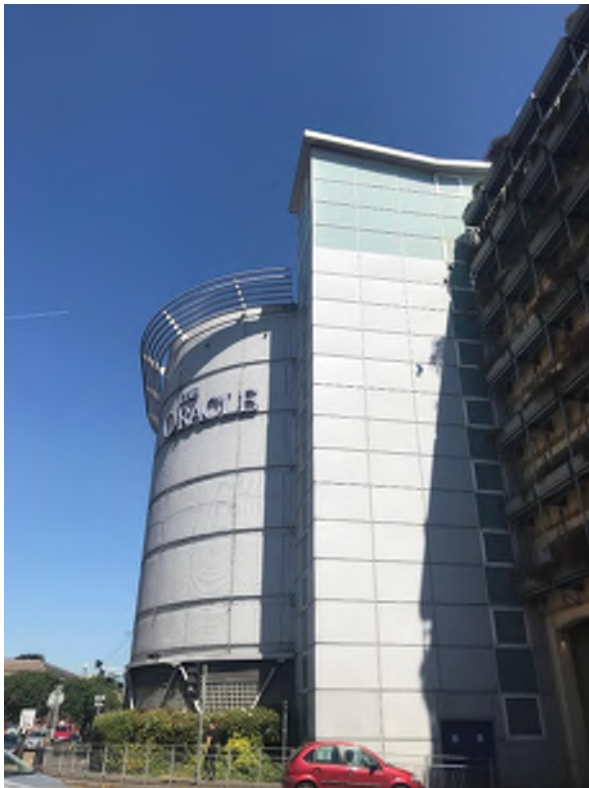
The Oracle Centre Building and Riverside car park entrance
