**MERCEDES BENZ, RICHFIELD  
AVENUE, READING**

**PRELIMINARY BAT ROOST & NESTING  
BIRD ASSESSMENT**

A Report to: Vertu Motors PLC

Report No: RT-MME-127294-02

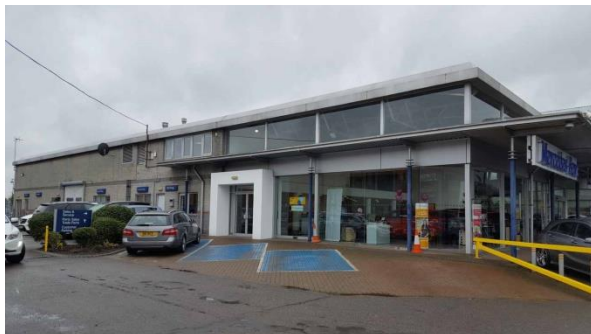
**Plate 4.1: Building 1 – Eastern Aspect**

The Mercedes-Benz showroom and MOT garage occupied the majority of the western portion of the study area. A rectangular shaped, two-storey structure consists of the façade, a full height glazed showroom and a grey brick workshop in the rear. The structure has a pitched trapezoidal composite panelled metal roof. Internally, the building comprised a large modern double height showroom, large modern double height workshop and two storeys of office space. Plates 4.1 and 4.2 depict the exterior of the building.

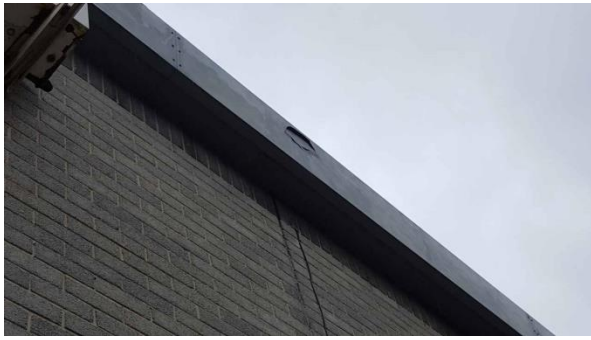
**Plate 4.3: Building 1 – Damaged Metal Fascia**

There was no access onto the roof of the building and therefore a survey of the roof was undertaken from ground level. There were no observed gaps, cracks or crevices around the exterior of the composite panelled roof. The metal fascia board was largely intact, however damage was noted on the western aspect providing a suitable access point a potential roosting location within the roof structure (Plate 4.3). Narrow gaps were recorded around piping on the eastern aspect, providing suitable access points for bats to roost features within the metal soffit and area above the dropped ceiling. (Plate 4.4). It was not possible to fully inspect these features due to the height at which they were located and as such it was not possible to establish if bats had used these features to enter a roost location at the time of surveying.

Where safe to do so, features identified within this building will be accessed utilising Mobile Elevated Work Platform (MEWP). Any PRF will be internally searched using a torch and endoscope. If the feature on further inspection is found to be unsuitable or less suitable for bats, then the status of the building will be downgraded to low or negligible bat potential and if possible, it will be fully inspected for evidence. If a roost is identified, if PRF extend beyond the reach of an endoscope, or if the PRF shows any signs of use by bats, appropriate additional survey work will be required.

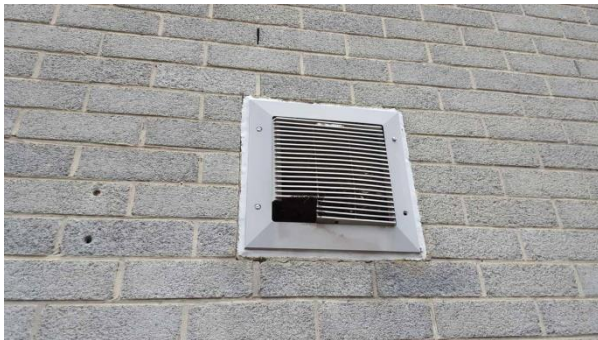
**Plate 4.5: Building 1 – Broken Air Vent**

A broken air vent was located on the western aspect of the warehouse (Plate 4.5). This air vent was considered to be generally unfavourable for bats to roost within as it led into a well-lit and heavily used building interior. The vent was fully inspected and no evidence of bats was noted within or around the feature. The brickwork was generally in good condition, however further features were recorded in the form of exposed external pipe holes providing possible access points to the interior of the building and small weep holes in the external walls providing access points to the internal cavity wall (Plate 4.6). The features within the brickwork were fully inspected and found to be largely free from debris and old cobwebs, indicating they may have been used by fauna to access the internal wall structure. No evidence of bats was recorded within the accessible areas of the features. However, it was not possible to examine the cavity wall itself.

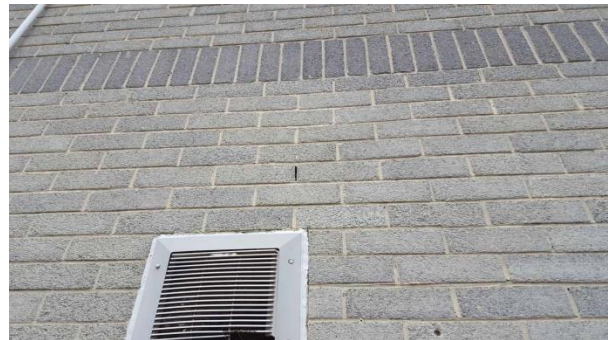
**Plate 4.6: Building 1 – Weep Holes**

A number of features were recorded around the building which could be used by bats to gain entry into the structure and potential opportunistic roosting locations. These features include:

- Damaged metal fascia board;
- Gaps around piping in metal soffit box; and,
- Weep and pipe holes in the brickwork.

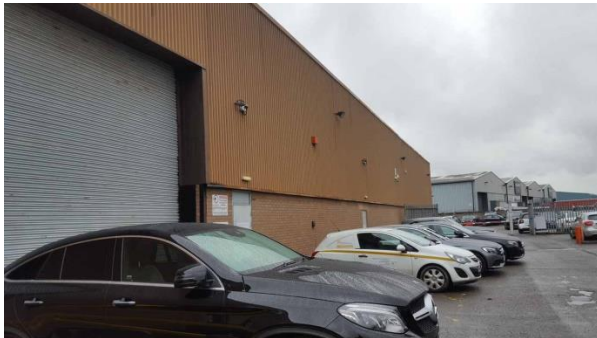
**Plate 4.7: Building 2 – Western Aspect**

The workshop was a large square warehouse structure located to the east of the Mercedes Showroom. The structure was two-storey, with a mixture of brick and corrugated metal walls, with a flat corrugated metal roof. A uPVC canopy extended from the northern aspect of the building. Internally the building was segmented into an actively used double-height warehouse and two floors of disused office space with suspended ceilings. Plate 4.7 and Plate 4.8 show the exterior of the building.

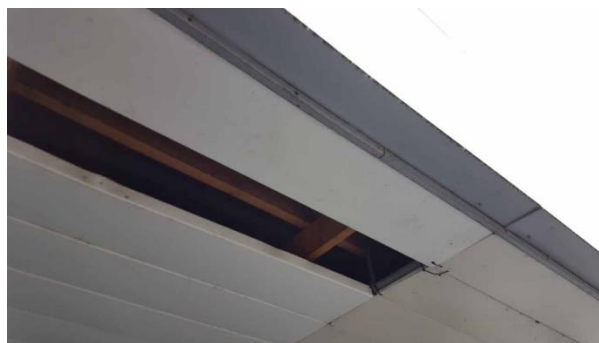
**Plate 4.9: Building 2 – Missing Canopy Panel**

There was no access onto the roof of the building and therefore a survey of the roof was undertaken from ground level. There were no observed gaps, cracks or crevices around the exterior of the corrugated metal roof. The metal fascia board was undamaged and the metal soffit box was generally in a good state of repair. Missing panels in the canopy provided access to the internals of the structure interior (Plate 4.9). The canopy was examined from the damaged panels and in areas which could be inspected it was found to be uninsulated with a thin uPVC shell and smooth wooden supports, reducing its value for roosting bats. There was no evidence of bat activity around the access points leading into the canopy.

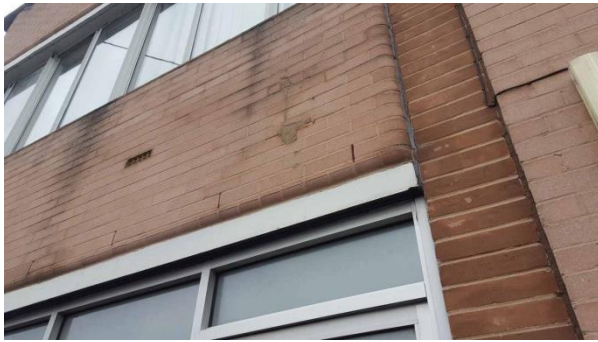
**Plate 4.10: Building 2 – Air Vent**

Air vents were present on all aspects of the building (Plate 4.10). These air vents were considered to be generally unfavourable for bats to roost within as they were too narrow for entry. The brickwork was generally in good condition, however further features were recorded in the form of cracks, exposed external pipe holes and large numbers of weep holes, providing possible access points into the internal cavity wall (Plate 4.11). Where the features were accessible they were found to be largely free from cobwebs and debris. No evidence of bats was recorded within the accessible areas of the features. However, it was not possible to examine the cavity wall itself and the weep holes located at height.

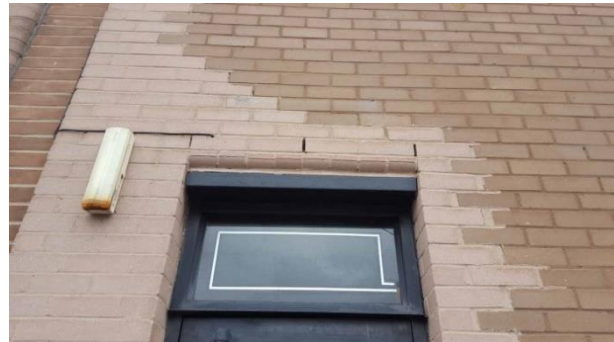
**Plate 4.11: Building 2 – Weep Holes**

The brickwork was generally in good condition but weep holes were present which led to an internal cavity (Plate 4.11). Where weep holes could be inspected they were found to be blocked and cobwebbed, however not all holes could be inspected.

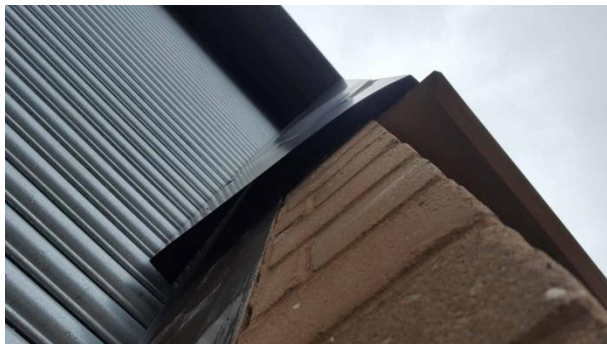
**Plate 4.10: Building 2 – Gaps Under Metal Cladding**

A further crevice was recorded leading under the corrugated metal cladding on the walls providing low value roosting location for bats (Plate 4.12). uPVC and wood framed windows and doors were largely intact and well-sealed, however an open window was also recorded leading into an internal bathroom and gaps were recorded around doors leading into the actively used workshop (Plate 4.13). No evidence of bats using these features for entry into the building was observed during the survey.

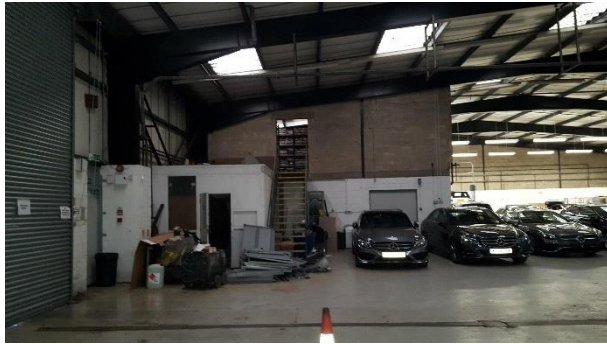
Plate 4.112: Building 2 – Workshop Interior

Building 2 was partially in use at the time of the survey with high levels of noise and disturbance within the workshop area. The office space was disused. The internal areas of the building consisted of bright, open double-height modern workshops with direct access to roofing, in addition to a two-storey disused office space with suspended ceilings. The internal areas had intact floors, walls and ceilings. The workshop area was subject to high levels of disturbance, had an open construction, with exposed corrugated roofing and metal beams. Due to the presence of multiple skylights, in addition to the high levels of disturbance, the internal roof structure was deemed unsuitable to support roosting bats. The disused office space was similarly unsuitable, with no internal features suitable for roosting bats. It was not possible to inspect the entirety of the void behind the ceiling due to access constraints. However, in areas where the void could be inspected, it was found to be well lit by skylights, with an unlined metal roof structure providing largely unfavourable conditions for roosting bats.
