## Preliminary bat roost assessment

| Site Location | 6A Hawthorne Gardens, Reading RG2 7NA |
| Document reference | CE1171-01 |

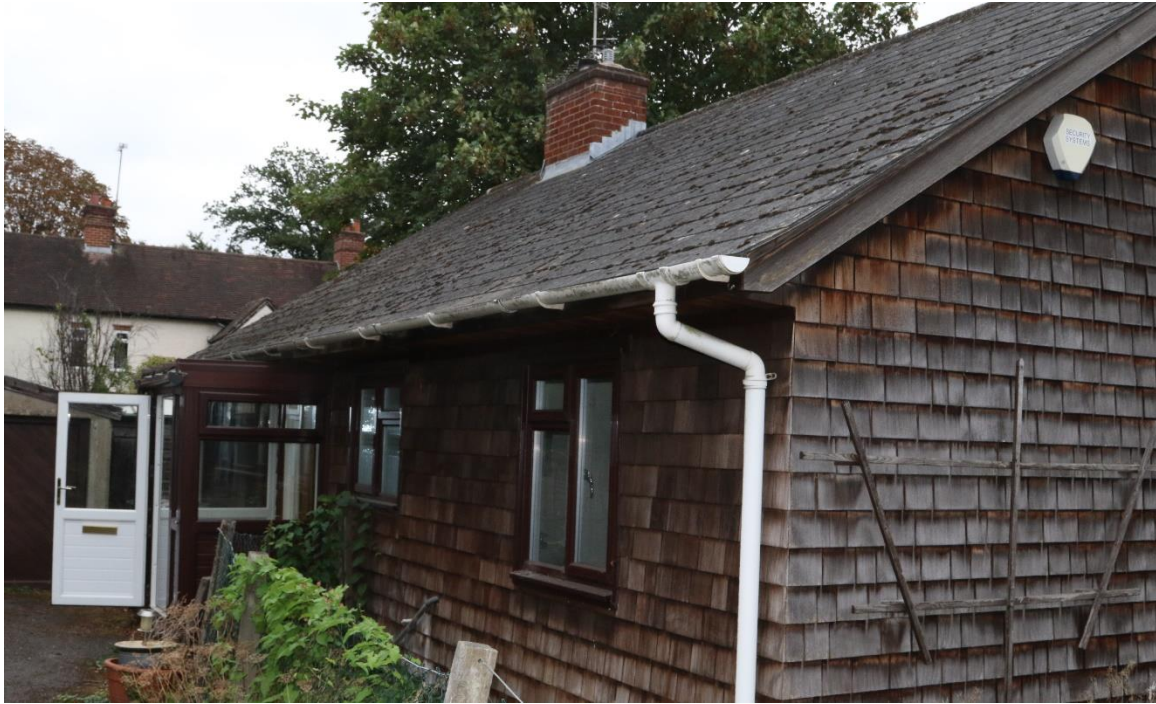
All for facing elevations of the single storey dwelling have demonstrated a covering from timber shingle tiles (Image 1, 3, 4) which looked to be in a well maintained level of condition.

The timber tiles around the external vertical elevations of the building have demonstrated high level of creosote odours which can defer from roosting

Image 1 – Front North facing elevation of the building demonstrating a timber shingle cladding which looked to be in a well-maintained condition within minimal gaps of value to bats. The timber gave off a high level of creosote odours which can deter from roosting

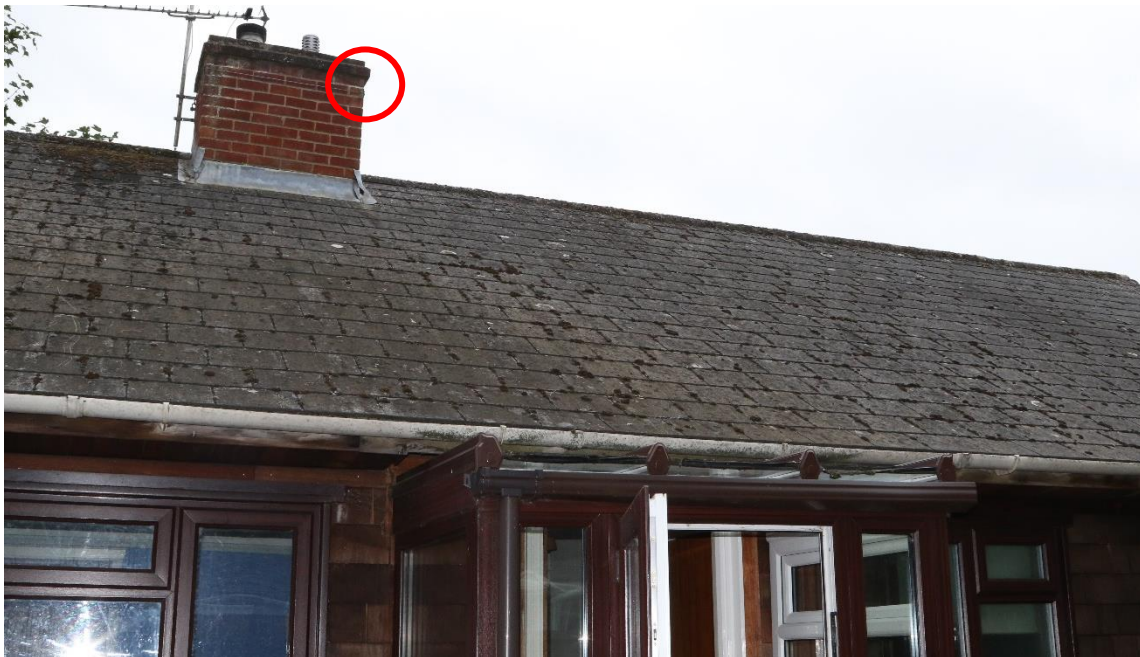
The roof coverings to the building have demonstrated no identified gaps within the tiled coverings.

Image 2 – North facing roof coverings which have demonstrated a well sealed covering with no identified areas of value to bats other than a small gap within the led works

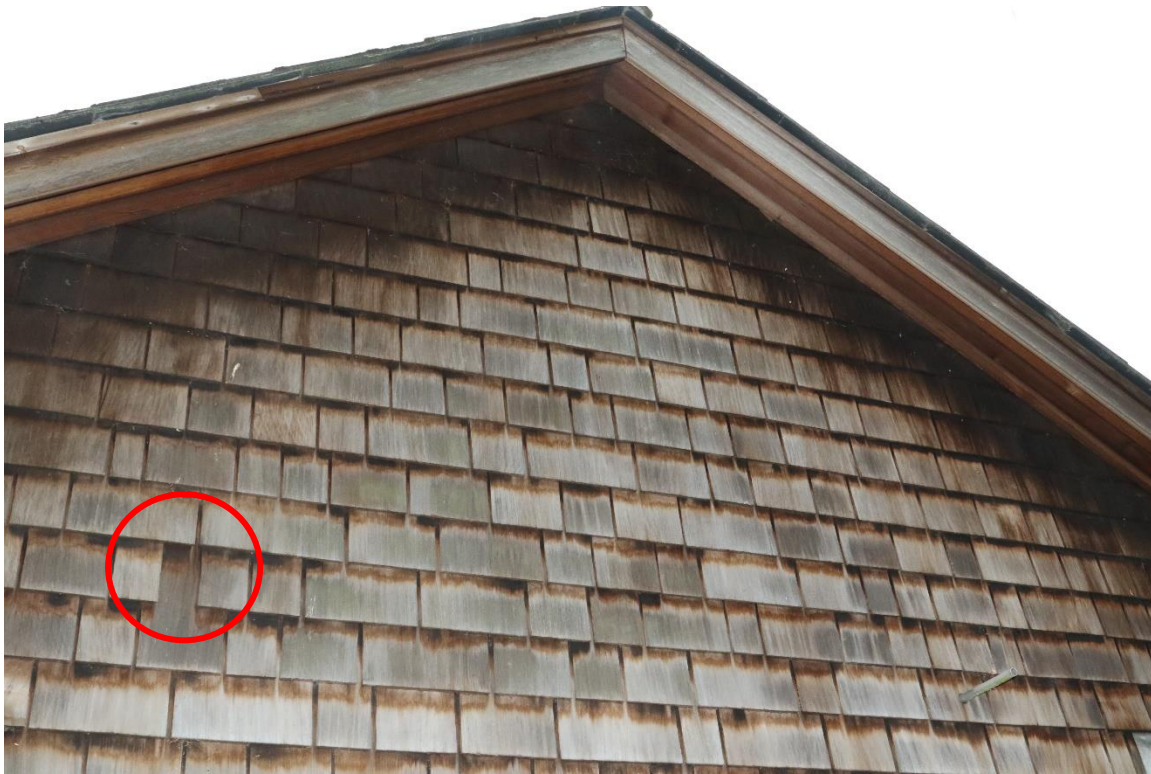
A small number of the vertical tiles were identified to the East & West facing elevations (3, 4) which may offer access into suitable roosting conditions used by crevice dwelling bats within.

Image 3 – East facing gable elevation of the building offering a single missed tile to the coverings

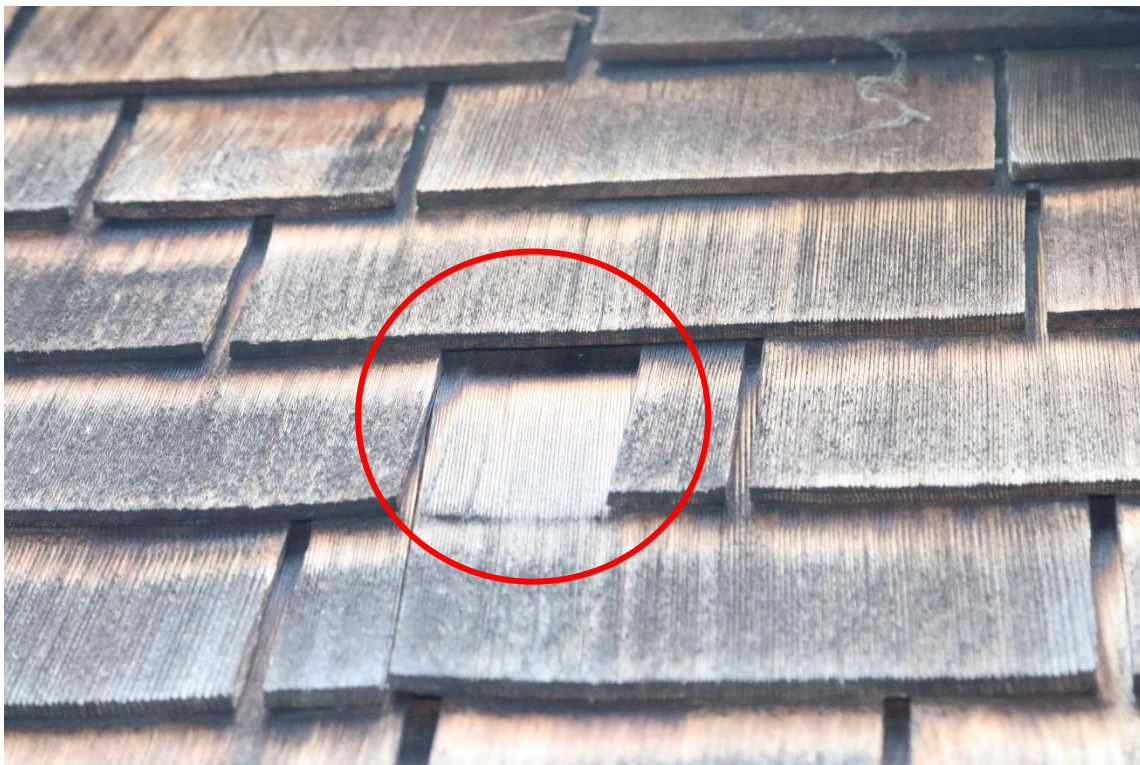
Image 4 – Further missing tiles to the West elevation offering access for bats within

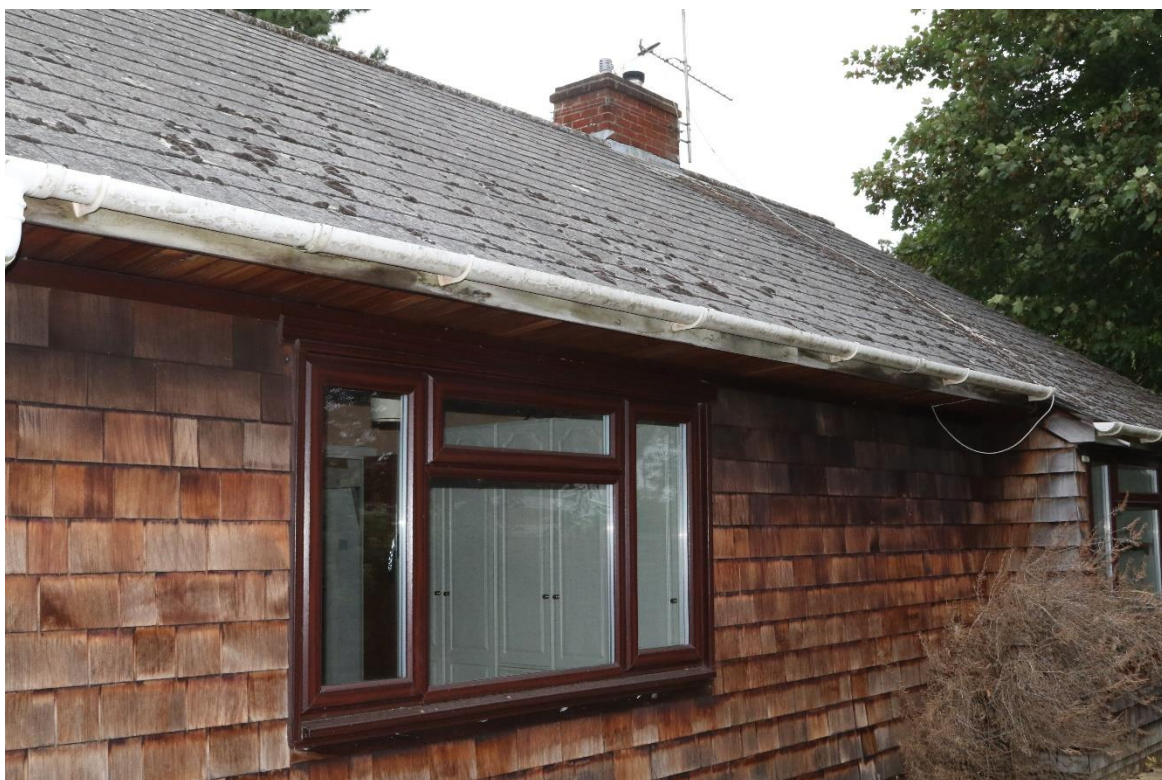
Image 5 – South facing elevation of the building

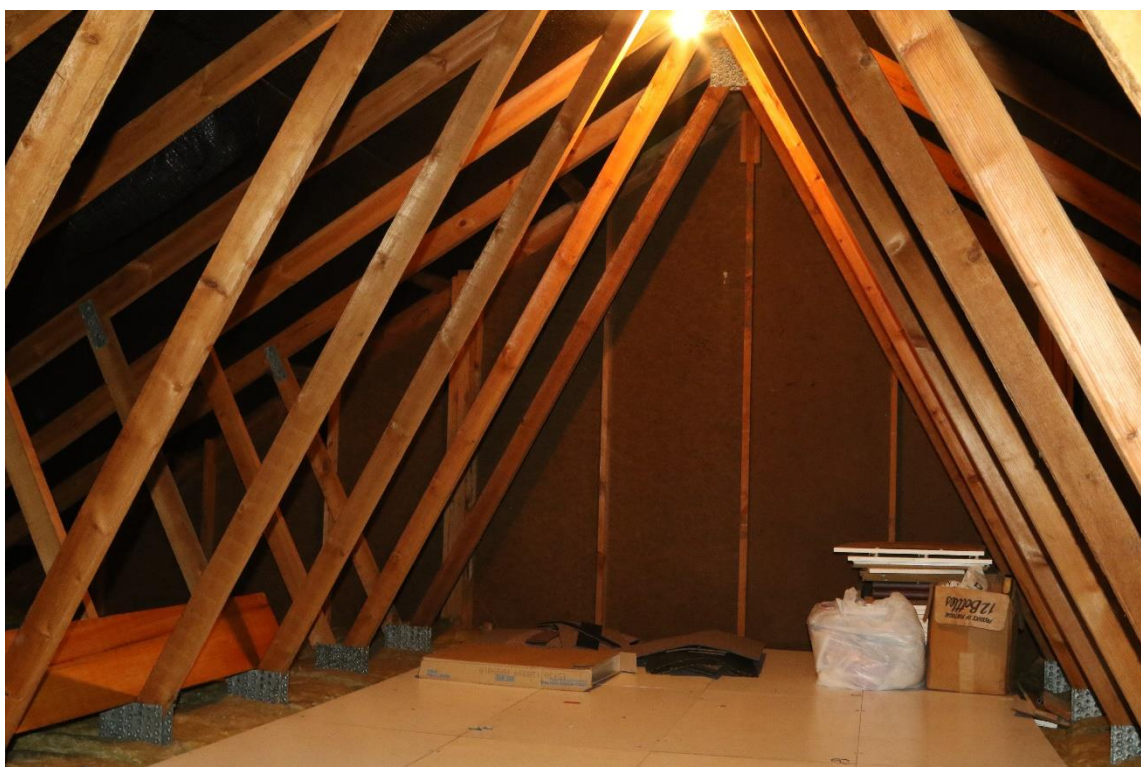
**4.7** Internally the roof void has demonstrated a full covering from a felt membrane situated below the roof tiles which looked to be in a good level of condition with no identified gaps or deterioration.

Image 6 – Internal view from within the roof void

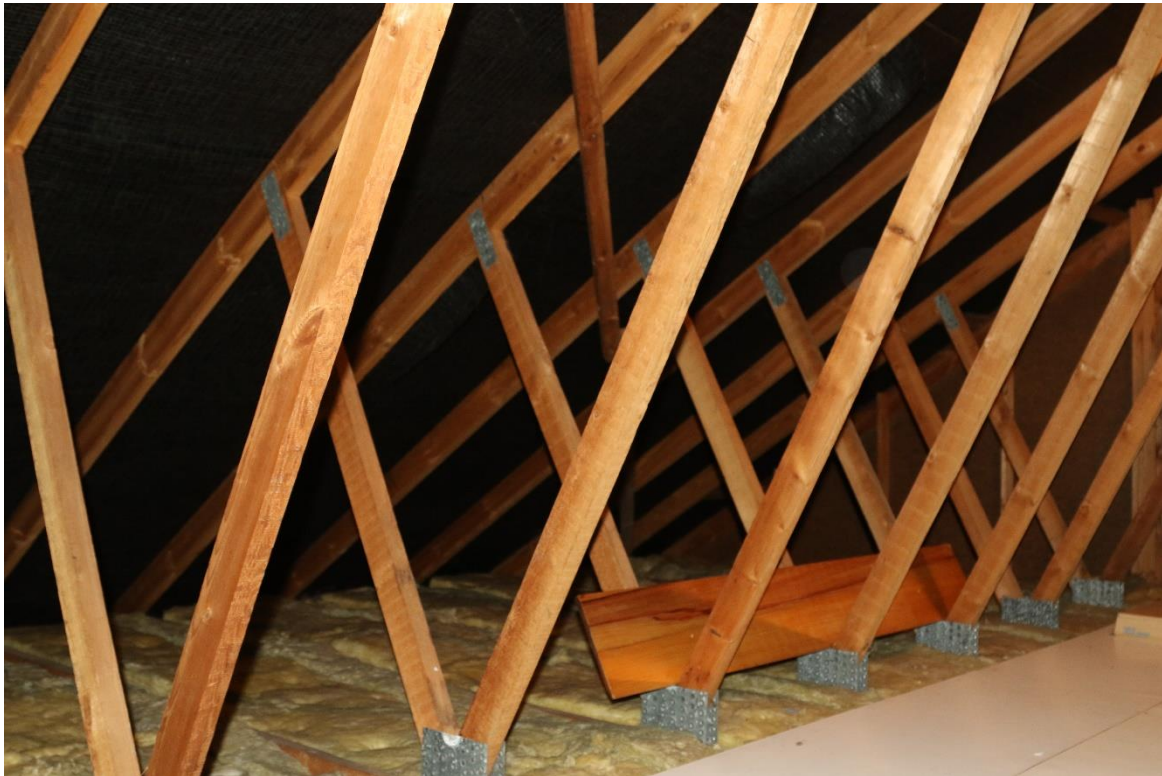
There is a layer of insulation across the floor areas within the loft void along with timber boards to the central areas of the floor.

Image 7 – Additional view from within the roof void demonstrating a felt membrane below the roof coverings, insulation to the floor coverings with timber boards across the central areas.

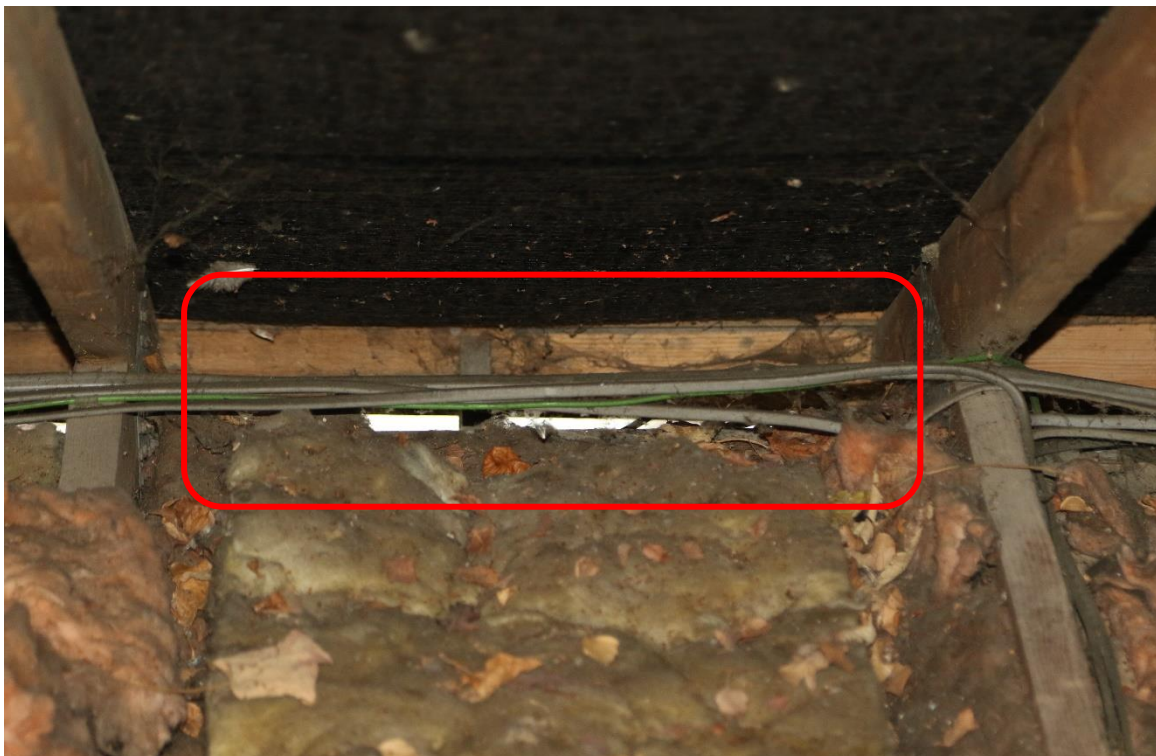
The eaves around the building also looked to be well sealed with a small gap of approx. 15mm to the North facing elevation.

To the North area of the loft void protruding daylight (Image 8) has been identified along with a gap to the eaves large enough for bats to enter the roof spaces.

Image 8 – Protruding daylight identified mid-way along the North facing elevation within the eaves

**6.5** It is advised that to fully establish if bats are using the building a single emergence survey should be carried out before the end of the survey season of May to September during optimal survey conditions.

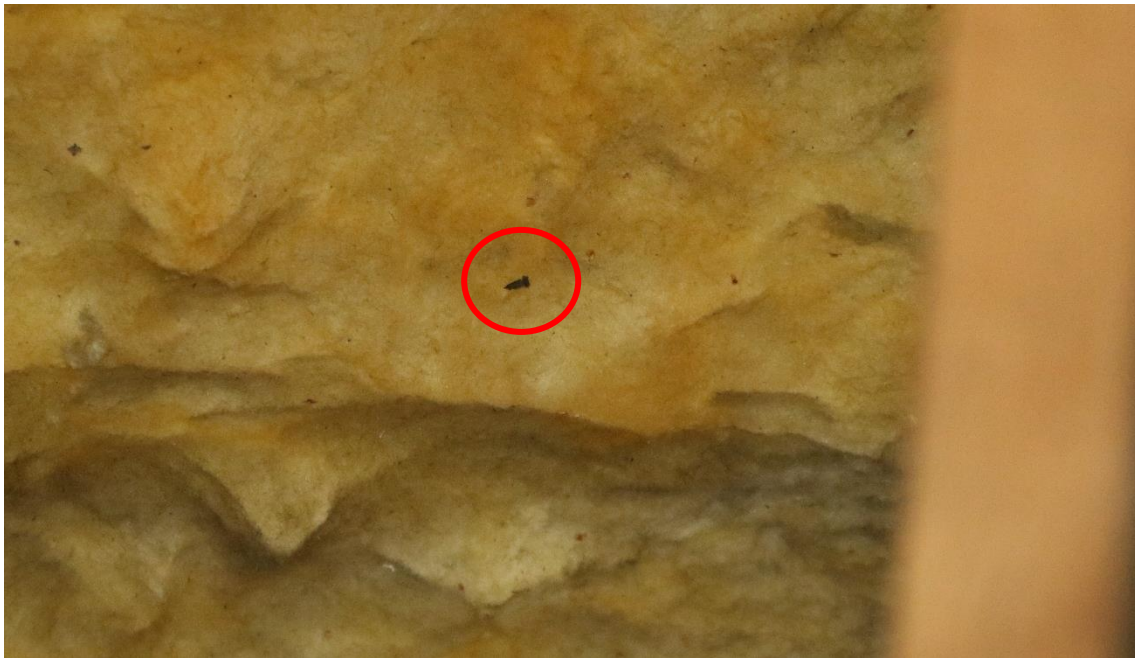
Three droppings were identified close to the gap within the eaves of which demonstrated characteristics from bats when crushed.

Image 9 – 3 old (6 months plus) droppings identified close to the gaps within image 8 which when crushed demonstrated characteristics of bat

**6.2** It has been evidenced that Bats have used features within the building from observation of 3 droppings located close to a gap within the eaves on the North facing elevation.

If bats are identified to be using the building, then a further two surveys would be required to support an EPS Mitigation Licence if the planned development causes any level of disturbance to bats.

**6.6** It is advised that no further works take place to the building at this stage as this may cause disturbance to any roosting bats, see section 2.0 of this report
