# 149 Chiltern Road

## Ecological Assessment

**November 2018**

Report Ref: DFA18095

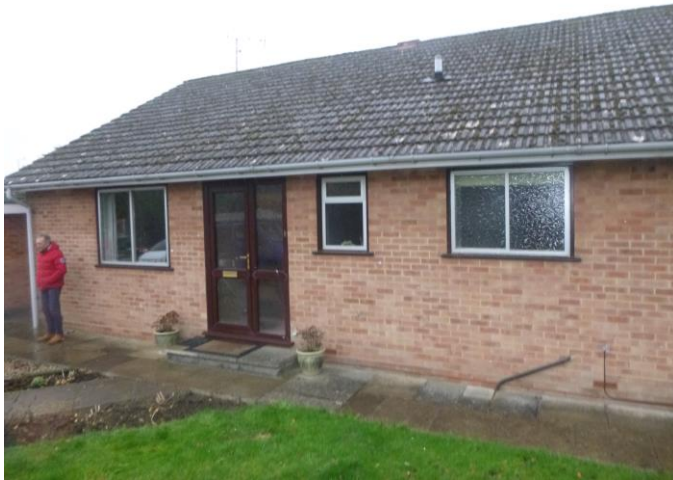
- 3.2.13 The bungalow is a brick built structure with a pitch, gable style roof. The building is approximately 50 years old and is currently occupied and in sound condition throughout (Plates 1 and 2).

Plate 1. General view of the front of the property

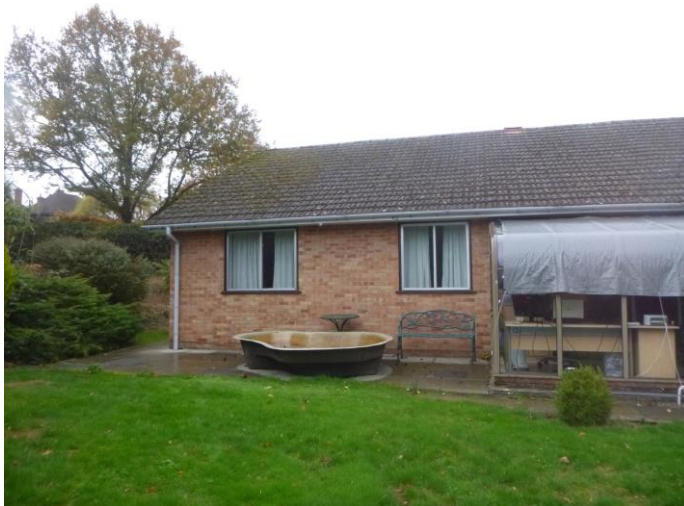
Plate 2. General view of the rear of the property

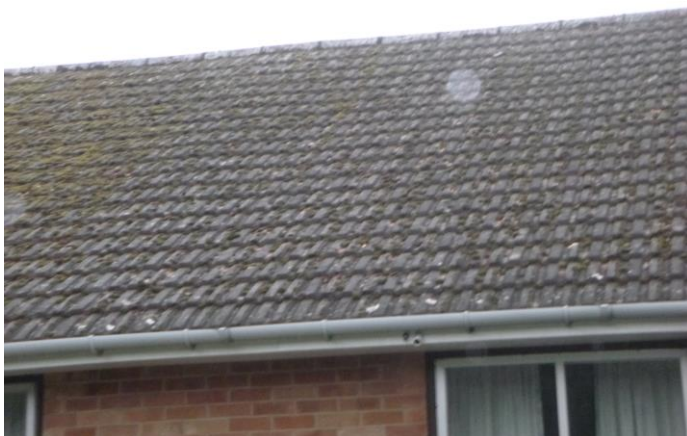
- 3.2.14 The roof is finished with interlocking, ridge clay tiles which are intact and tight with one another; no gaps or missing tiles were noted (Plate 3). The ridge line, which runs more or north west to south east, is also intact.

Plate 3. Typical view of the roof tiles

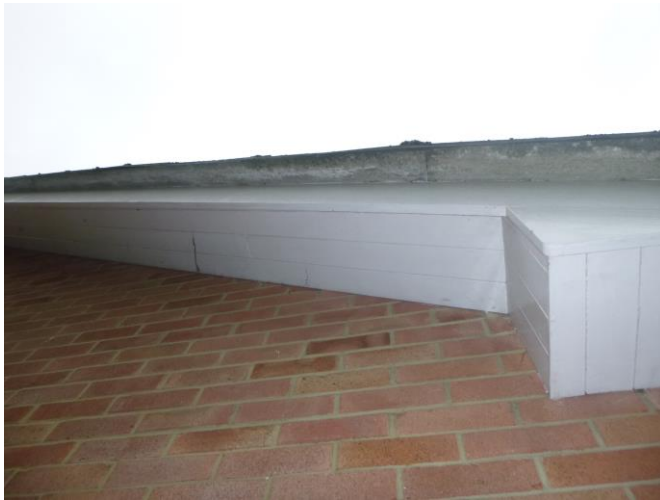
- 3.2.15 There are no hanging tiles or weatherboarding on any aspect of the building.
- 3.2.16 The wooden soffit and fascia boards are in sound condition throughout, with no potential gaps which would allow bat ingress being noted (Plate 4).

Plate 4. Typical view of the soffit and fascia

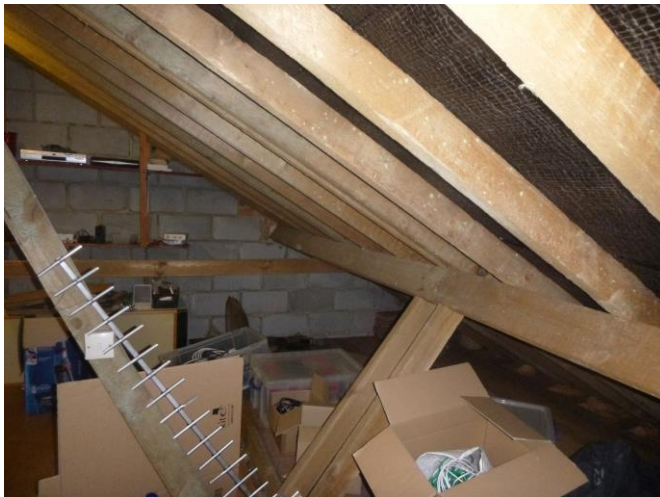
- 3.2.17 Externally, no potential ingress points were encountered.
- 3.2.18 Internally, the joists and rafters within the voids are of a simple design, with the trusses being of a Fink style. Nail plates are absent at the major junctions; however, any potential gaps are minimal and deemed too small to provide suitable bat roosting features. A moderate build-up of cobwebs was present around the junctions and throughout the void spaces in general, suggesting a lack of bat activity (Plates 5 - 6). No staining or scratch marks were noted along any of the beams, and there was no evidence of feeding remains. No droppings were noted despite a thorough inspection and the distinct smell often associated with bat roosts was absent.

Plate 5. Typical view of the internal void space

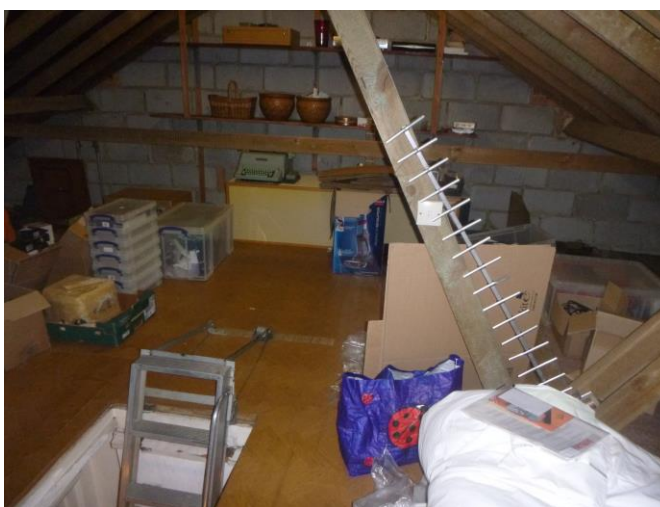
Plate 6. Typical view of the internal void space

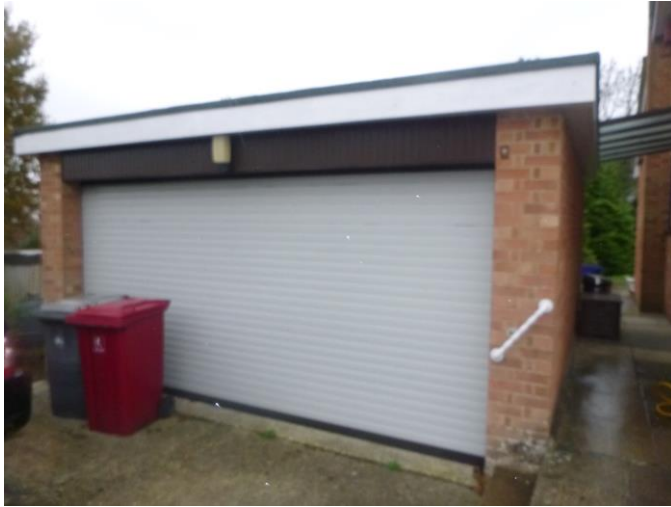
- 3.2.21 The double garage located on the south eastern side of the main bungalow supports a flat roof and was assessed as having negligible potential to support roosting bats (Plate 7).

Plate 7. General view of the garage
