# Initial Bat Assessment

**190 Henley Road  
Caversham  
Reading  
RG4 5LN**

**Dr Stacey Dawn Waring  
18-004-IBA  
January 2018**

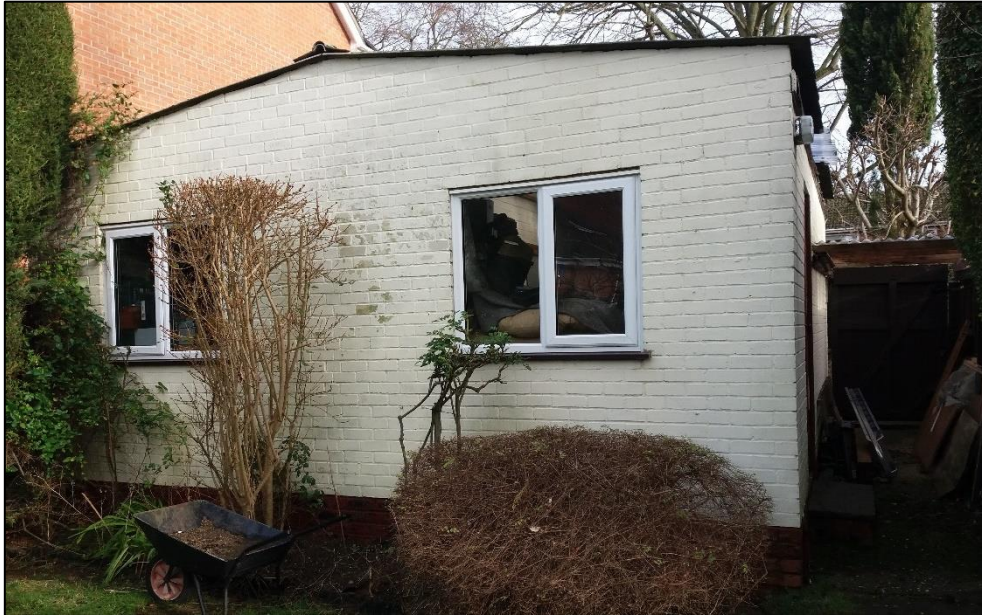
The site consists of a 20<sup>th</sup> Century, detached, single storey freestanding garage of single skin brick, wall construction (Figure 2 and 3) with a low-slope pitched (gabled) roof, consisting of timber rafters resting on the walls and a corrugated asbestos fibre board/plastic covering. The building is in fair condition and is currently used for car storage.

**Figure 2 – Rear (western) elevation of garage at 190 Henley Road**

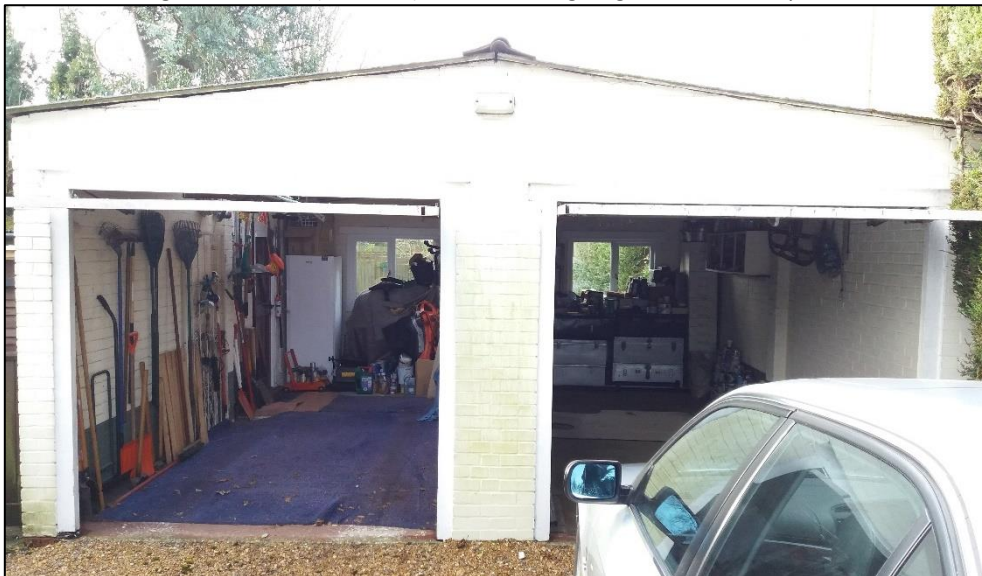
**Figure 3 – Front (eastern) elevation of garage at 190 Henley Road**

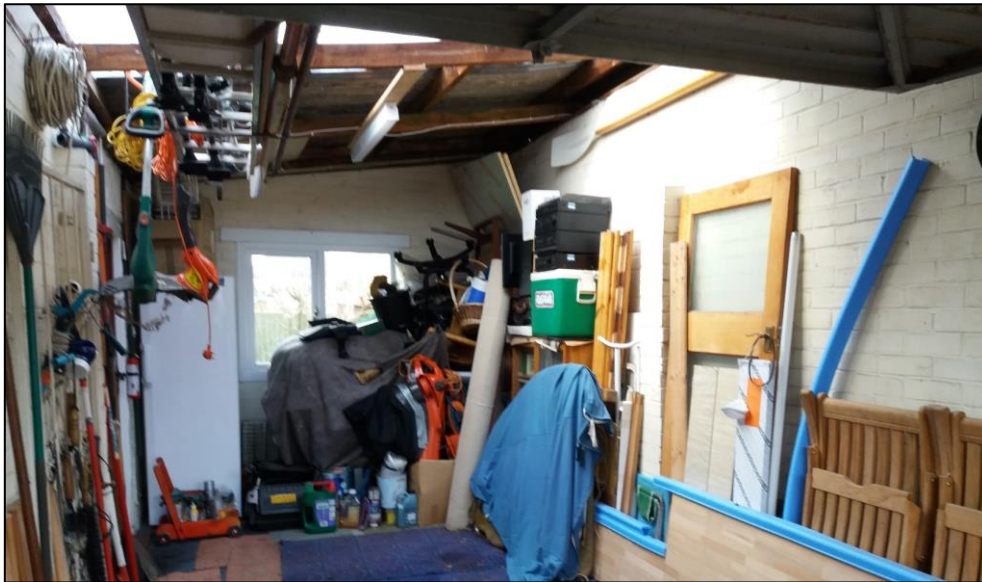
The garage consisted of a single open internal void (Figure 3), thus there was no separate roof void to inspect. The internal void was approximately 2.5m high at the central point. The garage had windows along the rear elevation (Figure 2) and sheets of corrugated plastic in areas along the roof, which resulted in the internal space being very light (Figure 4). The two double garage doors fitted to the front of the building (Figure 3), whilst in good condition, allowed an elevated level of air movement through the building. Consequently, the internal space was very draughty and the microclimate will be affected by the external environment. Whilst there is a central wall in the garage dividing the space into two rooms. The wall does not reach ceiling height (Figure 5) and so the conditions on both sides of the garage will be subject to the same environment.

There was no underlay fitted beneath the asbestos and plastic roofing, thus there were no areas internally that would provide a dark and suitable place for bats to roost. There was some evidence of cobwebbing throughout the garage, however, the regular use of the building for storage and the draughts could result in this. No evidence of bats was found during the internal inspection.

**Figure 4** – internal space of garage located at 190 Henley Road

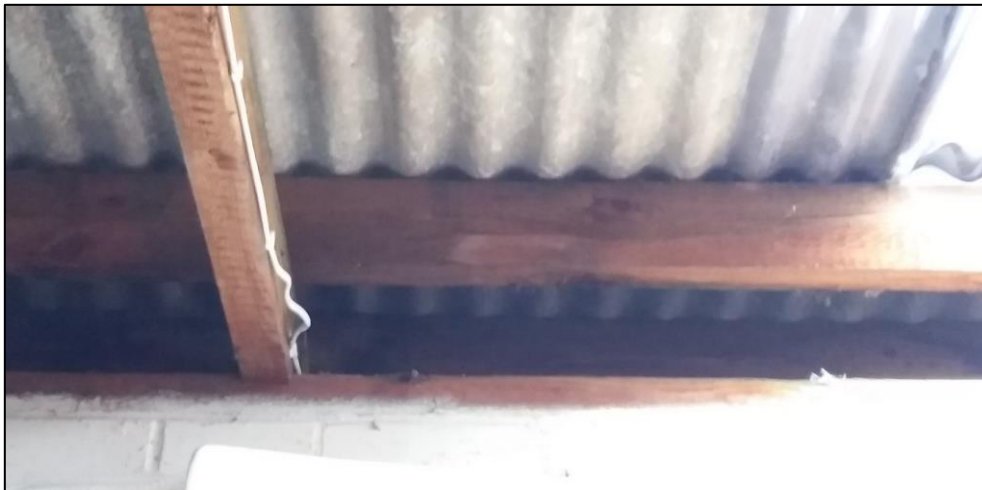
**Figure 5** – showing gap at top of wall dividing the garage

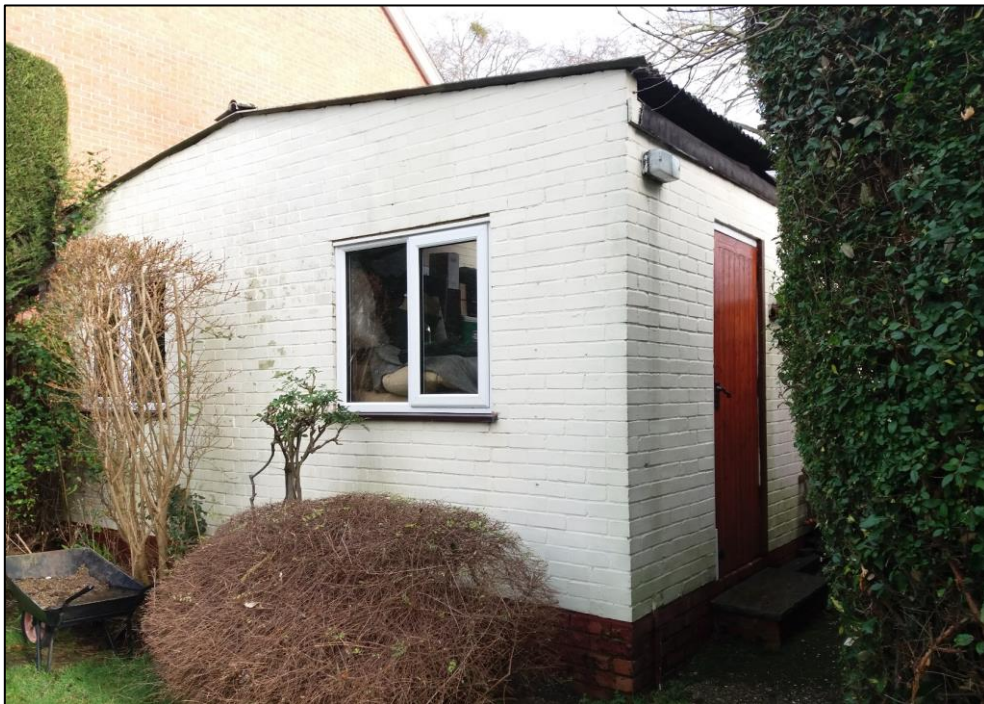
The primary roof covering consisted of corrugated asbestos fibre board and plastic over the whole of the property (Figure 9). The primary roof covering was in fair condition and had no overlapping boards or areas that could be utilised by bats. The construction of the roof means that the corrugated boards only rest on the gable walls of the garage. This means there are open eaves and verges (Figure 10 & 11) around the whole of the building. Whilst bats could use this for access, these gaps will further reduce the suitability of the internal microclimate for roosting.

roosting bats. The timber boards fixed at the eaves, along the side of the building (Figure 9), are in good condition and tightly fitted against the building.

**Figure 9** – rear of the garage showing corrugated roof and close-fitting timber boards at eaves

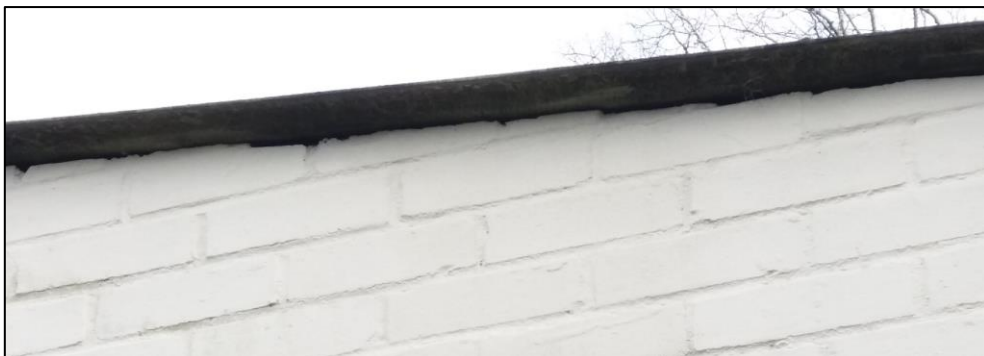
**Figure 10** – gable end showing gap between wall and corrugated asbestos fibre board

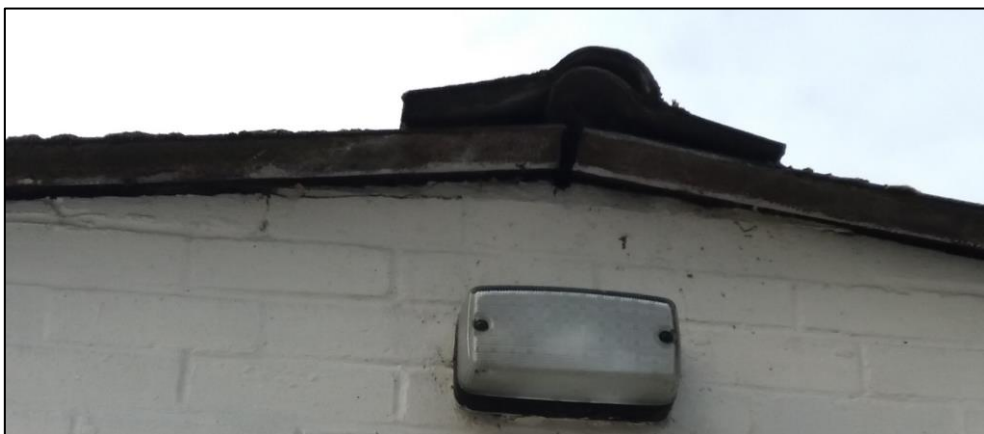
The ridge consists of a half round asbestos ridge fitting (Figure 11). The ridge was not sealed either along its length or at the ends. The underside of the ridge fitting was also visible from inside the garage. Consequently, the ridge was exposed to both draughts and light and provided no suitable areas for

**Figure 11** – showing open ended ridge fitting
