# GEOSHIELD Verification Report

PROJECT REFERENCE: GEO1001700/KC/P

PROJECT: Porcelenosa: Kenwood Construction

MEMBRANE SPECIFICATION: Gas membrane to specification BS8485 2015

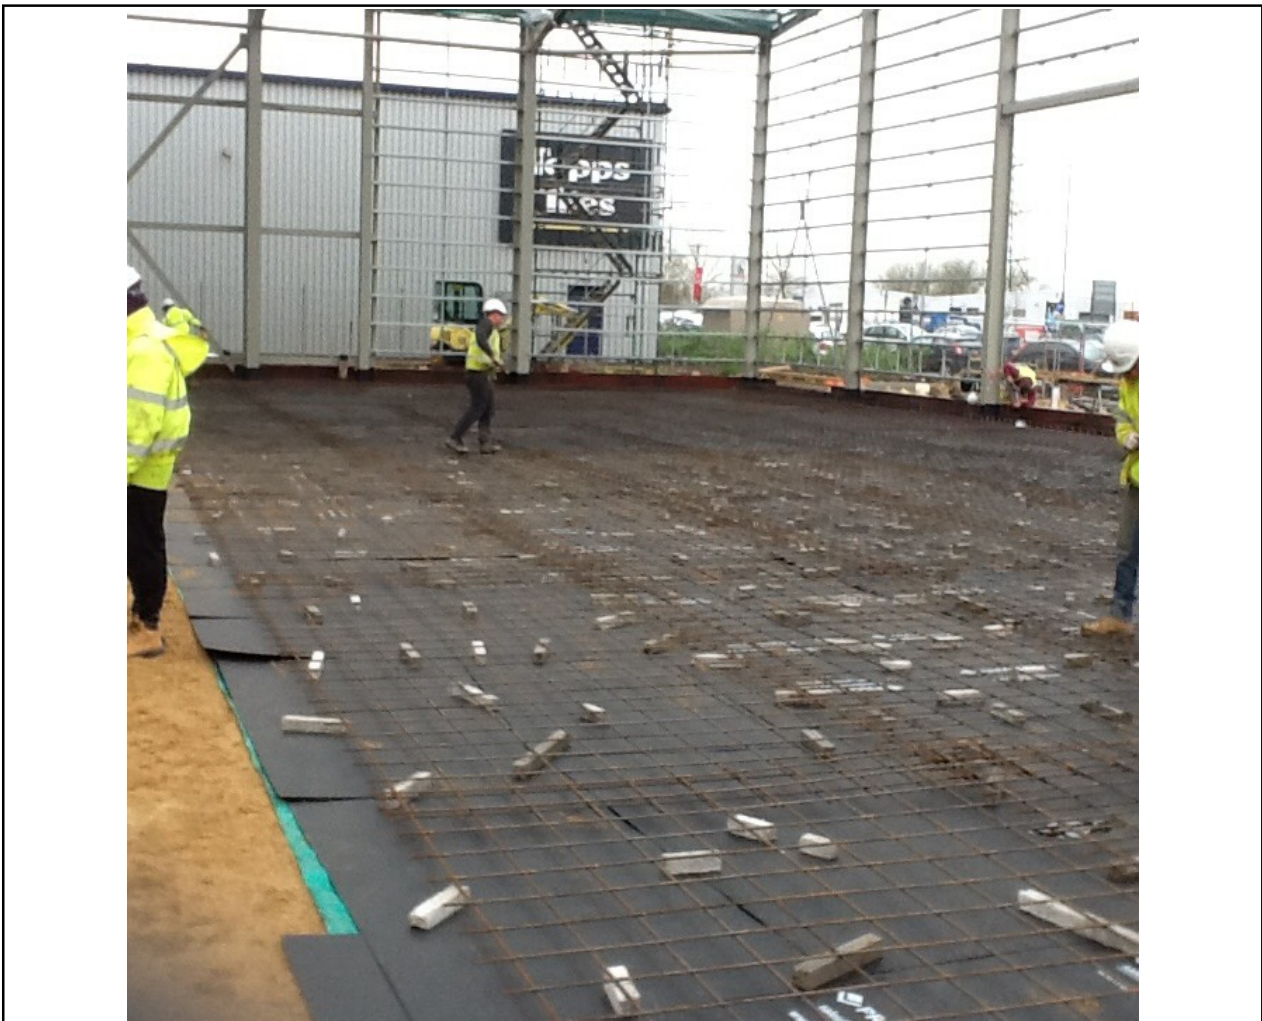
Overview premtech protection applied prior to pour

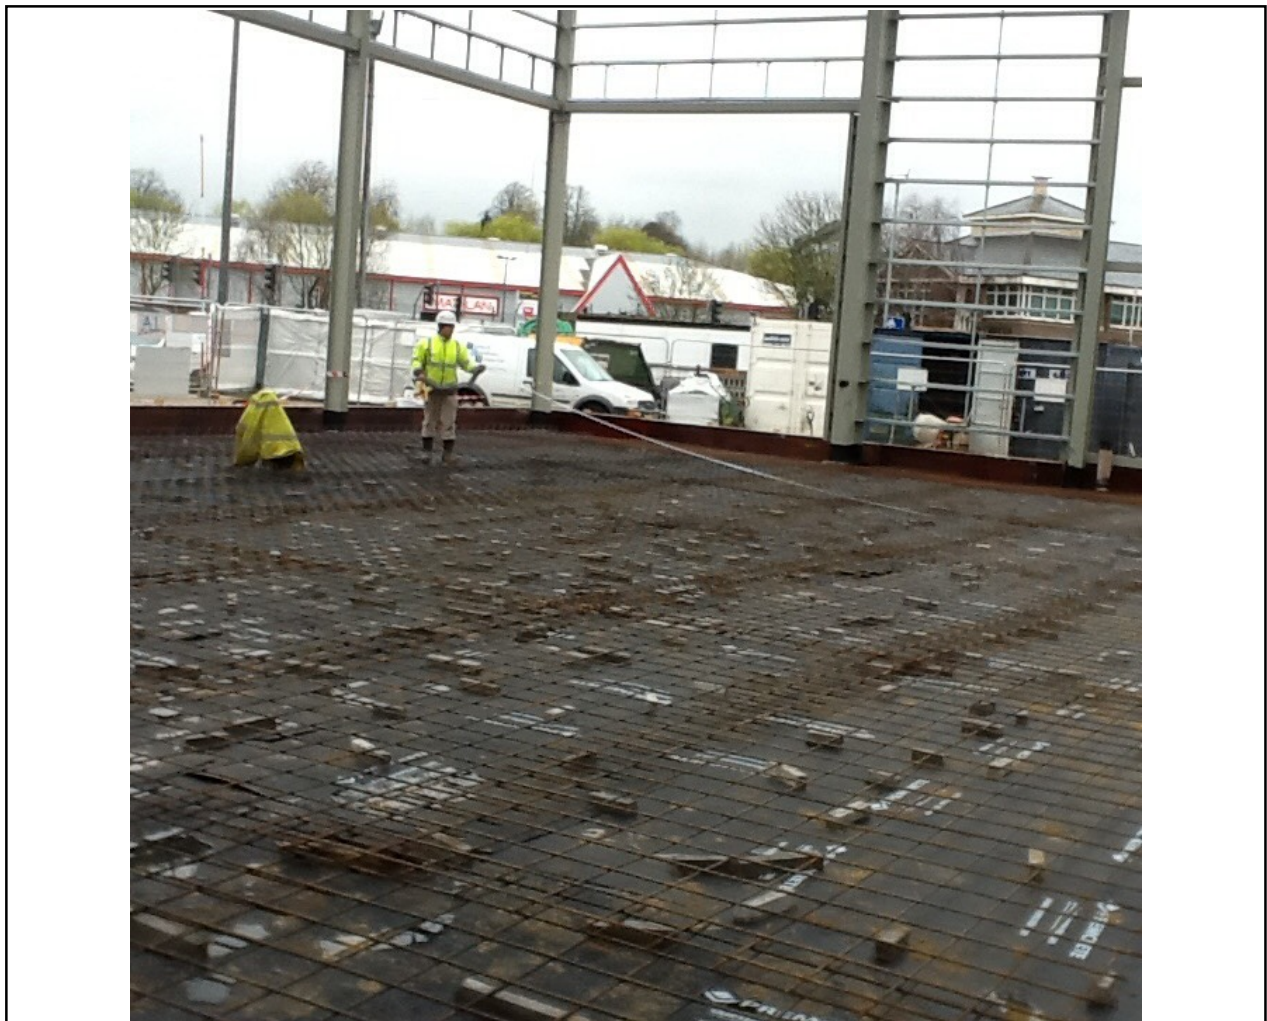
Overview looking toward A1-3

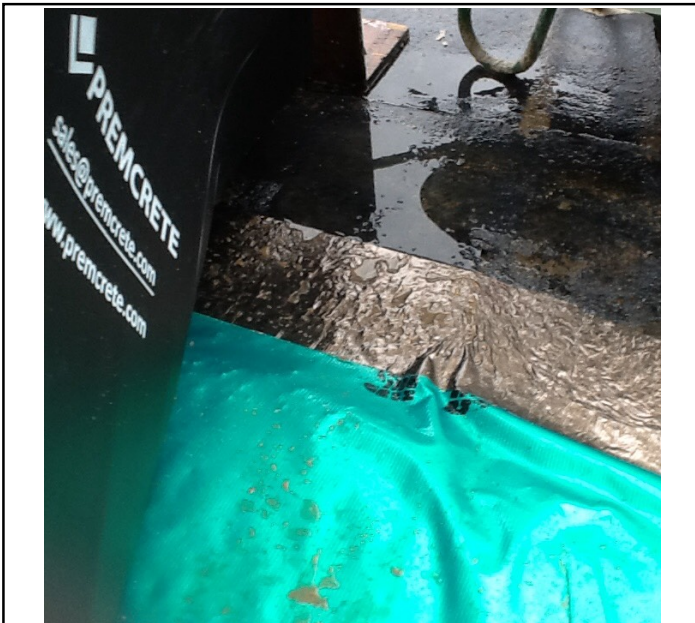
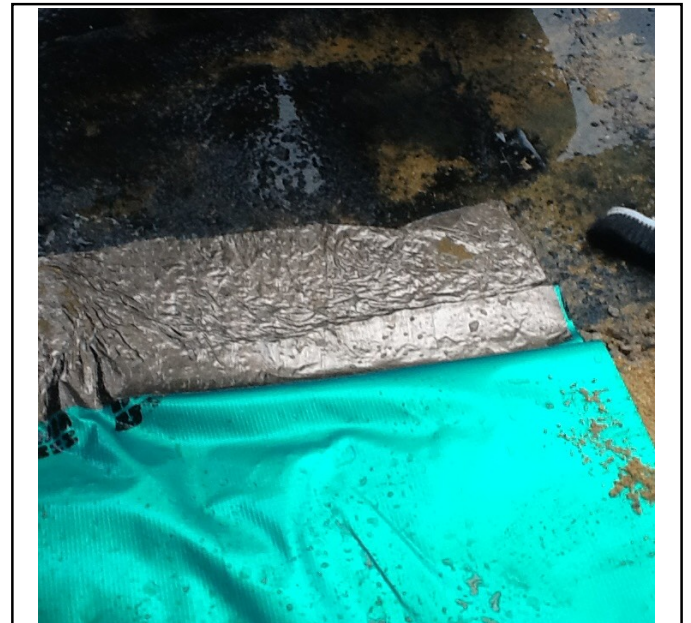
LOCATION/GRID LINE: A-4

Just prior to pour , protection lifted for inspection ,

Two views showing application of 300mm detailing tape to seal membrane to

Hydroprufe LG and edge beam

| Date | Nr | Remediation Description | Y/N |
|---|---|---|---|
| 23rd Mar | 002 | 300mm detailing tape overlaid to edge beams and membrane | ✓ |

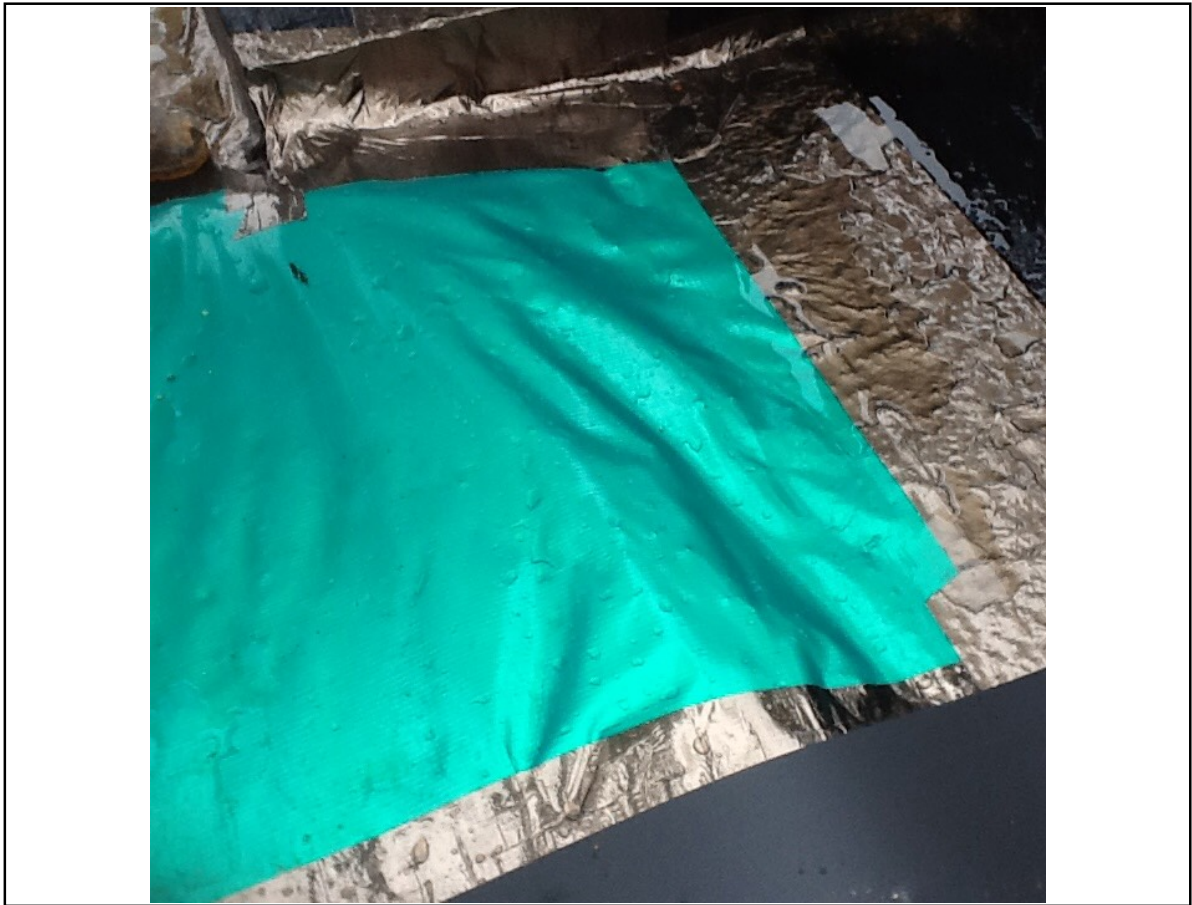
Overview detailing tape to seal membrane to LG and edge beam join

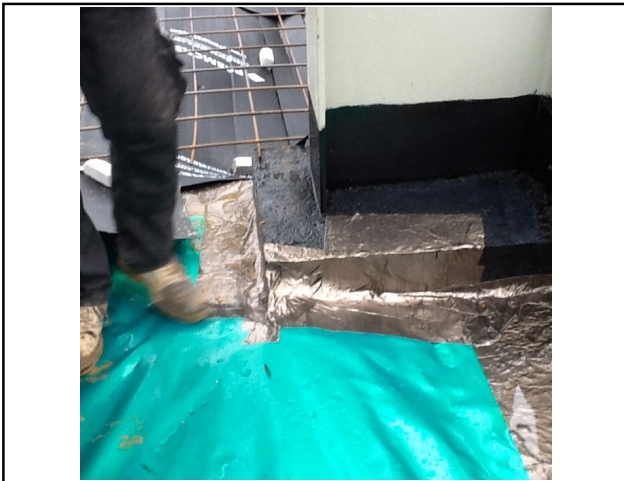
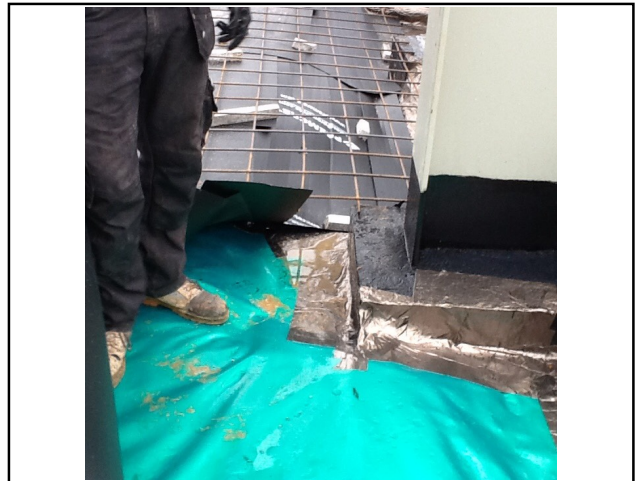
LOCATION/GRID LINE: A-4 column

NOTES: Two views showing detailing tape applied to the join

Between Columns , edge beam and main 8000 membrane

| Date | Nr | Remediation Description | Y/N |
|---|---|---|---|
| 23rd Mar | 002 | Column and edge beam detailing sealed to specification | ✓ |

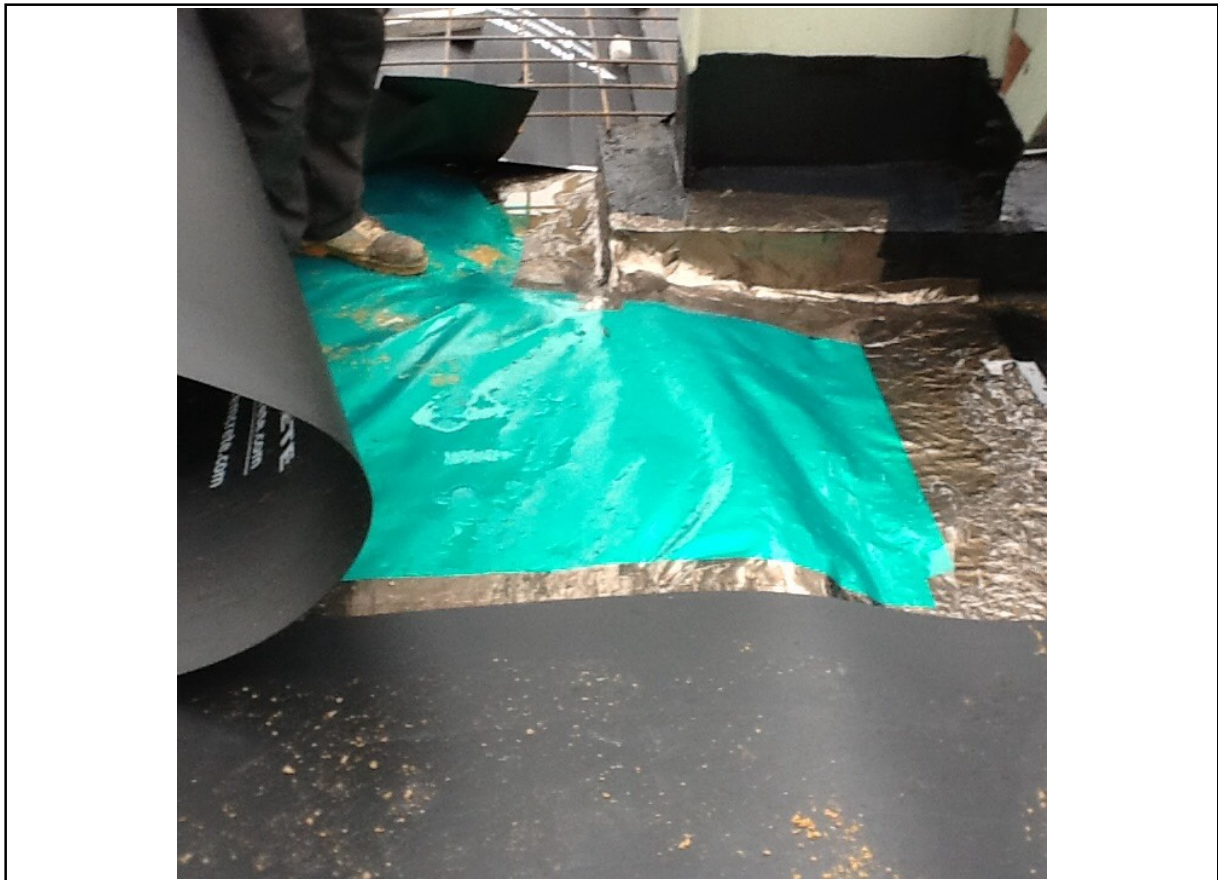
Overview also showing Hydroprufe LG applied to column bases,

Detail tape overlaid making seal between membrane

and columns .

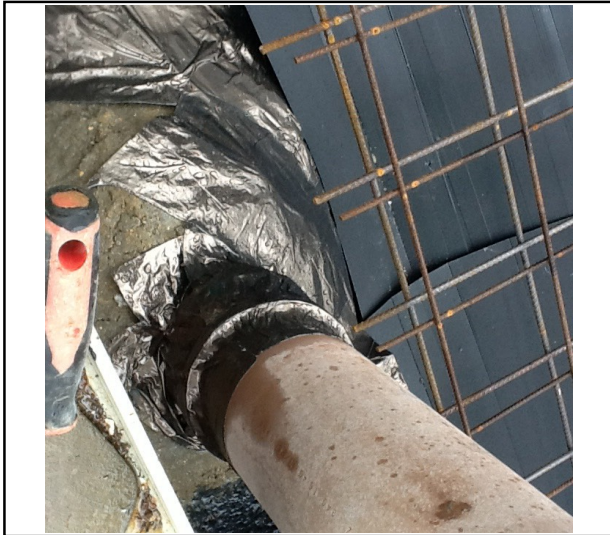
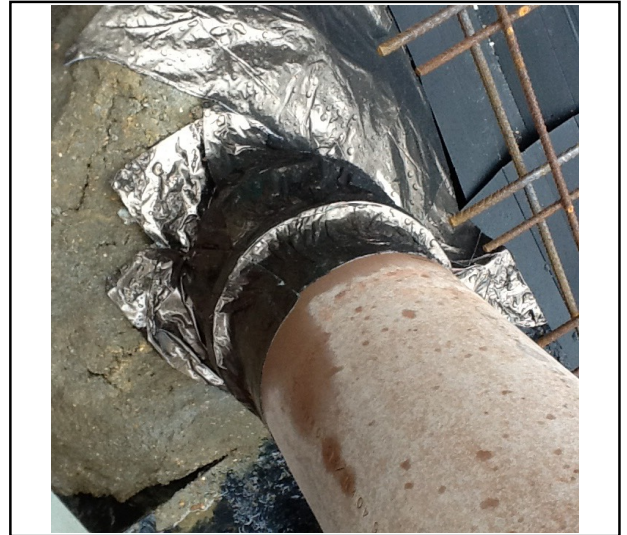
LOCATION/GRID LINE: Pipe penetration near grid ref A4

NOTES: Detailing tape around pipe penetration applied to

Specification

| Date | Nr | Remediation Description | Y/N |
|---|---|---|---|
| 23rd Mar | 002 | Pipe penetrations detailed to specification | ✓ |

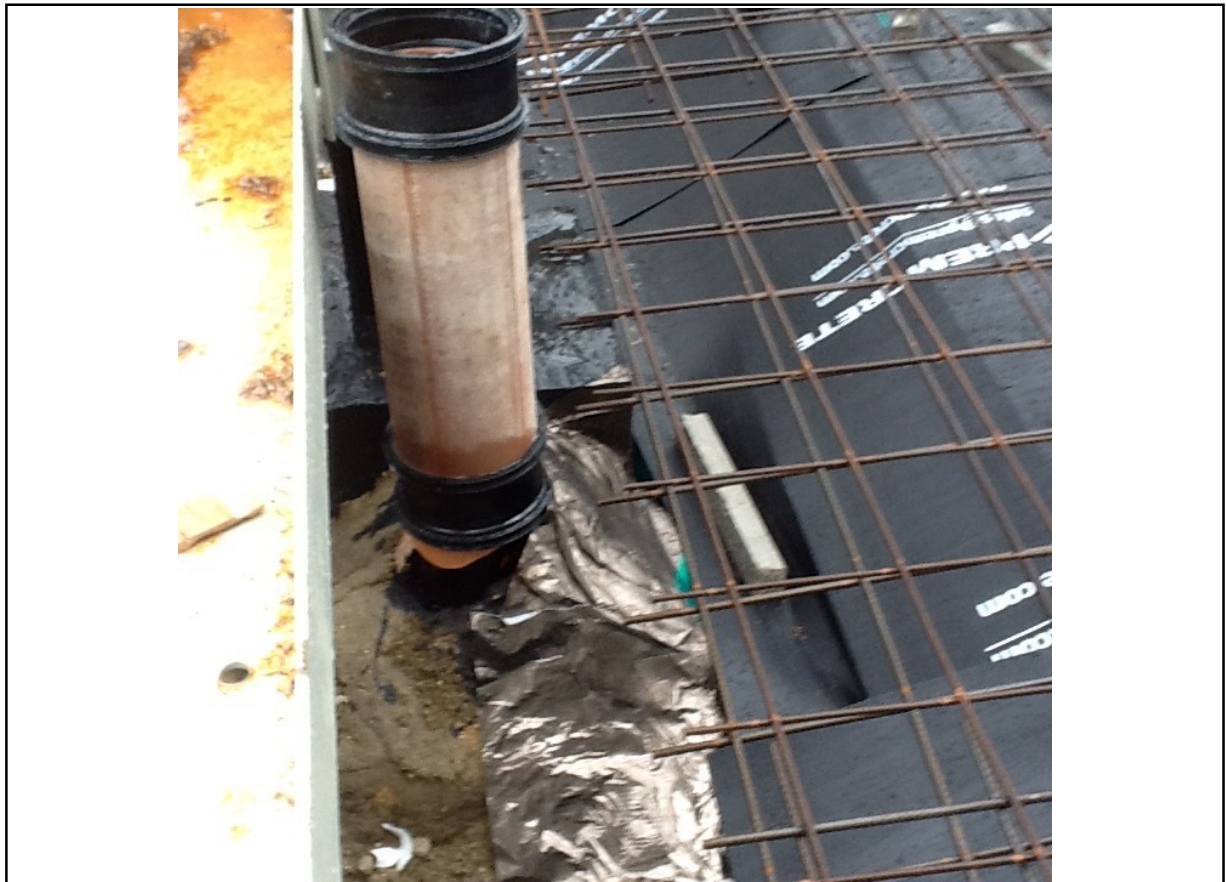
Overview pipe penetration detail
