96 Bath  
Road,  
Reading,  
Berkshire,  
RG30 2EU

## Preliminary Roost Assessment: Daytime Bat and Nesting Bird Survey Report

July 2018

Ref: 18-4431

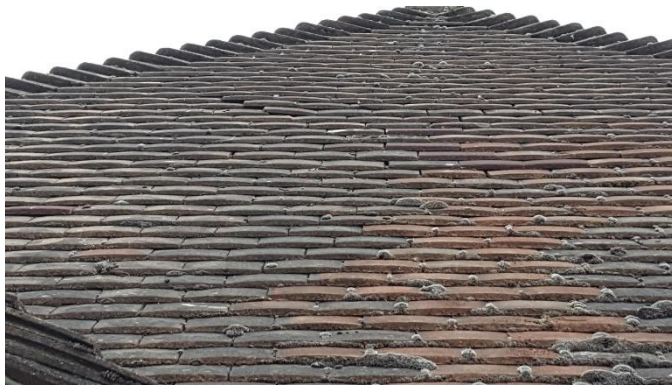
| Location | Feature | Confirmed Presence or Potential |
|---|---|---|
| Roof | Plain Cement Tiled with Cement Ridge Tiles | Southern, western and eastern roof slopes with notable lifts and gaps. Eastern elevation noted missing cement in edge tiles. Several tiles without lichen and or moss growth suggesting potential movement.<br><b>OVERALL: Potential for Access and Crevice Space</b> |

lifts in the front elevation roof space

- 8.9. To ensure that this site complies with wildlife legislation and the National Planning Policy Framework, the following recommendations are made:
- 8.9.1. A further echolocation survey is to be carried out during the active bat season (May to August inclusive). The further survey will inform the mitigation strategy, determine roost type(s), confirm species and numbers.

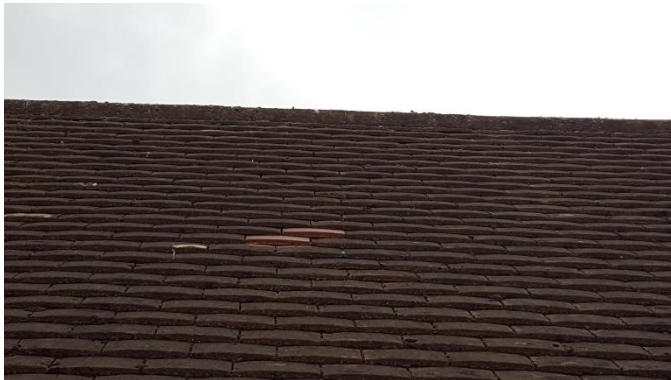
slight lifts in side elevation (eastern)

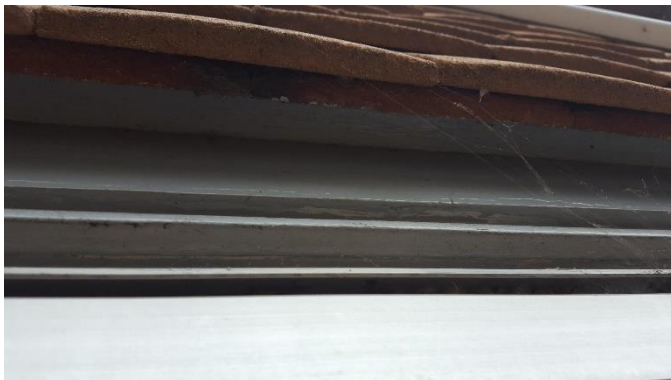
| Location | Feature | Confirmed Presence or Potential |
|---|---|---|
| Dormers | Cement hanging tiles, brick wall | Meets the main tiled roof with no gaps and or lifts, hanging tiles tight and intact – <b>OVERALL: –no potential for access and crevice spaces</b> |

tight intact features of dormers – front

elevation

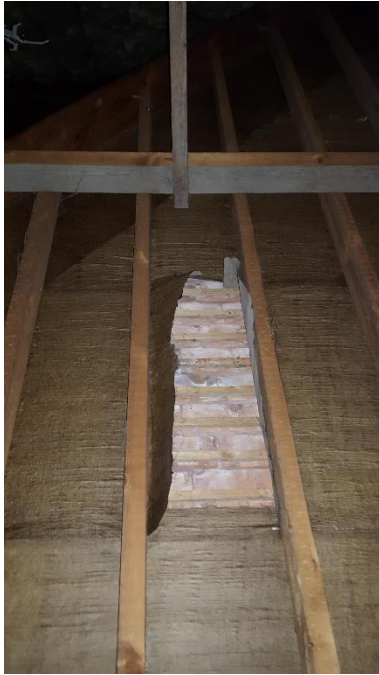
6.3.4. The loft space noted visible light noted on the northern, western, eastern and southern slopes. Three areas of torn felt was noted within the eastern and western roof slopes. Closer inspection of these torn areas noted tight intact tiles with no areas of visible light. The ridge beam area noted heavy cobwebs. The figure below details the loft inspection features and noted potential. No signs of bats in the form of droppings, debris, marks and or stains were noted during the inspection.

Internal – rip in felt roof space on western side of loft

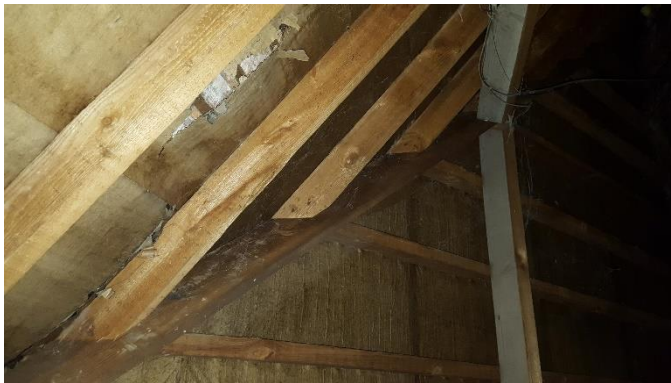
internal – rip in felt roof space on eastern

side of loft
