Projex Building Solutions

**Broad Street Mall, Reading**

BAT SURVEYS

August 2017

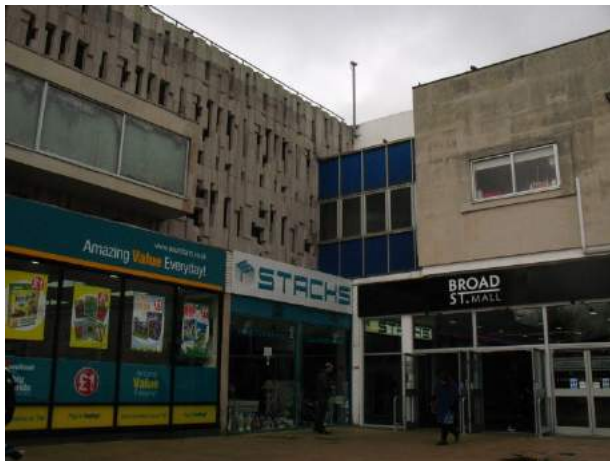
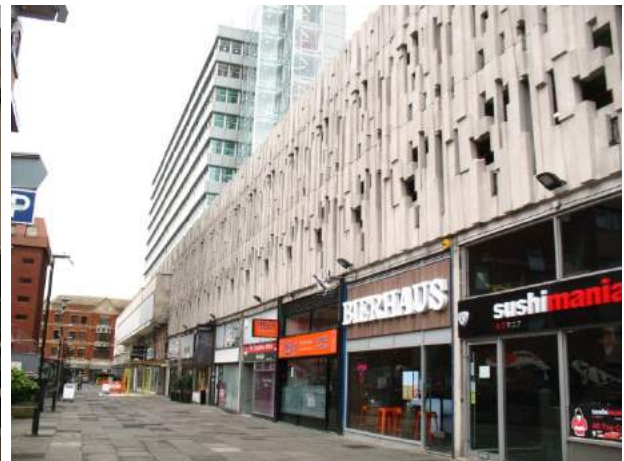
- 3.7 The main shopping centre and associated multi-storey car park (Area A, Figure 2) was constructed from concrete with flat roof areas (Photographs 1-6). Externally, the concrete walls of the main complex were in excellent condition, with an absence of any cracks or cervices that might be considered suitable access points or roosting features for bats. There were areas of the car park wall with holes designed in the concrete which went through to the multi-storey car parking area as an artistic feature. These features represented potential points of access for bats into the 24-hour illuminated car parking area, but did not allow access into any cavity wall area or other features that may be considered suitable for roosting.

- 3.8 The other external walls of the main complex were in excellent condition with a number of surfaces (in particular the northern and eastern aspects) embodied with shop-front cladding. Where present the cladding was all in excellent condition and well-sealed, with no suitable access points or roosting spaces. There were small areas with gaps present on the southern aspect of the mall where the main complex joined the nightclub building and small gaps were present in the brickwork at the eaves.

Above: Photographs 1 and 2 showing the southern aspects of the Mall and multi-storey car park

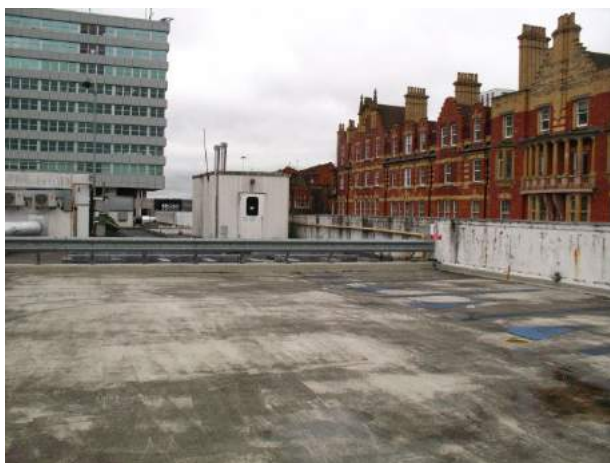
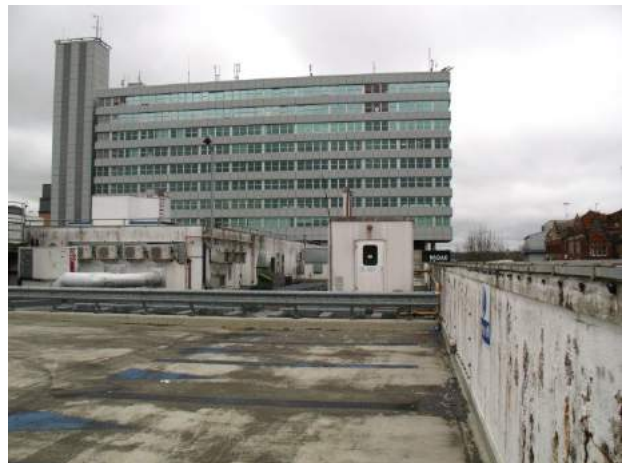
- 3.10 There were two commercial office blocks present on the roof of the main complex; the western one (*Fountain House, Photograph 4, Figure 2*) was a large multi-storey office block and the eastern one (*Quadrant House, Photographs 5 and 7, Figure 2*) was a combined one and two storey concrete structure with central tower. Fountain House will remain unaffected by the development proposals whilst Quadrant House will be redeveloped as part of the masterplan. Externally, the roof surfaces were in excellent condition with minimal gaps observed at edges of roof coverings on Quadrant House, however on closer inspection with an endoscope these did not extend beyond a few millimetres into the structure and provided no suitable roosting for bats.

- 3.11 No roof voids were present in the Fountain House or Quadrant House office blocks and no suitable areas for roosting bats were present internally.

Above: Photographs 3 and 4 looking towards Fountain House on the rooftop car park

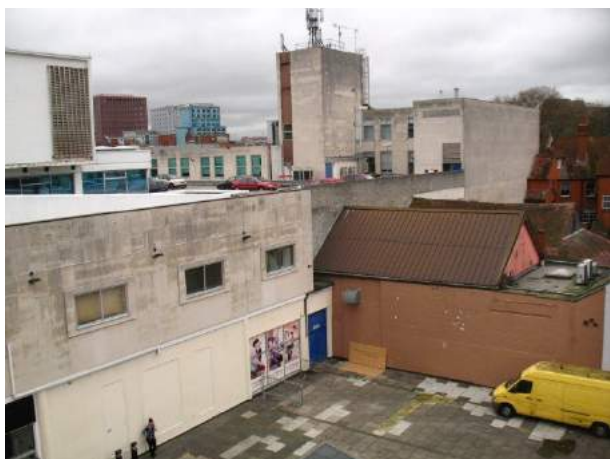
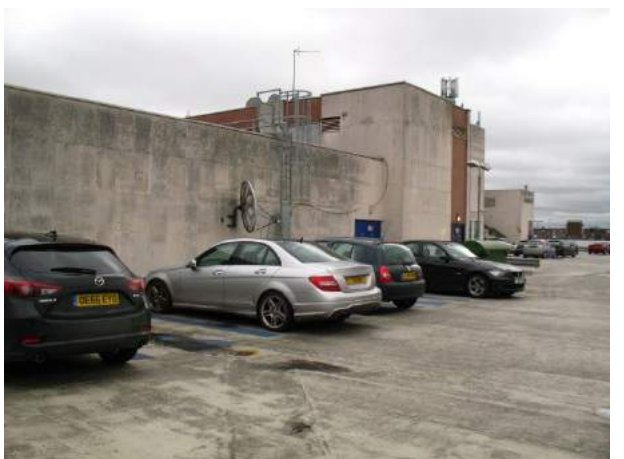
Above: Photographs 5 and 6 looking towards Quadrant House across the multi-storey car park

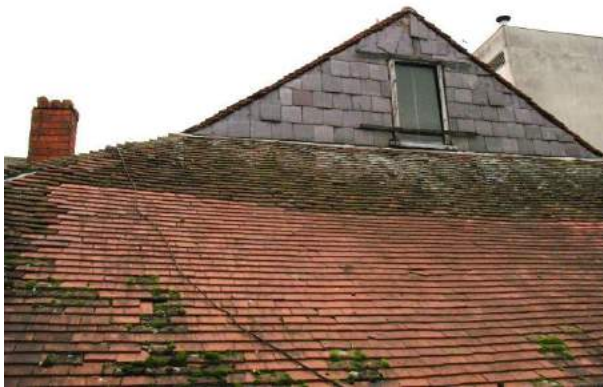
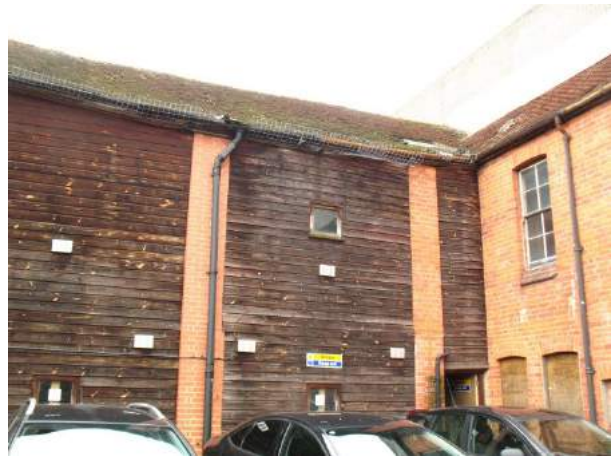
- 3.15 The outbuildings of the army recruitment centre adjacent to the nightclub consisted of two pitched roofed outbuildings; one was a two-storey and the other was a single storey structure.
- 3.16 The two storey structure was attached on the eastern aspect to the nightclub and on the northern aspect to the shopping mall. It was a brick built structure with areas of wooden cladding on the eastern and southern aspects; however this wooden cladding was in good condition and well-sealed with no obvious cracks or crevices. This building had a pitched roof with pan tiles and there were a

number of slipped and missing tiles in association with this roof which provided potential bat access points and roosting locations. There was a glass window in the roof void on the upper part of the southern gable end which allowed light into the roof space, making the internal space of the void less suitable for roosting bats due to the increased light levels. This gable end had hanging slates present with a number of gaps present in association with these which provided potentially suitable bat access points. Below this was a small roof pitch facing south with a pan-tile covering that met with the balcony area of the nightclub courtyard area. This feature also had a small number of slipped and missing tiles present which allowed bat access beneath the tiles.

**Above: Photographs 7 and 8 showing the two pitches of the Army recruitment 2-storey outhouse**

- 4.10 If demolition works have not commenced by Spring 2019, further surveys will be required to confirm the continued absence of roosting bats.
- 4.11 It is recommended that consideration should be given where possible to the provision of additional bat roosting opportunities as an enhancement to the completed development. This could include some additional roosting opportunities as part of the fabric of the built development.

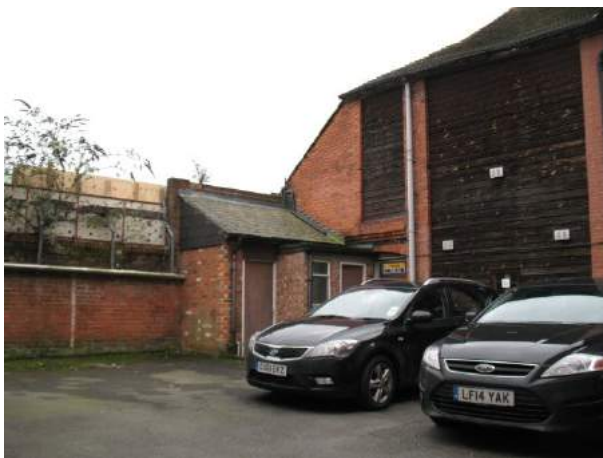
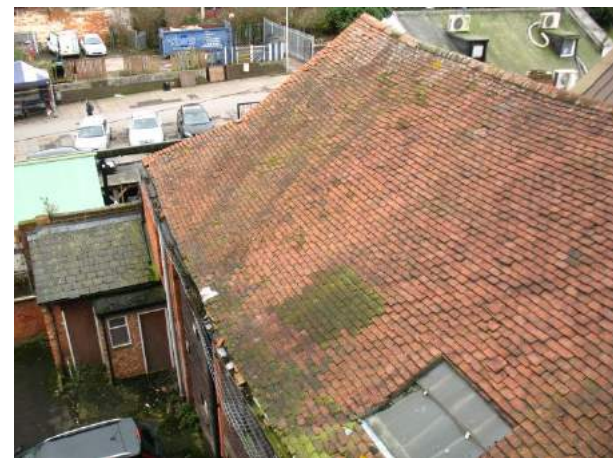
- 3.17 The small single-storey structure was brick-built and was attached on the western aspect to the two-storey building. It had a small single pitched slate roof and area of flat roof with bituminous felt both of which were in good condition. No suitable features for bats was observed in association with this single storey outbuilding.
- 3.18 Internally the two-storey outbuilding of the army recruitment centre had two large open rooms, with a staircase leading to the upper floor, which not accessible at the time of survey, and therefore the roof void could not be inspected for evidence of bats.

**Above: Photographs 9 and 10 showing the two pitches of the Army recruitment 2-storey outhouse and the single-storey outhouse with flat roof section**

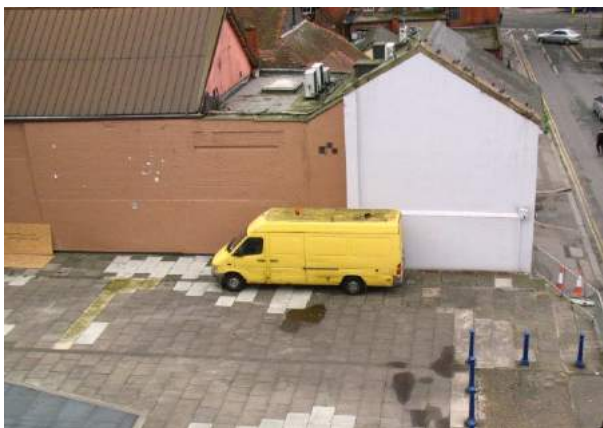
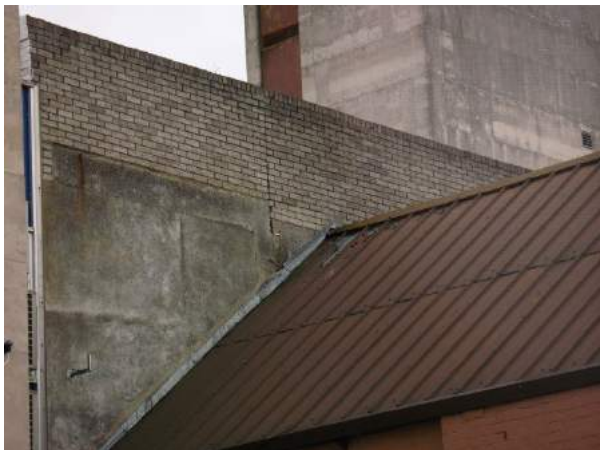
- 3.13 The nightclub building was a brick-built two-storey structure with a pitched corrugated metal roof. The northern end of the ridge had a gap underneath that had the potential to permit bat access under the roof. Externally the brickwork of the nightclub was in excellent condition with the exception of the small area mentioned above where the northern aspect of the building joined the main mall complex, and a small gap was present between the two structures. A strip of lead flashing was present along the pitched roof at this point and at the ridge there was a small area of lifted flashing that had the potential to permit bat access underneath, but did not appear to extend very far thereafter.

- 3.14 Internally the nightclub roof void had been converted into part of the venue and so no roof void was present. A basement area was present but this was used on a daily basis as a store and refrigeration room for the bar area on the ground floor. No evidence of bats was present and no gaps suitable for bats to enter the area were present.

**Above: Photographs 11 and 12 showing the two roofs of the nightclub buildings including the join to the shopping mall.**
