Project: 34-38 Southampton Street, Reading, RG1 2QL

## Preliminary Bat Roost Assessment Report

April 2018

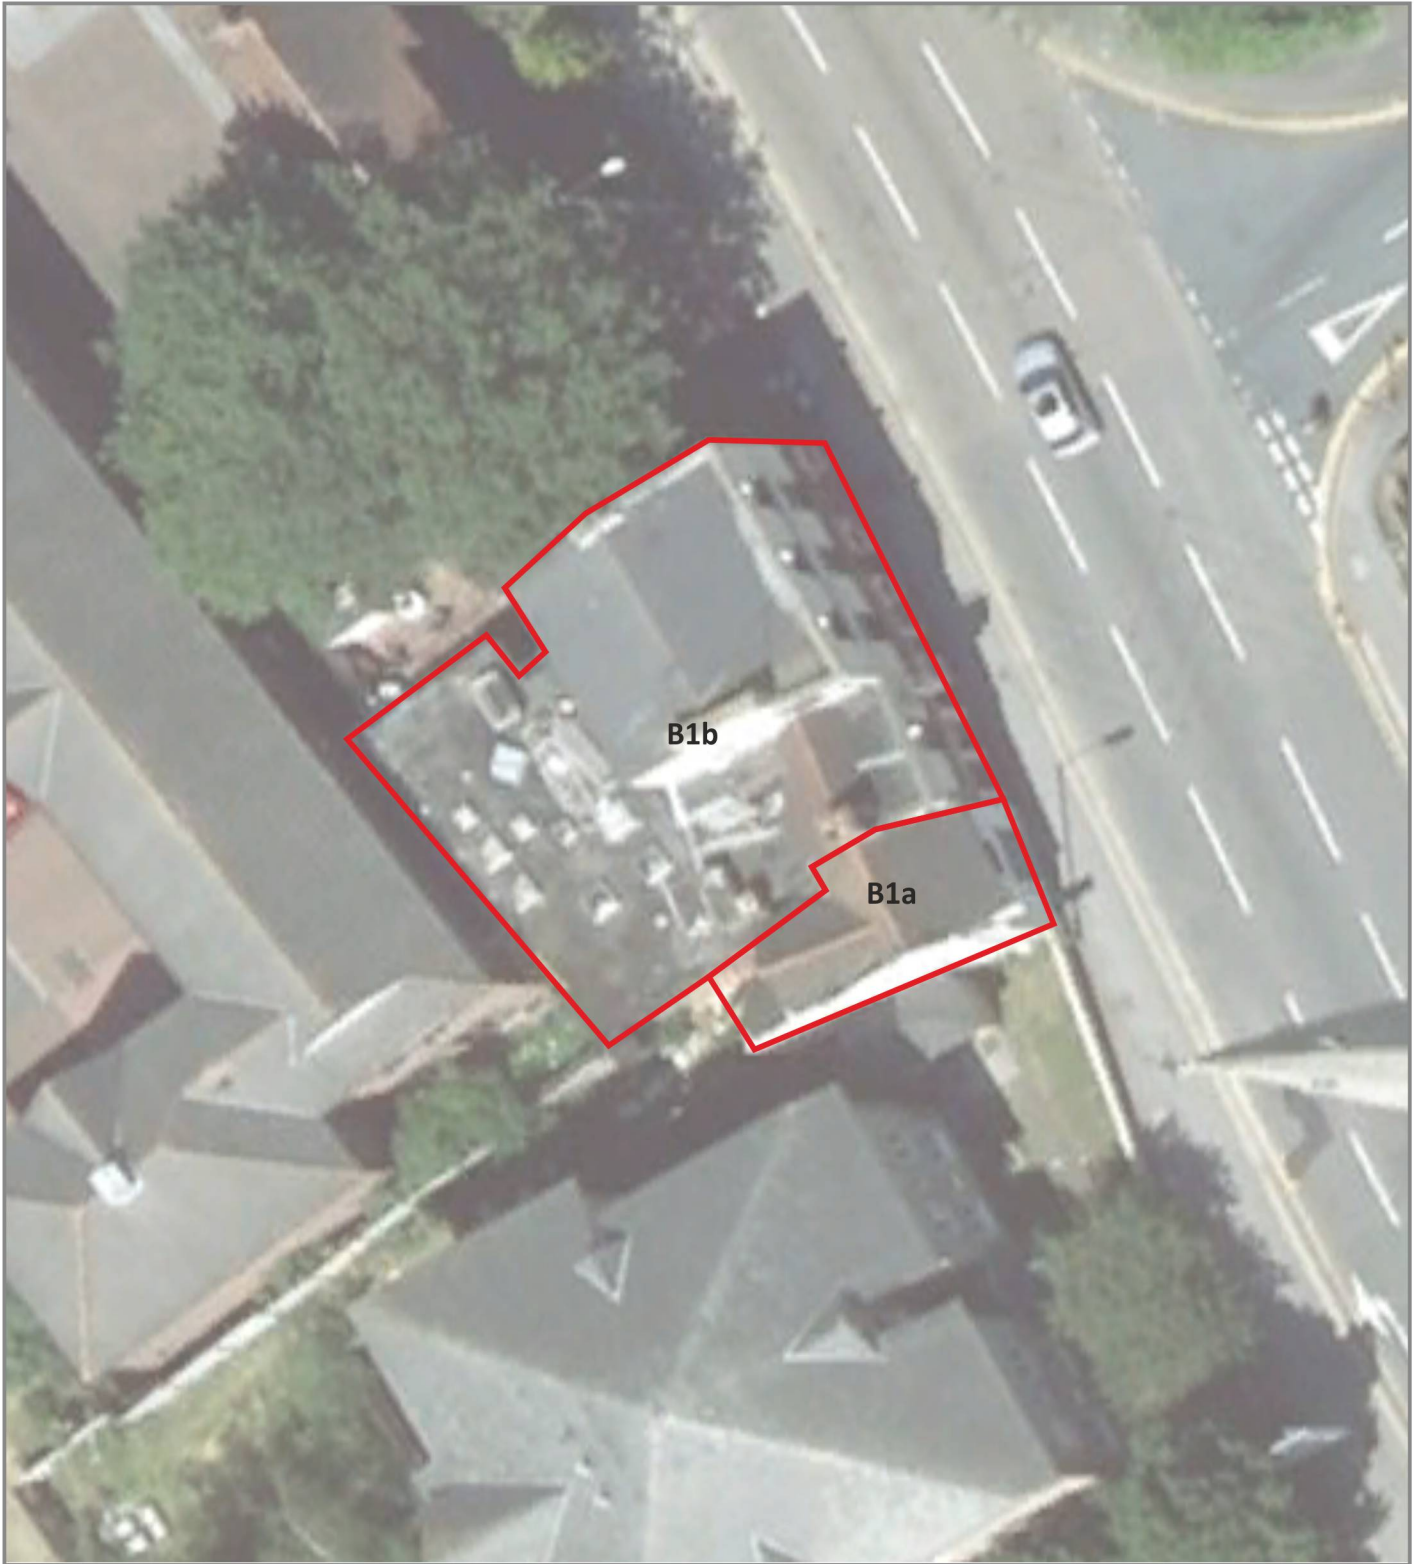
## Plan 5364/PRA1:

- 3.2.1 The site comprises a two-storey residential building, which adjoins a public house (The Red Lion), hereafter referred to as building **B1a** and **B1b** respectively (see Plan 5364/PRA1), located in an urban context within central Reading. The site lies adjacent to Southampton Street on its eastern aspect, which was recorded to be a busy road with a large amount of traffic. Two street lights are located at the front of the building which illuminate the eastern aspect. To the rear of the building lies a small garden which has become overgrown with scrub. No trees are present within the site.

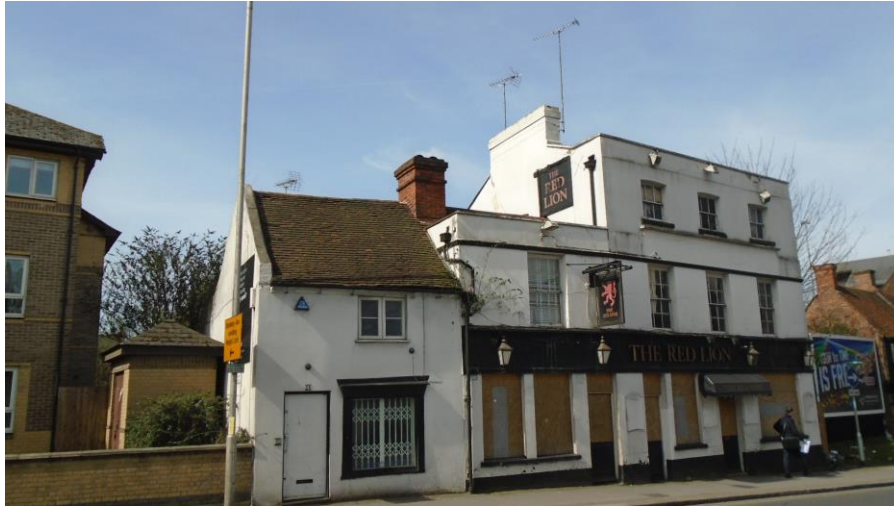
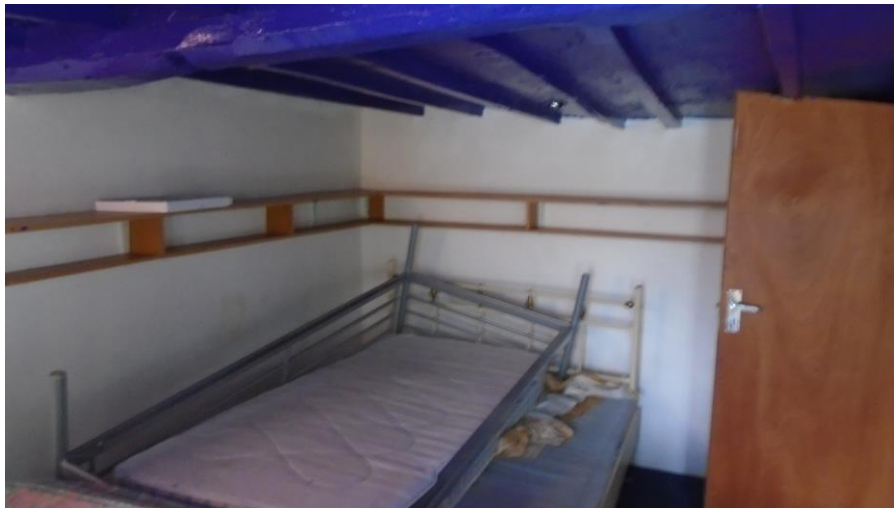
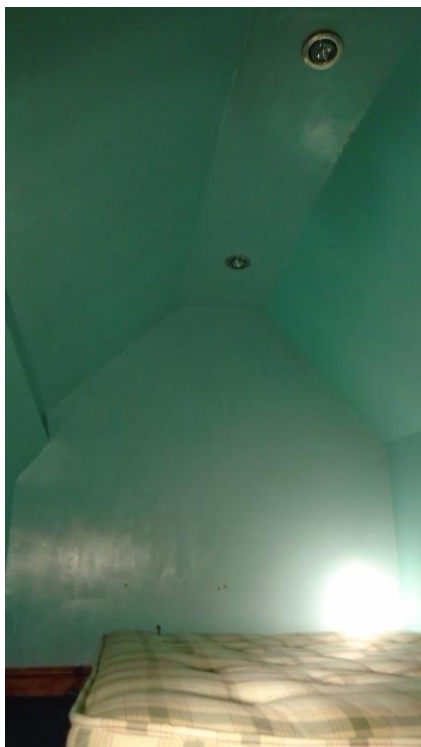
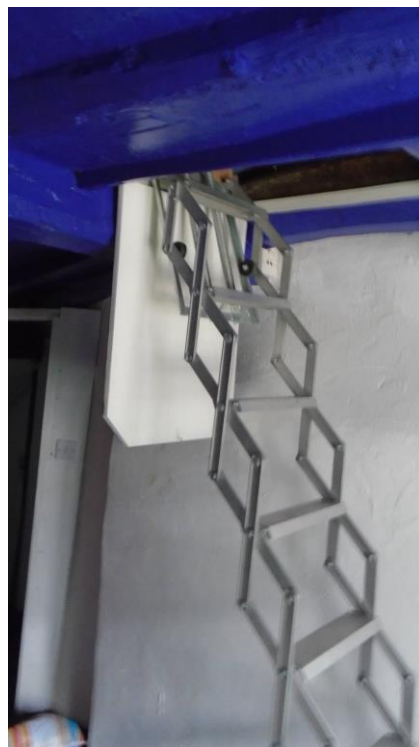
- 3.2.2 Building **B1a** is a two-storey, unoccupied semi-detached residential building of brick construction with rendering on the majority of the external façade. Building **B1a** supports a multi-pitched, clay tile roof with a gable end and associated lean-to structure at the rear of the building which supports a slate tile roof. A brick retaining wall is present to the south of the building, which forms part of the external wall of the building and associated lean-to. The exposed external walls are of a construction considered unlikely to support a cavity, and were recorded to be in an apparent good state of repair with occasional small cracks and crevices. Potential access features for bats include lifted, damaged or missing roof and ridge tiles, lifted or missing lead flashing and crevices around damaged window sills.

- 3.2.3 Internal inspections of building **B1a** confirmed that the loft had been converted into a windowless bedroom, with a small inaccessible loft void (<30cm high) likely to be present at the apex to facilitate wiring to the spotlights. The remainder of the building appeared to be in a relatively good state of repair, with any broken window panes covered by tightly fitting security boarding, leaving the remainder of the windows uncovered which results in high levels of ambient light inside.

- 3.2.4 A number of potential opportunities for roosting bats were recorded to be present across the building, primarily external features such as roof tiles, ridge tiles, lifted or missing lead flashing, crevices around damaged window sills and cracks and crevices in the external brickwork. Such features could potentially be used by individual bats opportunistically, however the building is unlikely to be suitable for maternity of hibernation roosts and no evidence of bats was recorded. The building is subject to high levels of ambient light, draughts and street lighting, in addition to being situated in an urban context (notwithstanding the presence of suitable foraging habitat such as the churchyard and River Kennet in the wider area) next to a busy road. On this basis, and given the context of the site within the surrounding landscape, building **B1a** is considered to be of negligible to low

suitability for roosting bats and no evidence of roosting bats was recorded during the survey work undertaken. Accordingly, no further survey work e.g. dusk emergence / dawn re-entry, is considered necessary.

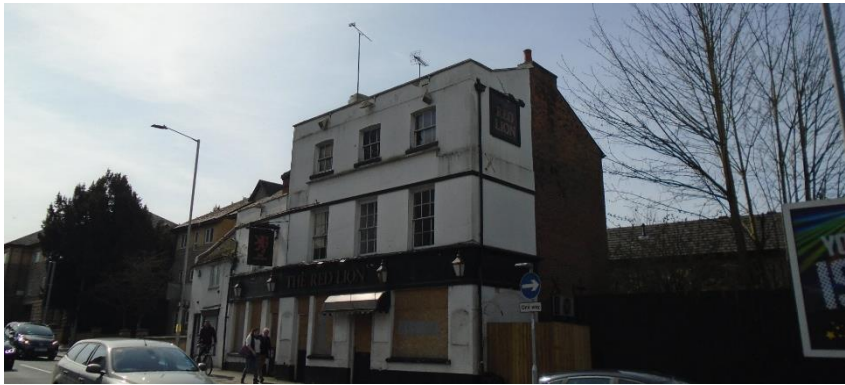
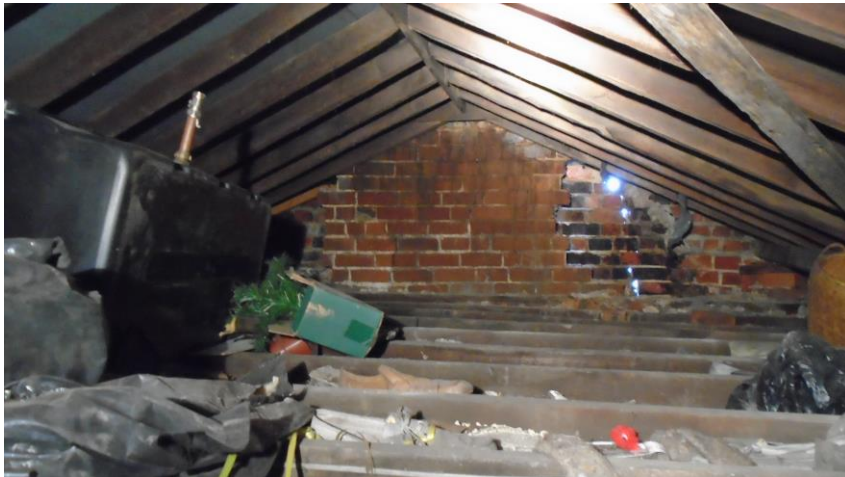
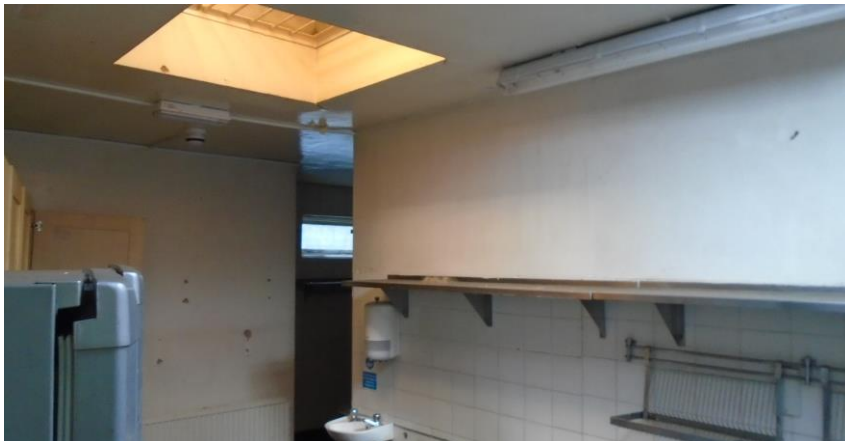
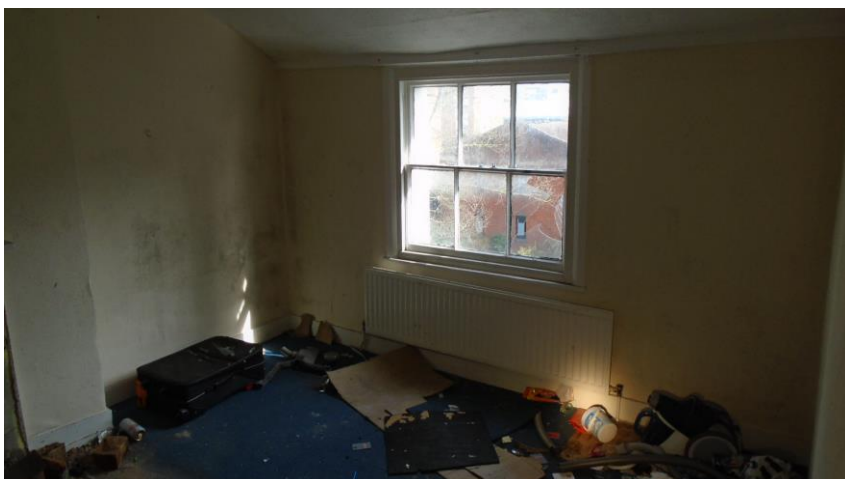
- 3.2.5 Building **B1b** is an unoccupied, semi-detached public house of brick construction with rendering on most of the external façade. **B1b** supports multiple storeys and is three storeys at its highest, excluding a basement which was inaccessible at the time of survey. A single storey extension is present at the rear of the building which appears to be a disused kitchen associated with the former use of the building as a public house. Building **B1b** supports a range of roof types including a pitched slate tile roof at its northernmost aspect with associated loft void, a pitched clay tile roof where it adjoins building **B1a** and a flat, bitumen clad roof on the single storey extension at the rear of the building which is unlikely to support a loft void. A dormer window with clay hanging tiles is present on the westerly aspect of the clay tiled roof, indicating that the loft in this aspect of the building may have been converted. However, due to the access constraints as set out at section 2.3, it was not possible to confirm if this was the case. The exposed external walls on the main building did not appear to be of a construction type likely to support a cavity, and a number of cracks and crevices were present. The kitchen extension at the rear of the building is of a construction type likely to support a cavity and missing brickwork was recorded on its southern wall. Other potential access features for bats include lifted, damaged or missing roof and ridge tiles, lifted or missing lead flashing, lifted bitumen felt, crevices around damaged window sills, broken windows and gaps behind soffit boxes and weather boarding.

- 3.2.6 Internal inspections of building **B1b** confirmed that a small loft void is present at the northernmost aspect, which was missing a loft hatch at the time of survey. The loft is approximately 3m wide, 6m long and 1m high at its apex and of wooden rafter and waterproof membrane construction. The interior of the loft void was recorded to be relatively light and draughty due to the absence of a loft hatch, a crack in the brickwork at the gable end and a small circular hole through the roof membrane. No insulation was present and the interior was relatively cluttered with a small number of cobwebs. The remainder of the building was light and draughty due to a number of broken windows and skylights.

- 3.2.8 A number of potential opportunities for roosting bats were recorded to be present across the building, primarily external features such as lifted, damaged or missing roof and ridge tiles, lifted or missing lead flashing, lifted bitumen felt, crevices around damaged window sills, broken windows and gaps behind soffit boxes and weather boarding. As with building **B1a**, these features could potentially be used by individual bats opportunistically, however the building is unlikely to be suitable for maternity of hibernation roosts (the basement is inaccessible to bats) and no evidence of bats was recorded. The building is subject to high levels of ambient light, draughts and street lighting, in addition to being situated in an urban context next to a busy road, as noted previously. On this basis, and given the context of the site within the surrounding landscape, building **B1b** is considered to be of negligible to low suitability for roosting bats and no evidence of roosting bats was recorded during the survey work undertaken. Accordingly, no further survey work e.g. dusk emergence / dawn re-entry, is considered necessary.
