Reference: 15028.6.1\_18.11.27

**Discharge of Condition No. 9 for Launchpad Reading's Supported Housing Development to the rear of 36 Mason Street, Reading, RG1 7PD. (Application 160342)**

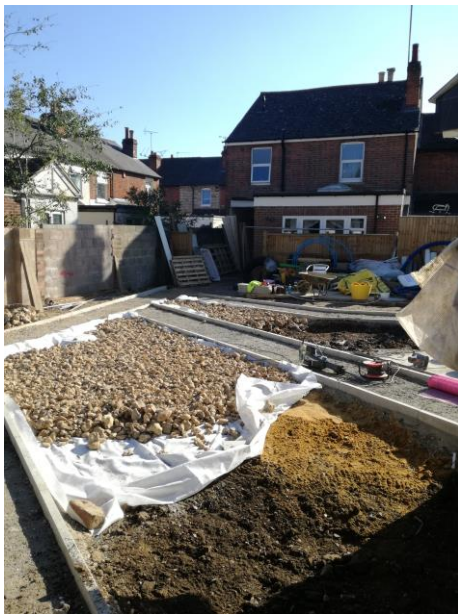
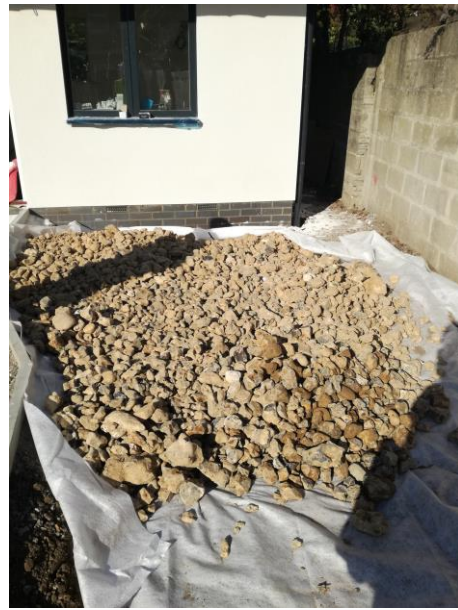
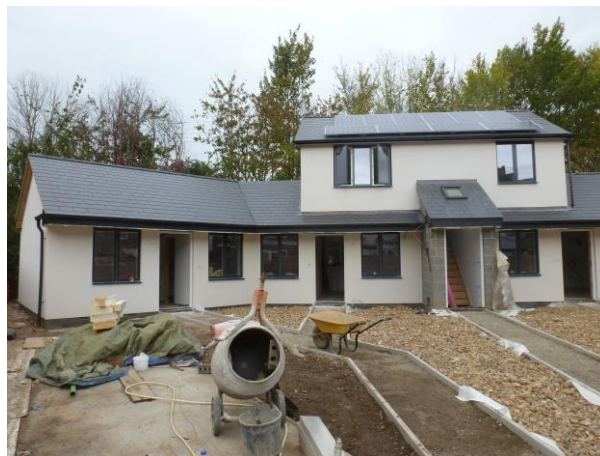
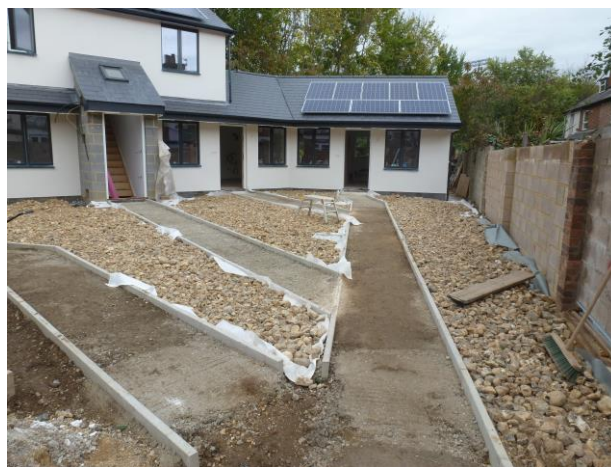
Fig. 1, 2, 3 & 4 – Geotextile membrane laid on ground formation level, 100mm of compacted open graded crushed rock being laid on top.

The build-up implemented on site consists of a permeable geotextile membrane laid on the ground formation level, over-laid with 100mm of compacted open graded crushed rock with no fines, finished with a 50mm depth of 20mm diameter slate chippings. This build-up exceeds the requirement stated in the remediation method statement. Please refer to photographs below illustrating the works that have been completed on site:

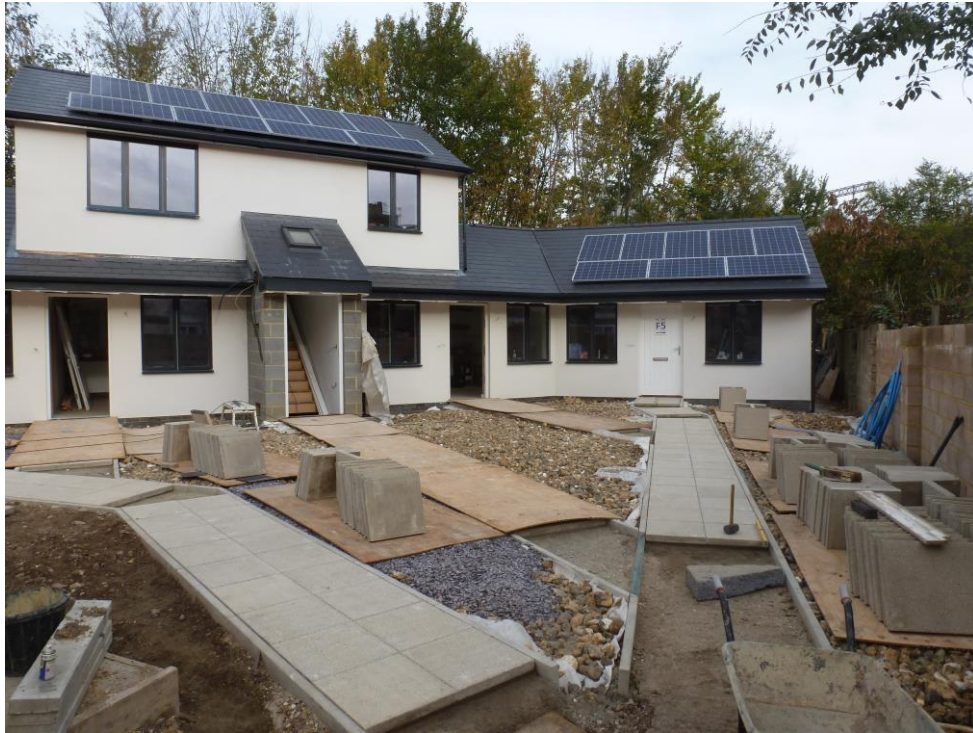
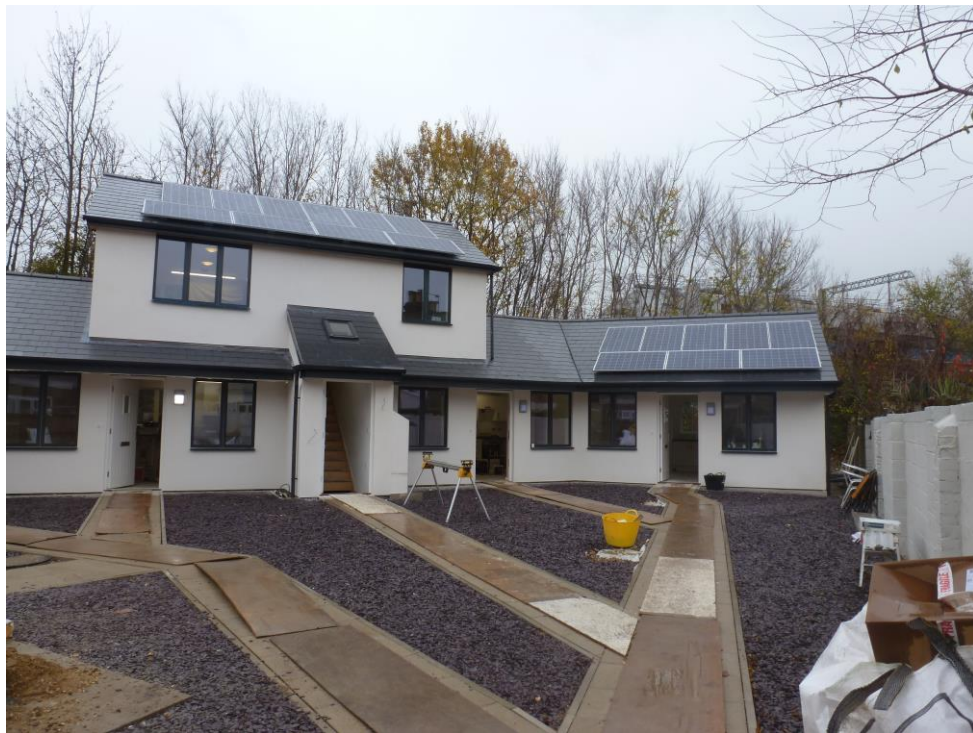
Fig. 5 & 6 – Finishing 50mm deep layer of 20mm diameter slate chippings laid on top of the 100mm depth of compacted open graded crushed rock.
