# ECOLOGY REPORT

The Abbey Junior School, 30 Christchurch Rd,  
Reading, Berkshire RG2 7AR

Prepared on: 28 July 2017

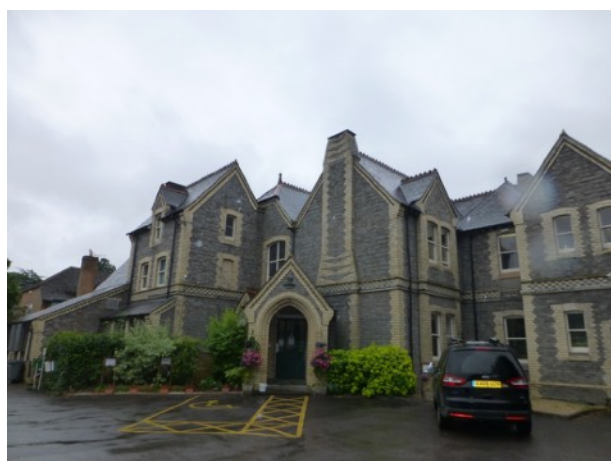
Figure 2. N elevation of buildings

1.4 Description of Site - The Junior School is composed of a number of buildings, but only one will be affected by the proposed development, which is Kensington House. Kensington House was built between 1875 - 1877. It is brick with wooden windows and doors. There are no soffits or fascias. The building was re-roofed in 2014 - 2015 with a slate-type tile. There is a flat-roofed building on the W side of Kensington House with aluminium doors and windows (Figs. 2 - 6).

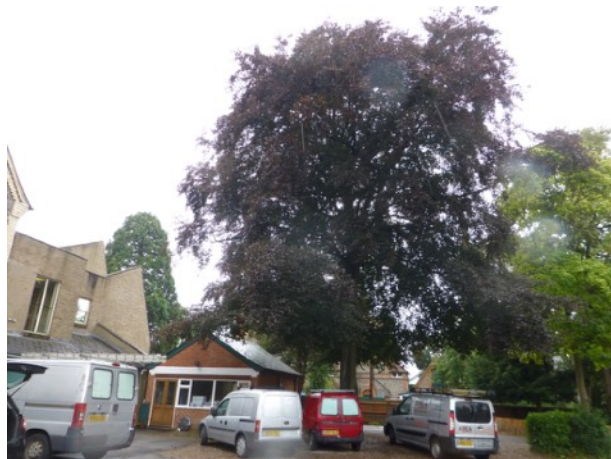
Figure 4. Flat-roofed building with copper beech

The area around the buildings is tarmac for parking, with wooden boundary fences and trees, incl. copper beech (Fig. 4).

4.4. Trees - The trees do not have any potential roost features for bats and therefore have LOW bat potential.

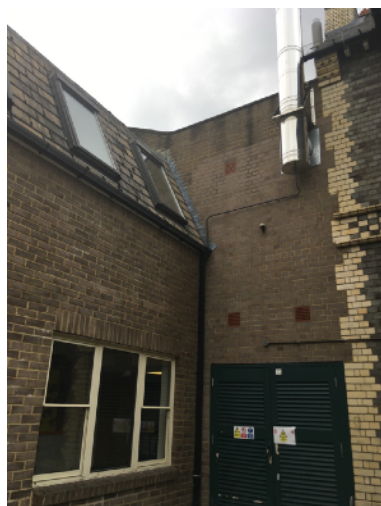
Figure 6. Rear of building (S)

The tiles on the outside of the building are very tight and the concrete is all intact. There are no gaps. No bat droppings, or staining was observed on the outside of the building.

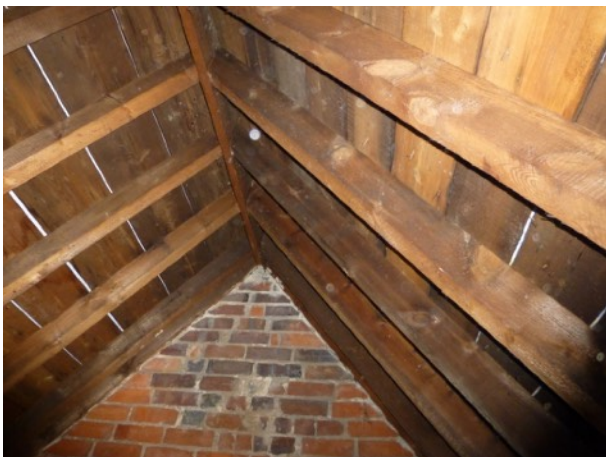
Figure 6. West roof void of building

4.1 Building - There are two roof voids in Kensington House. Both have breathable membrane, which was added when re-roofing work was undertaken in 2014 - 2015. The W rood void is lined with wooden sarking boards, with breathable membrane in between the tiles and the boarding. The E loft space has breathable membrane lining the tiles. No bats or evidence of bats was found in either of the loft spaces.
