## **78 Tilehurst Road – Bat Habitat - Preliminary Roost Assessment**

This survey report accompanies a planning application to extend the existing dwelling upwards and provide 4 No. flats. Since the proposed works would involve removing the existing roof structure, the likelihood of bats being present is considered by way of this report.

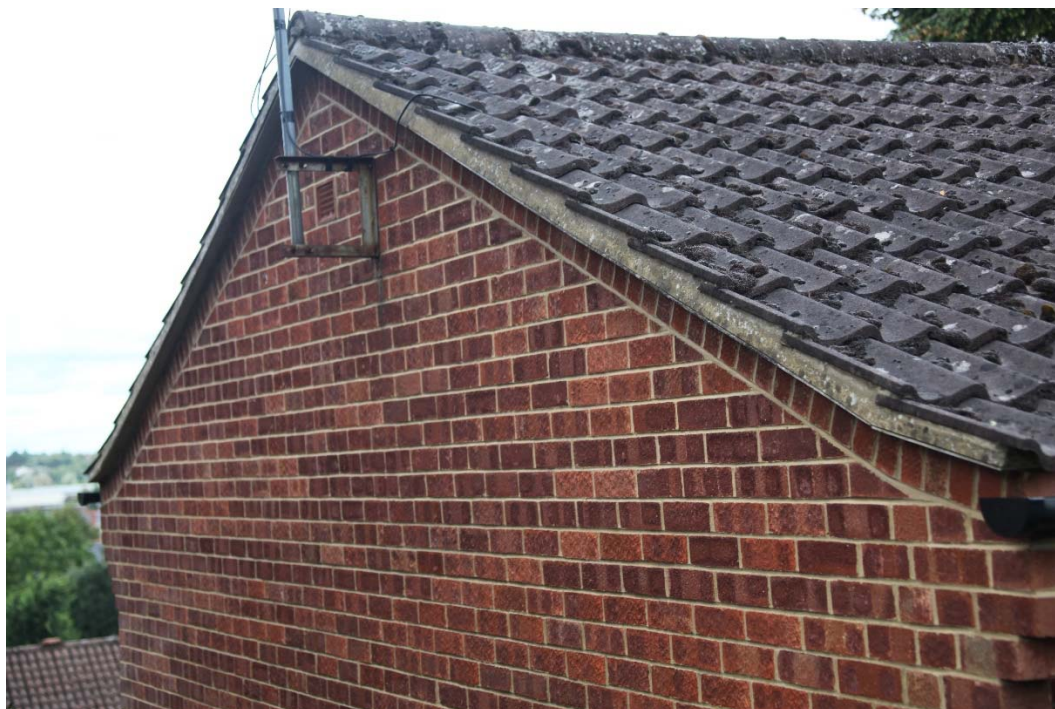
Fig. 1 – West Facing Gable

Generally, there are no visible gaps to the walls and eaves boxes or verges, and all roof tiles are in place and intact. There are no gaps to mortar bedded ridge tiles or verges.

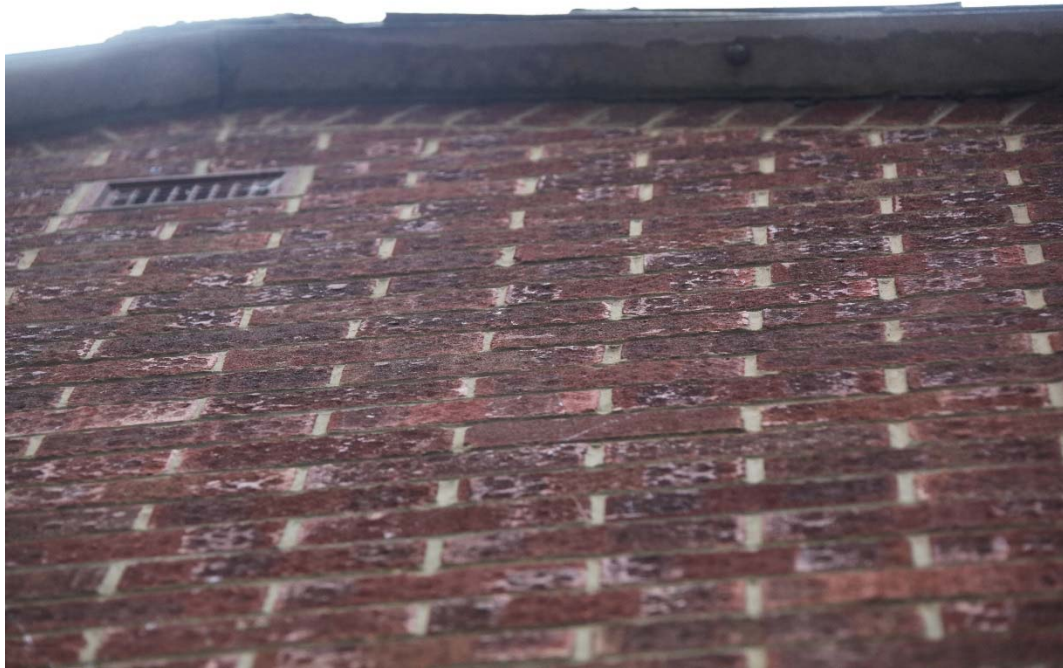
Fig. 3 – East Facing Gable Verge

The roof is covered with interlocking concrete double pantiles laid over 25sq. timber battens and bituminous sarking felt. The gable verges are mortar sealed, with edge tiles laid over an asbestos type board. Box eaves comprise of a timber fascia, and asbestos type soffit. The roof structure comprises of braced timber fink trusses.

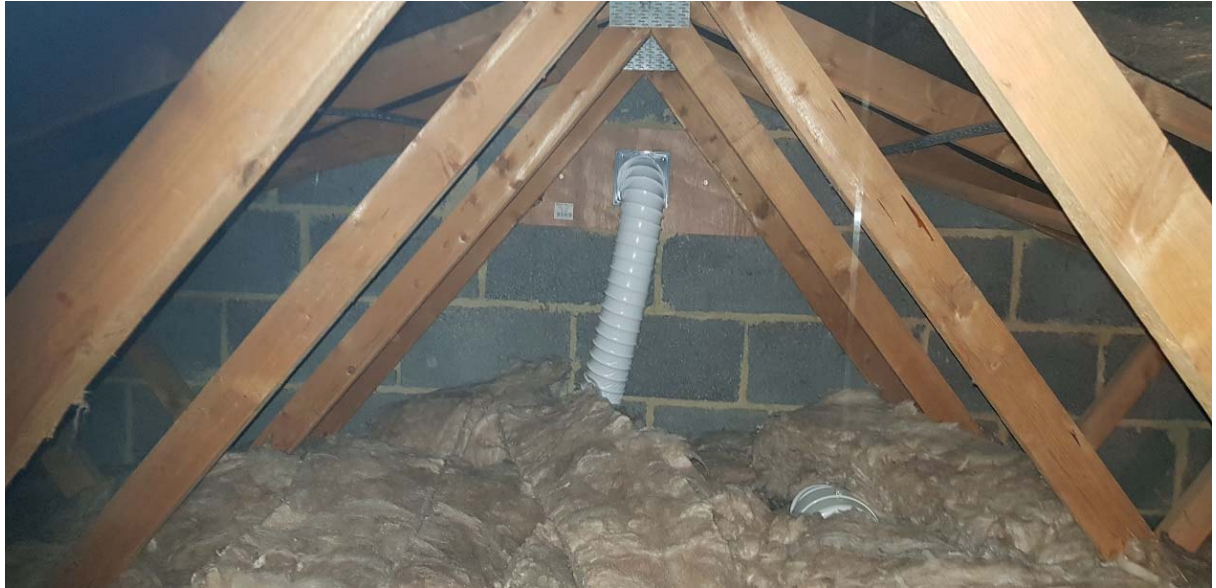
Fig. 7 – Attic

Internally, the roof structure is cobwebbed, and no daylight is visible. No evidence of mammal activity was found, particularly any droppings or remains.
