Thomas Homes Ltd

# Land at Newark Street, Reading, Berkshire RG1 2SR

Preliminary risk assessment

Project Ref. 29651 R01 (00)

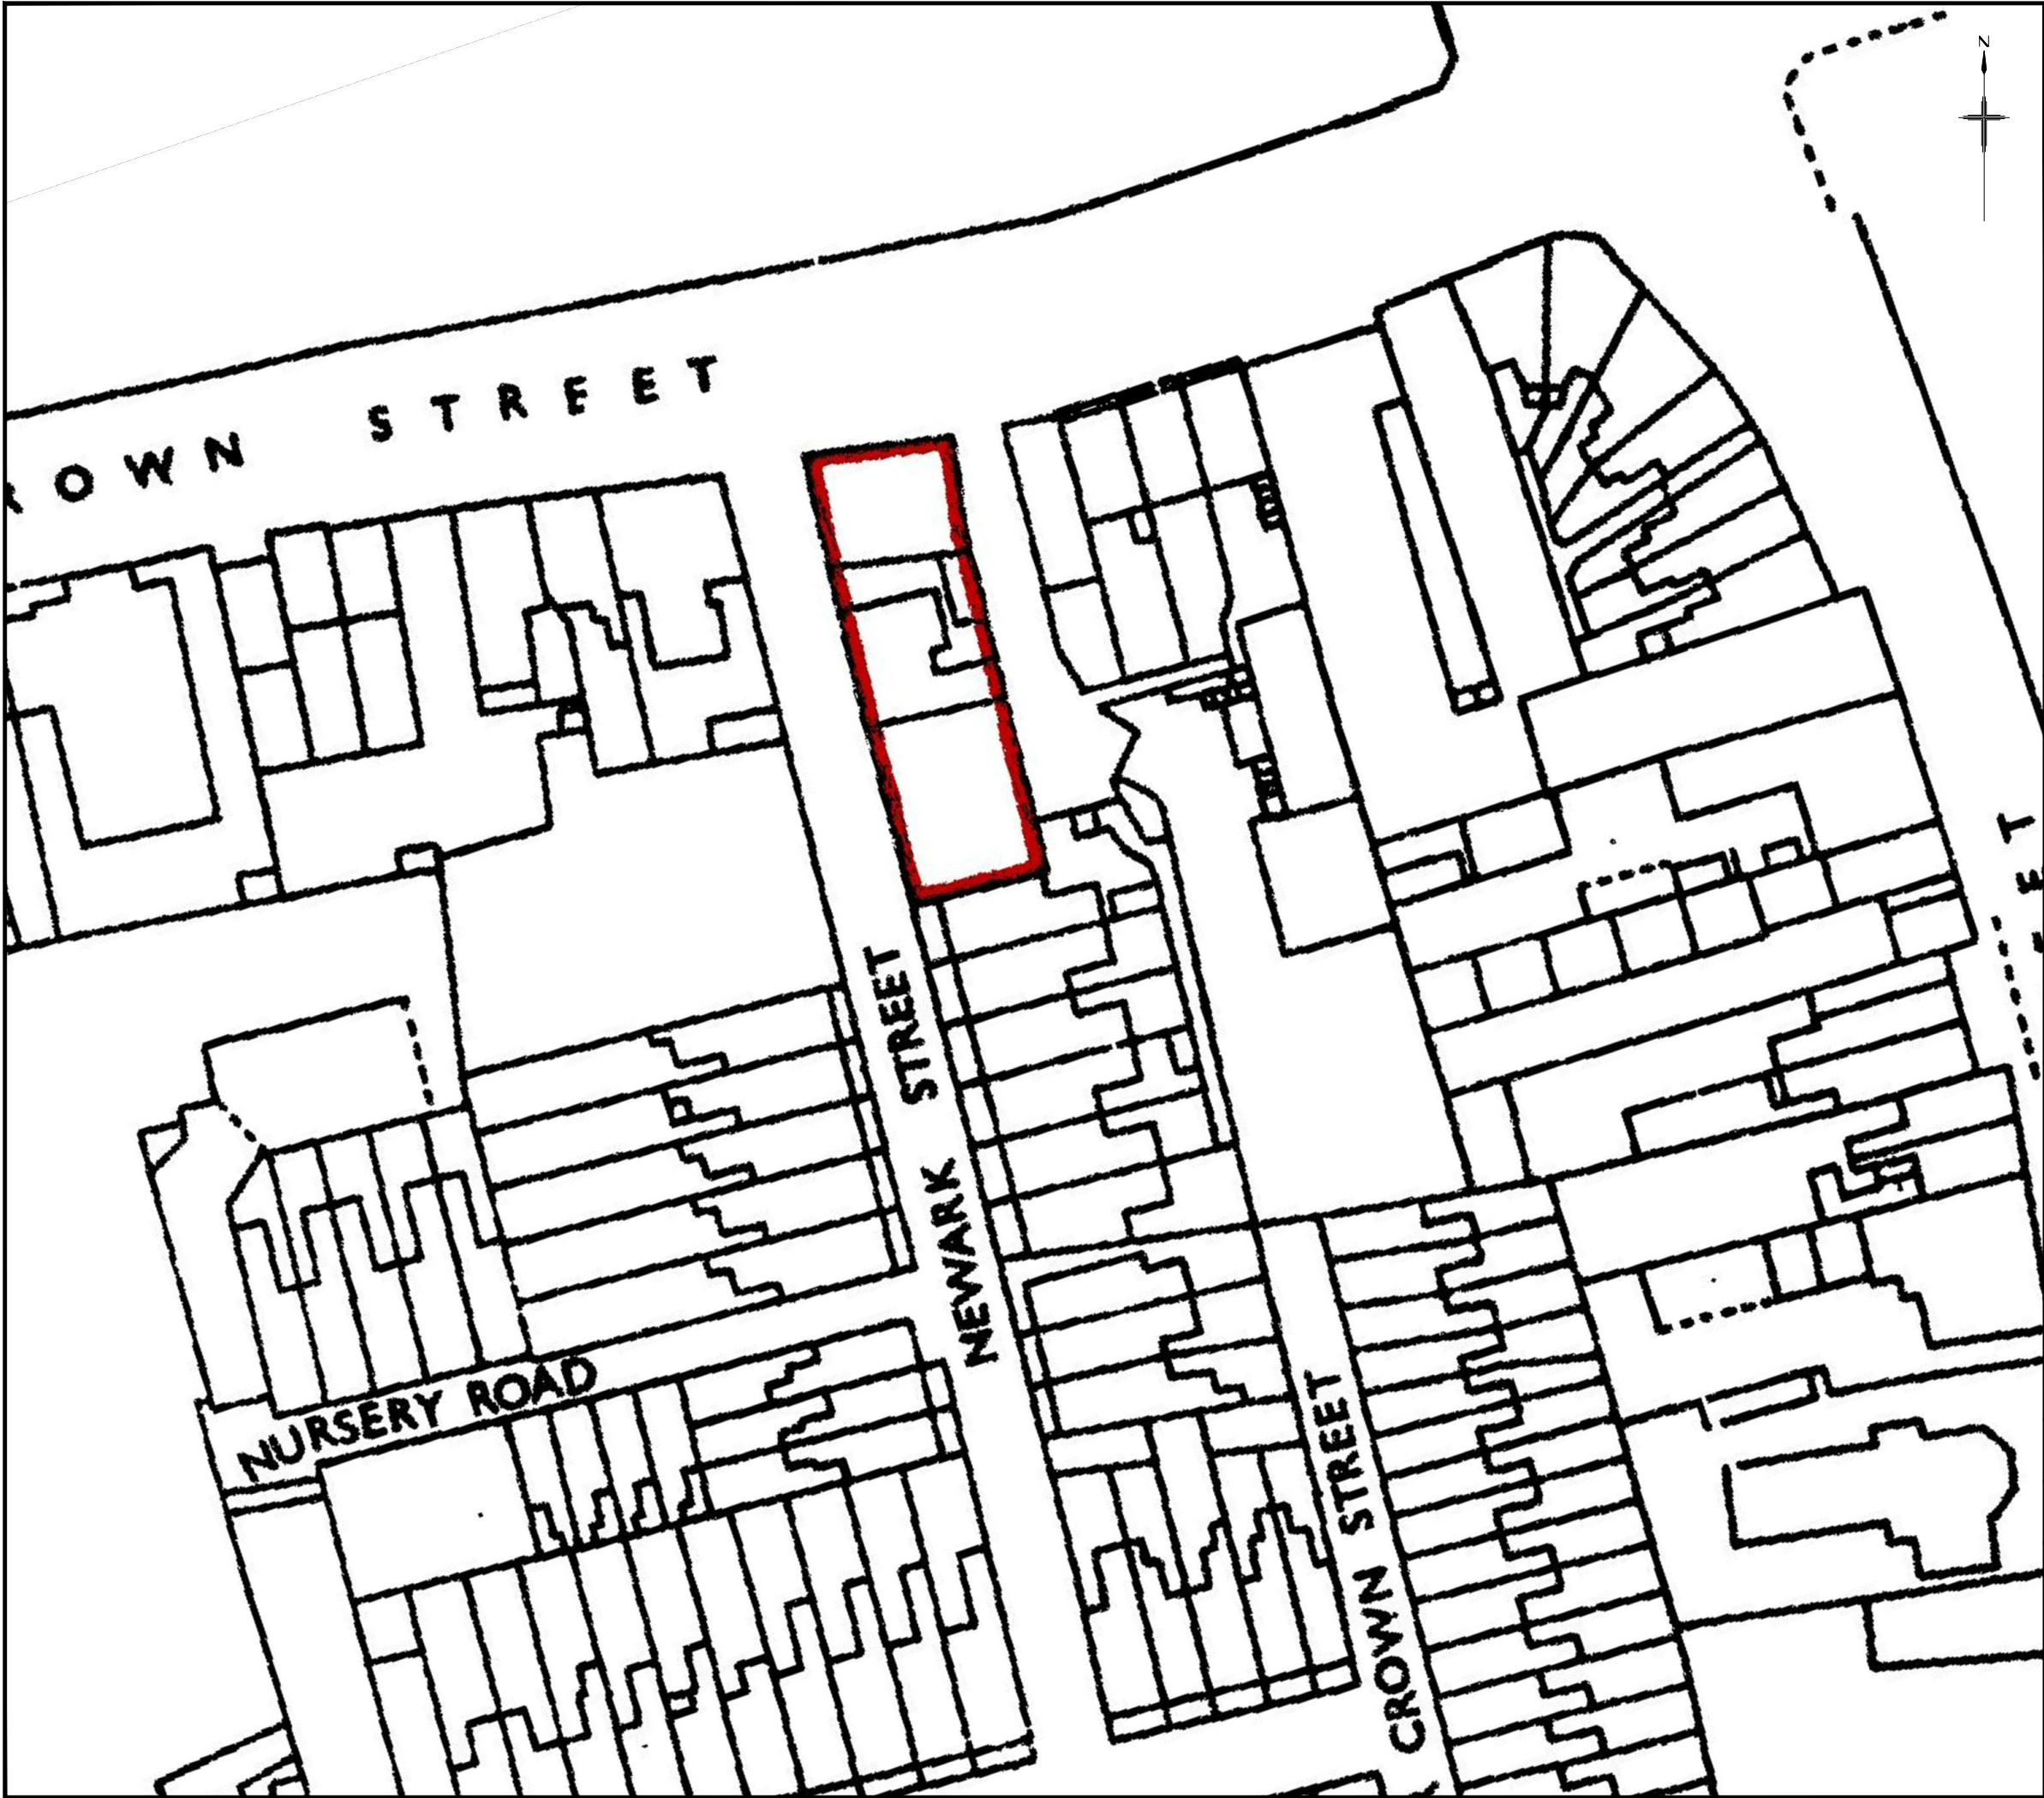
FIGURE 1

The site is located on the corner of Crown Street and Newark Street, Reading, Berkshire RG1 2SR at National Grid reference 471823, 172846, as shown on **Figures 1** and **2**.

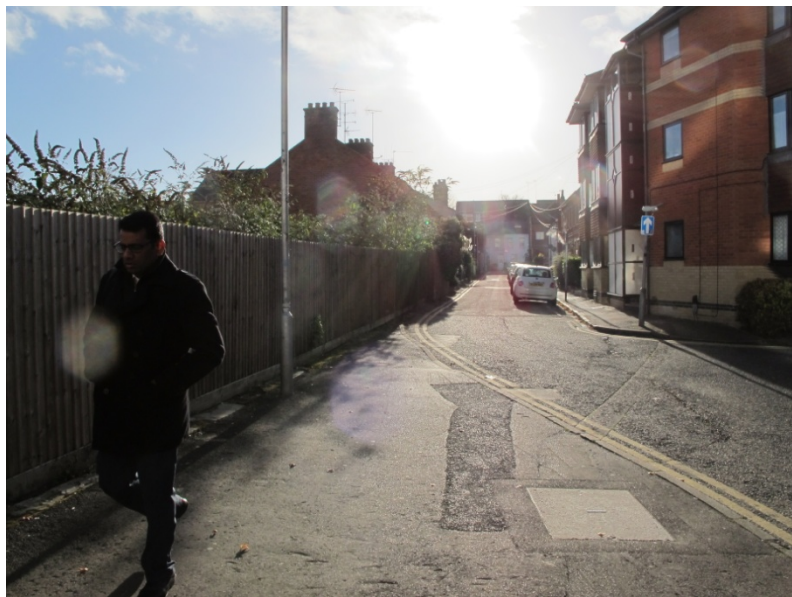
| PHOTOGRAPHIC LOG | | |
|---|---|---|
| Photo no.<br><br>1 | Date:<br><br>01/12/2017 | |

| PHOTOGRAPHIC LOG | | |
|---|---|---|
| Direction photo taken:<br><br>South | | |
| Description:<br><br>The western boundary | | |

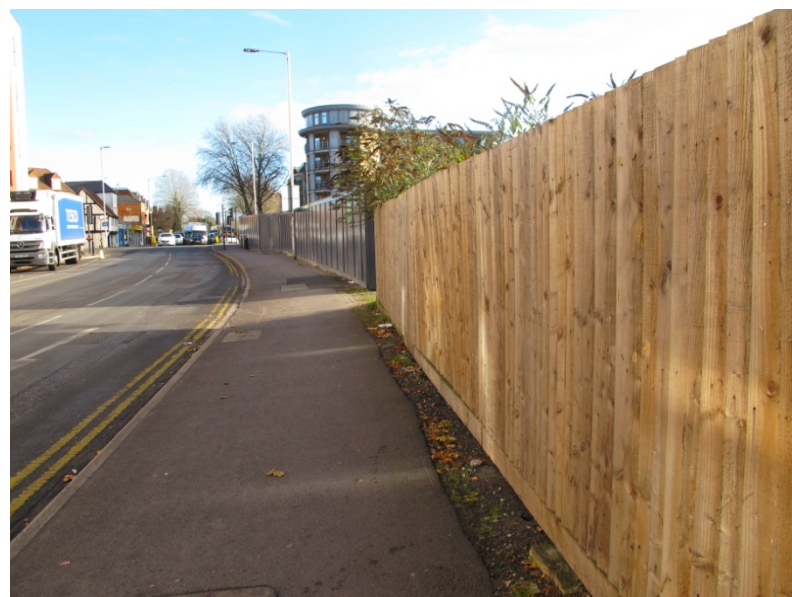
| <b>Photo No.</b><br><br>2 | <b>Date:</b><br><br>01/12/2017 | |

| <b>Direction photo taken:</b><br><br>East | | |
| <b>Description:</b><br><br>The northern boundary | | |

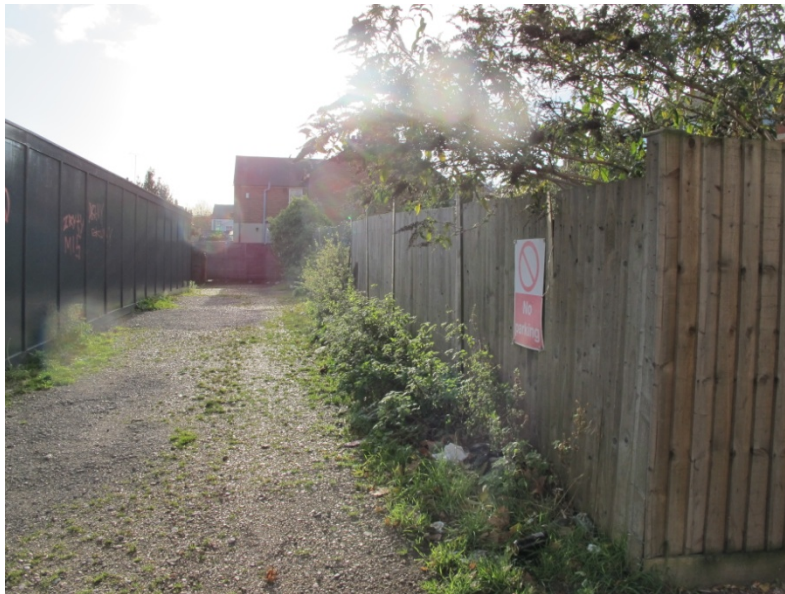
| <b>Direction Photo Taken:</b><br>South | |
| <b>Description:</b><br>The eastern boundary of the site, located along the strip of land with no title | |

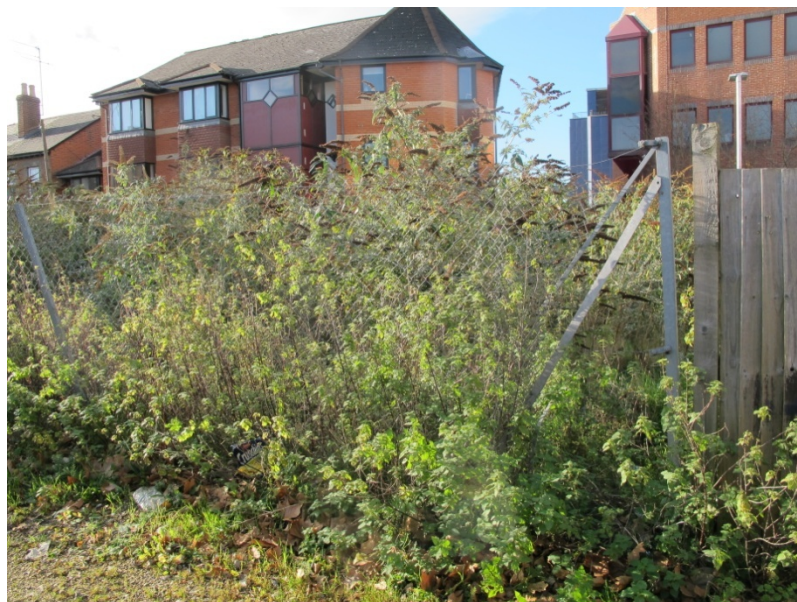
| <b>Photo No.</b><br>4 | <b>Date:</b><br>01/12/2017 | |

| <b>Direction Photo Taken:</b><br>West | | |
| <b>Description:</b><br>Typical vegetation | | |

Japanese knotweed is a non-native, highly invasive species and spreads via rhizomes (underground 'stems') rather than seeds in the UK. It is found in a range of habitats across the UK including roadsides, riverbanks and derelict land. Japanese knotweed was not identified during the site visit. However, Japanese knotweed is difficult to identify outside the growing season (March to September/October). As the site visit was conducted in December, it is unlikely that any Japanese knotweed present could be identified accurately and, as such, we recommend that the site be resurveyed during the growing season.

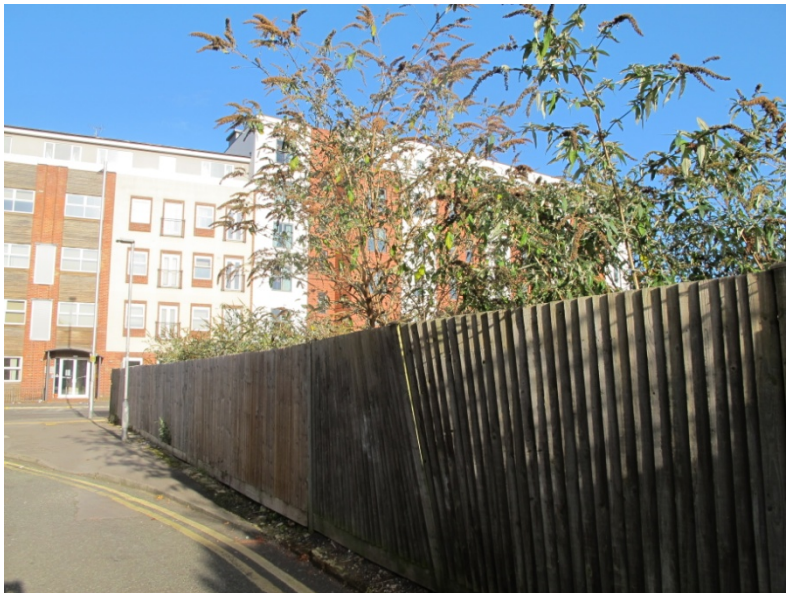
| <b>Photo No.</b><br>6 | <b>Date:</b><br>01/12/2017 |

| <b>Direction Photo Taken:</b><br>North | |
| <b>Description:</b><br>Dense buddleia identified on the site | |
