**35 Cockney Hill, Tilehurst, Reading, Berkshire RG30 4HF**

**Bat Survey - Preliminary Roost Assessment**

20<sup>th</sup> January 2016

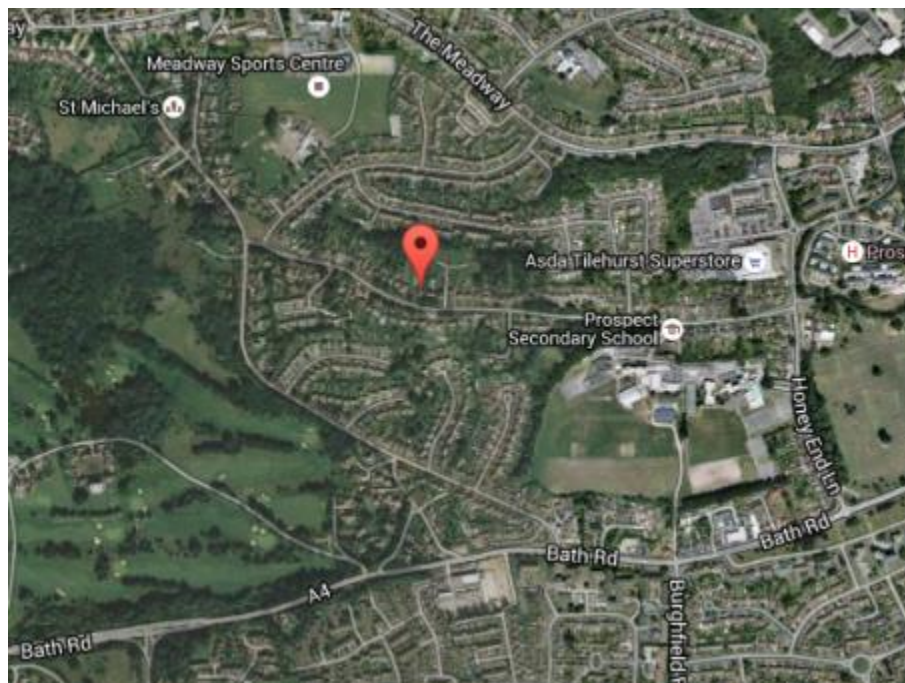
A review of aerial photographs (Figure 1) and OS maps shows the site forms part of a garden habitat corridor for bats. The woodland at the end of the back garden forms part of a larger wooded area of approx. 0.35ha.

Figure 1: Aerial photo of site, showing landscape structure

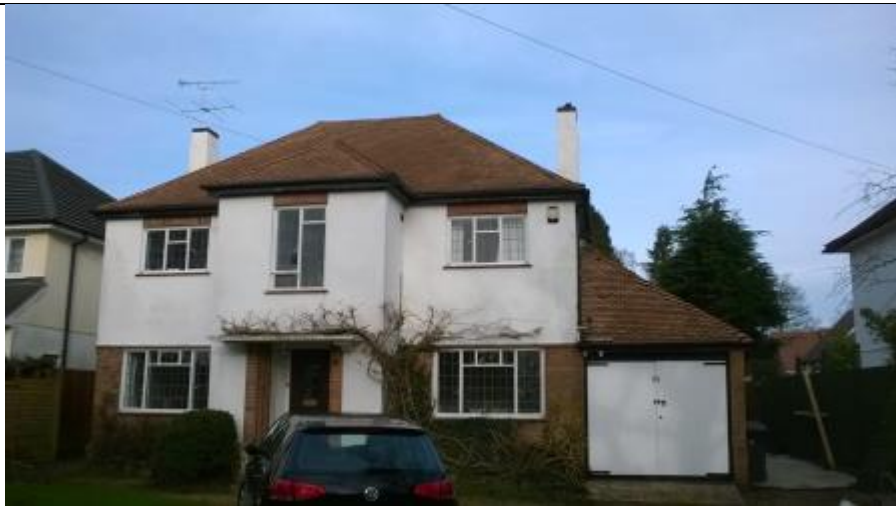
- The building is of brick construction with a hipped, clay tiled roof. (Photo 1)  
The roof tiles are generally undamaged and tight fitting apart from recent damage where the roof has been pressure washed in December 2015. This has caused tiles to be chipped and displaced, creating potential roosting crevice for bats. (Photo 3 and 4) With the use of binoculars, no evidence of bat use could be found around the broken tiles such as scratching, droppings or urine staining. The garage sub roof wraps around the side and rear of the building. This roof is where the majority of tile damage has occurred. The timber soffit boards are tight fitting leaving no roosting access for bats. Window frames are tight fitting leaving no roosting access for bats. There is a timber and glass conservatory at the rear of the building with a sloped plastic roof. There are no features on this part of the building that would allow bat roosting access. (Photo 6)

Photo 1: front of the building.

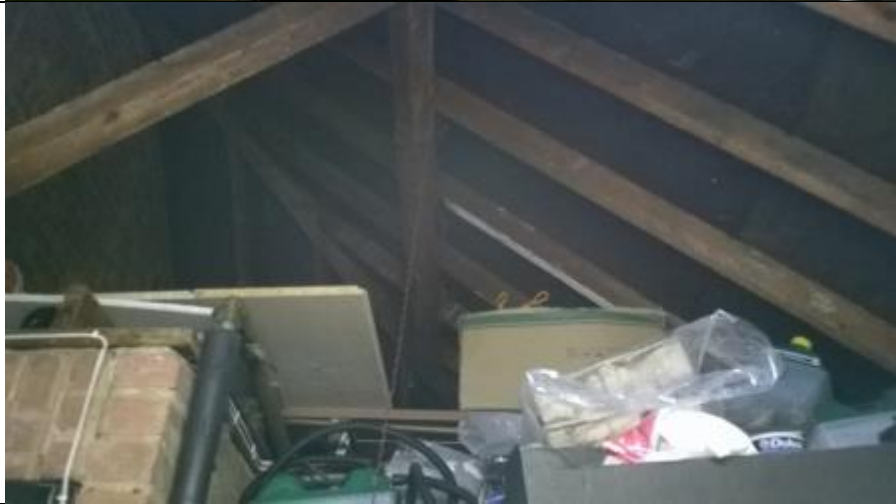
- The garage interior is vaulted and bitumen lined which is damage free and would not provide access for bats. Modern timber rafters, trusses, purlins and ridge beam are present with no evidence of bat use such as urine staining or scratches. The window and door are tight fitting leaving no potential access points. (Photo 2)

Photo 2: internal garage roof structure.

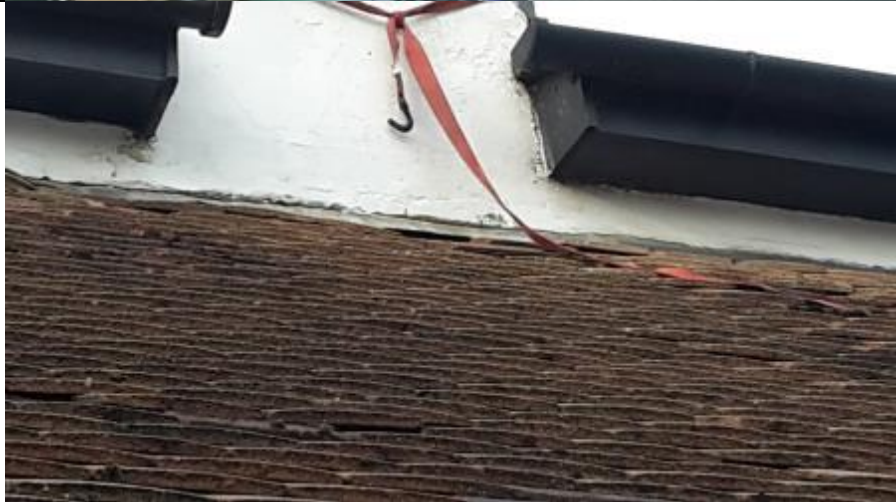
Although at the time of the survey there were damaged tiles present on the garage roof (suitable features for crevice dwelling bat species), the damage was very recent, caused by pressure washing of the roof. It is assessed that as the damage was caused in December, when bats would be hibernating, it is extremely unlikely that bats would have started using these features at this time of year. The tiles are due to be replaced within the next two weeks, after which the building will not be suitable for roosting bats. See Appendix 5 for the letter from Express Maintenance stating the work carried out.

Although the building does currently provide potential roosting features due to slipped and broken roof tiles, it is highly unlikely that these will have been used by bats since the start of December when the damage was caused. The tiles are due to be fixed before the end of January, and will therefore no longer be suitable for bat use by the time bats come out of hibernation in the spring.

Photo 3: missing tile under lead flashing on the side of the garage roof.

We are proposing to return to site within the next 14 days to replace tiles where the lower half was fractured and fell away and also to apply silicone sealant around the overflow extrusion.

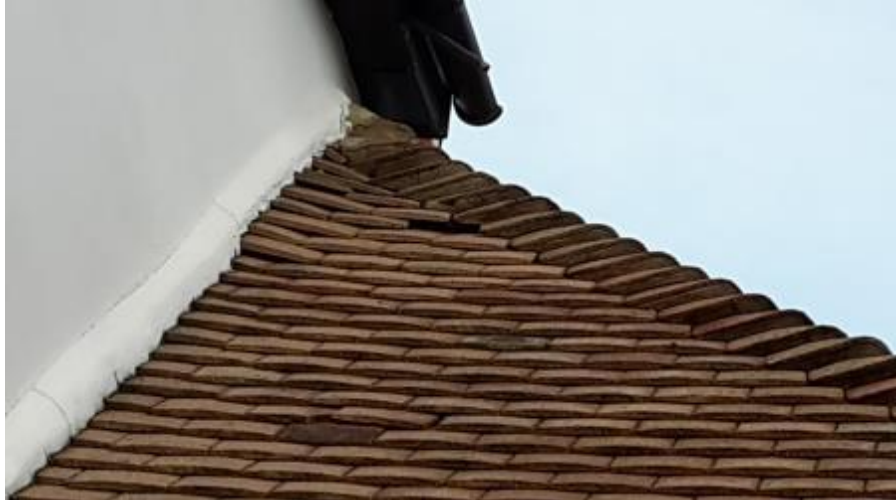
Photo 4: missing tile on the front of the garage roof.

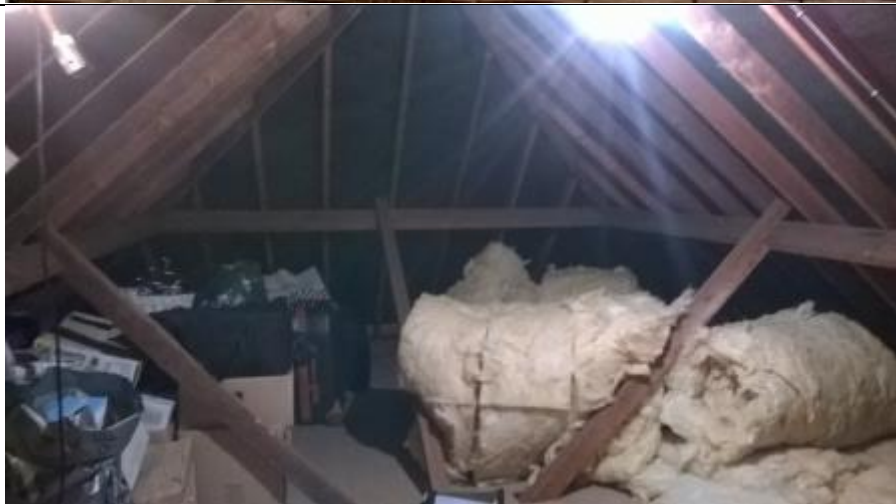
- The loft is bitumen lined which appears to be in excellent condition with no damaged areas that could allow bat roosting access. The floor is mostly boarded apart from around the eaves where mineral wall insulation is in place between ceiling joists. Modern timber rafters, trusses, purlins and ridge beam are present with no evidence of bat use such as urine staining or scratches. The ridge height is approx. 10f. (Photo 5) The temperature was approx. 9% and humidity approx. 74%.

Photo 5: loft.

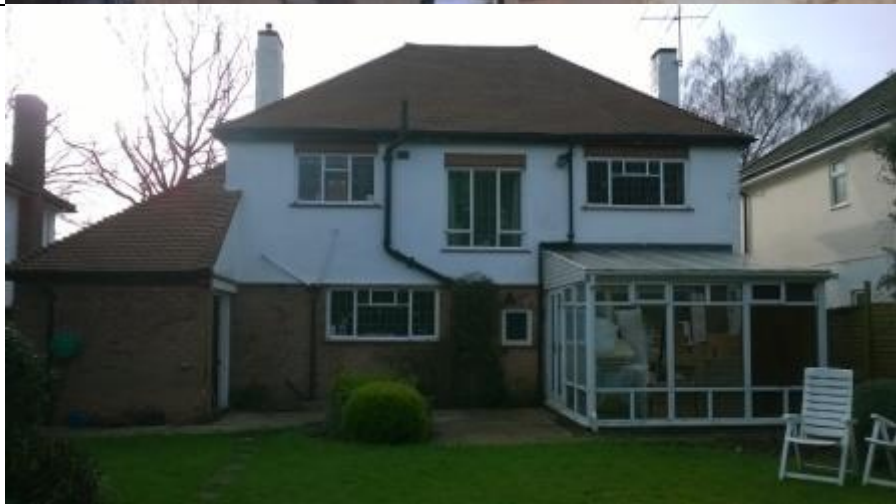
Photo 6: rear of the building.
