# TECHNICAL NOTE

| Job | <b>Green Park Village</b> |
| Technical<br>Note no. | <b>1620000492/TN/003</b> |
| Subject | <b>Phase 5 Ground Investigation Findings and Remedial Options</b> |

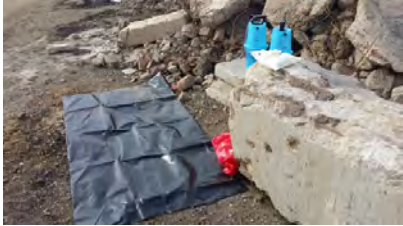
| Operative | Note | Date |
|---|---|---|
| <br><b>Scott Landells</b><br><i>Lead Surveyor</i> | Personal Decontamination Area<br> | Thursday, 7th July, 2016 |

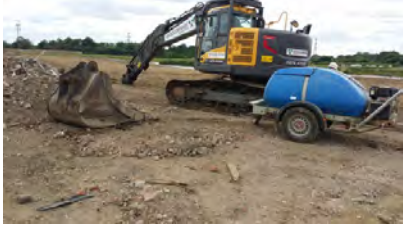
| Operative | Note | Date |
|---|---|---|
| <br><b>Scott Landells</b><br><i>Lead Surveyor</i> | JCB hosed down<br> | Thursday, 7th July, 2016 |
