## **BS 5837:2012 TREE SURVEY FOR 57 BAKER STREET READING**

**Ref: SPH/PB/5837-01/18.07**

**18<sup>th</sup> July 2018**

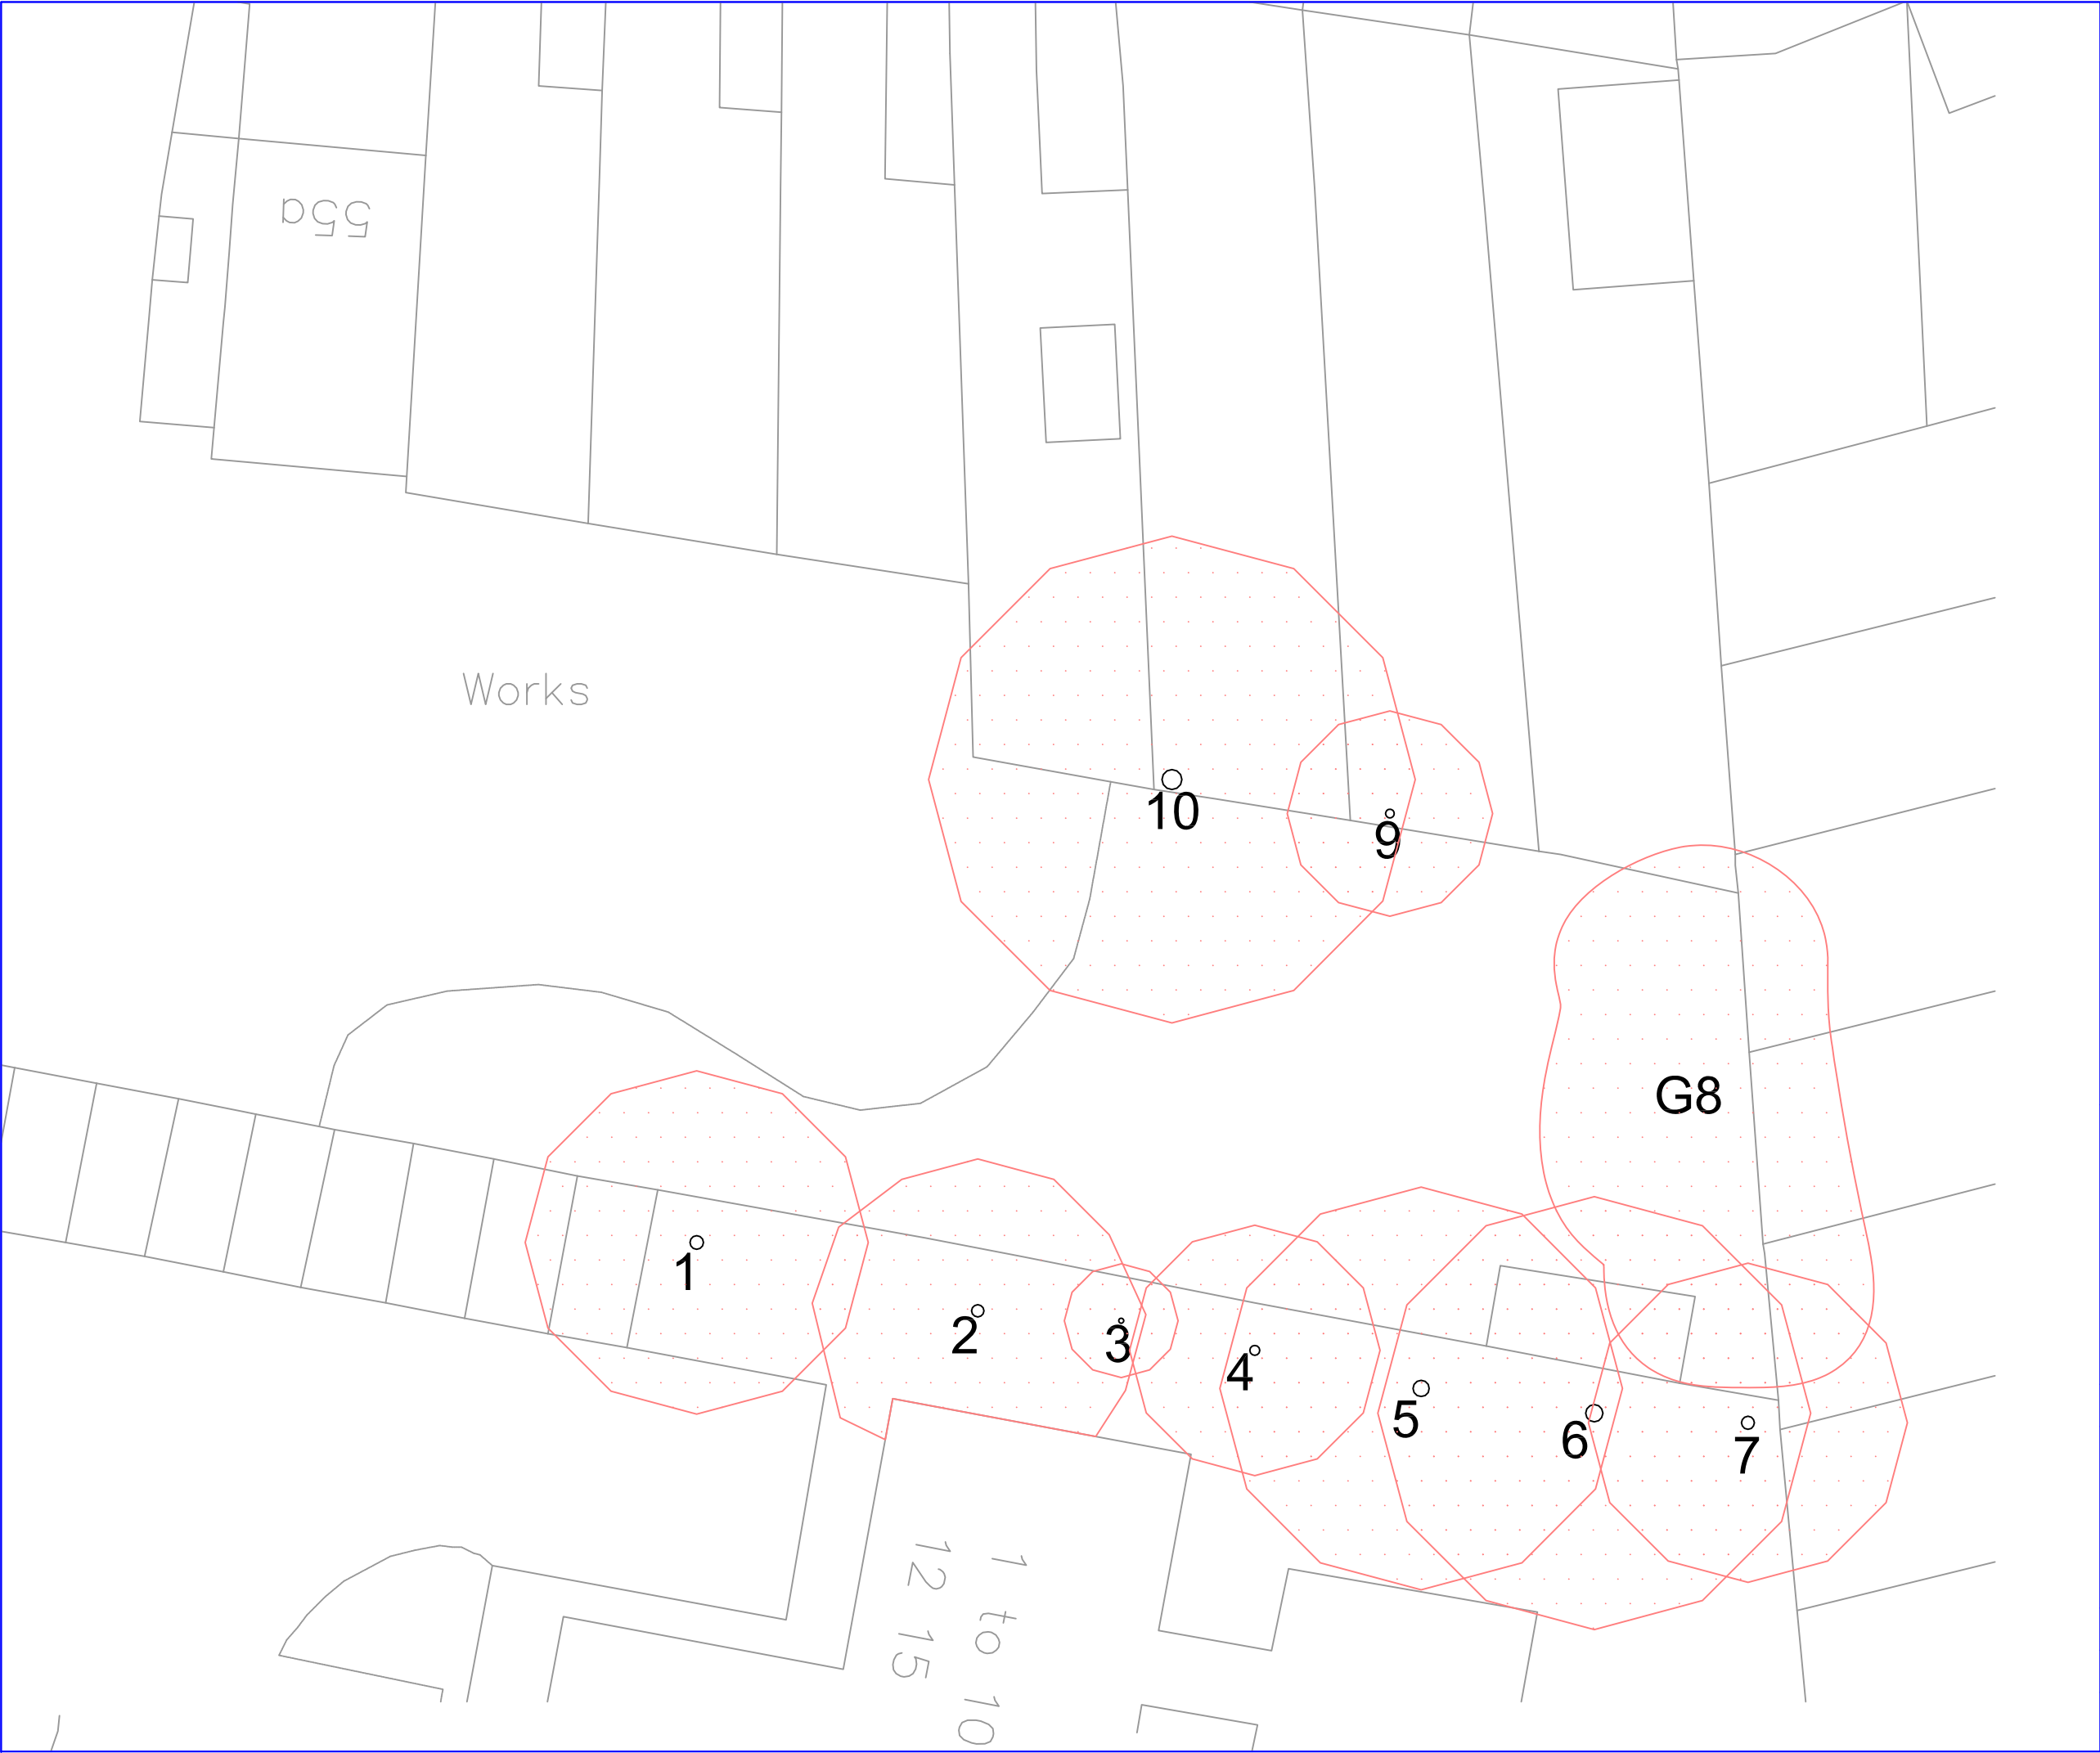
| Drawing Title | ROOT PROTECTION AREA PLAN | |

- 4.2.1 Using BS 5837:2012 the RPAs have been calculated for the trees by reference to section 4.6.1 (a) and/or (b). The RPA is frequently described as a circle with a radius of prescribed distance within which no unspecified activity should occur and a high level of care is needed during any activities that are authorised within them, if they are to be successfully retained.

- 4.2.2 Specified intrusions into the RPAs can take place only where the ground is adequately protected in accordance with the requirements of section 6 (6.2.3.3) of the BS or as may be agreed with the Local Planning Authority (LPA). We have plotted the RPAs as dodecagons taking account of the site constraints on the RPA drawing, included at Appendix 3.

- 4.2.3 The shape and position of the RPA may only be modified by an arboriculturist to meet the pre-existing site conditions or other factors that indicate that rooting has occurred asymmetrically. In all cases, we have considered the adjacent constraints including such things as the existing site access, buildings, walls and site topography.

- 5.1 To protect retained trees from construction activities, notwithstanding the need for an Arboricultural Method Statement (AMS) in specific instances, the retained trees must be protected by suitable protection barriers and ground protection, the accompanying root protection area drawing shows the RPAs and specific tree protection locations required prior to and during the construction activities.

- 5.2 The tree protection barrier is designed to provide construction exclusion zones around the RPA of all trees to be retained.
- 5.3 The tree protection fencing should be fit for the purpose of excluding construction activity and appropriate to the degree and proximity of work taking place around the retained trees. The default specification for protective barriers is that specified in BS 5837:2012 Figure 2, section 6. A copy of Figure 2 is reproduced at Appendix 5. All weather signs must be attached by cable ties to each Heras panel as set out in Appendix 6.

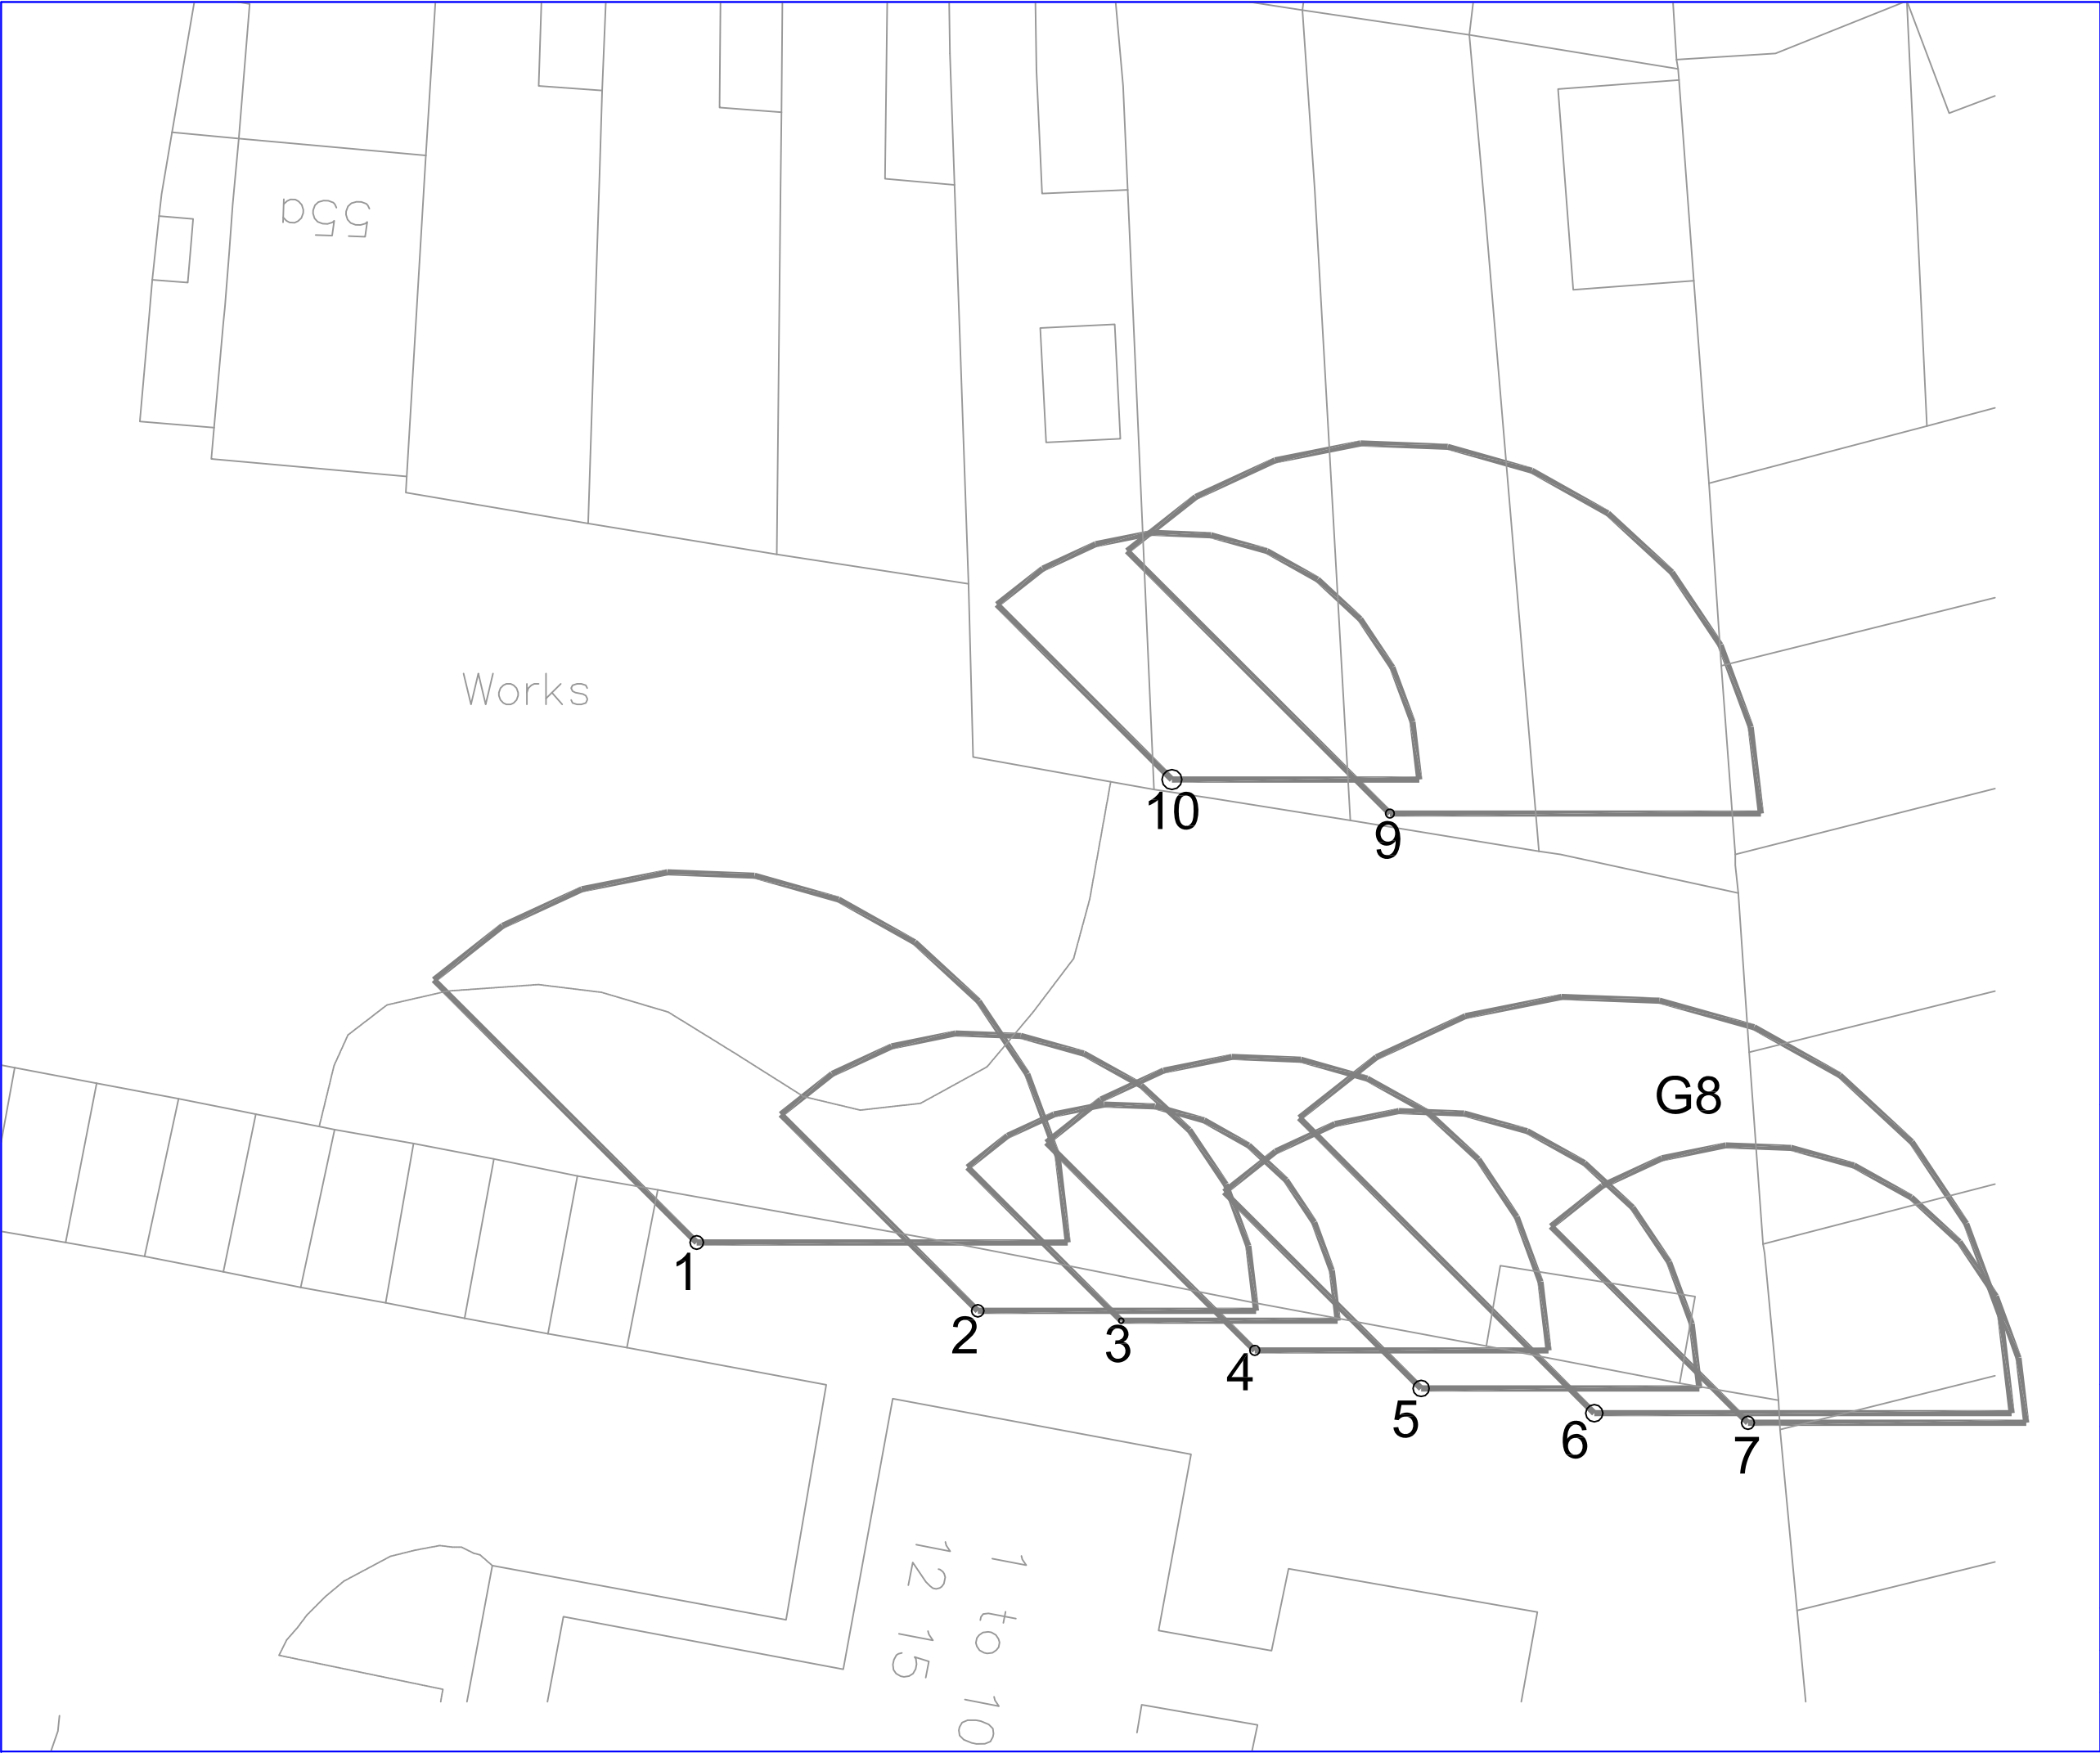
| Drawing Title | SHADE CONSTRAINTS PLAN | | |

- 4.3.1 Large trees that cast dense shade may result in pressure to prune or remove them. Whilst either shade or sunlight might be desirable depending on the potential use; the design should avoid unreasonable obstruction of light. The shade constraints posed by the trees are plotted onto the shade constraints drawing, included at Appendix 4.
