# **GREEN PARK VILLAGE** **GROUND** **INVESTIGATION** **REPORT**

Revision **1**  
Date **04/01/2017**  
Made by **Jack Taggart**  
Checked by **Oli Mills**  
Approved by **James Flack**  
Description **Ground Investigation Report**

Ref 1620000492/RPT/002

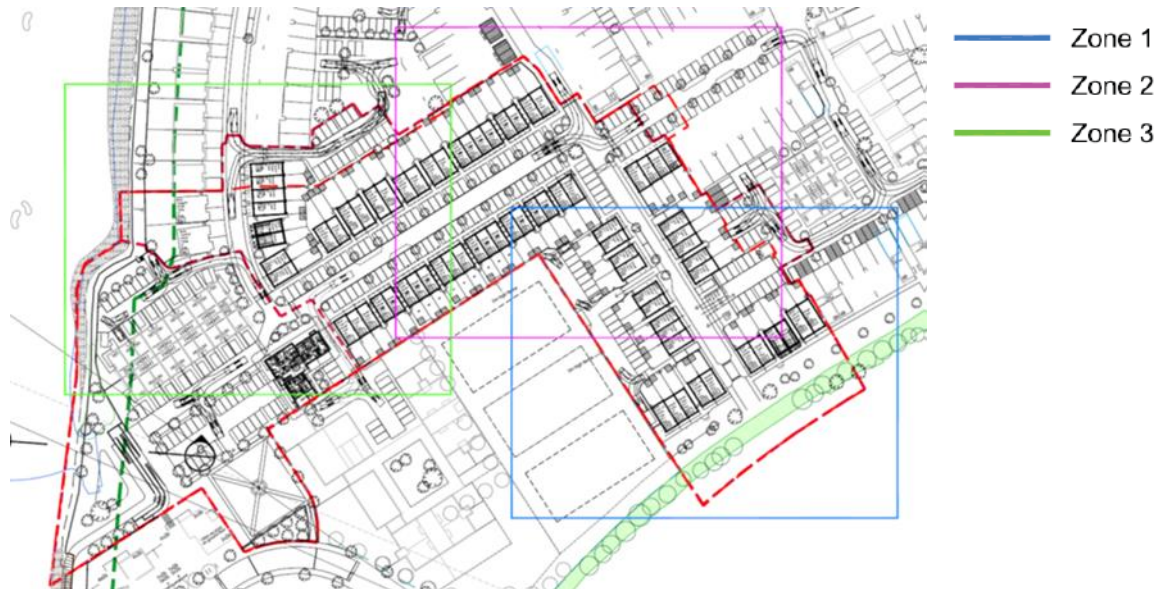
**Figure 12 Plan showing extents of Zones 1, 2 and 3 of Phase 1**

Phase 1 is subdivided into three zones; Zone 1, Zone 2 and Zone 3, as indicated in Figure 12. The exploratory holes within Zones 1 and 2, and some of the exploratory holes in Phases 3 and 5 have been used in the review of ground conditions and the foundation solution for the building. These are trial pits referenced TP101 to TP113.

Within Zones 1 and 2 for Phase 1 ground improvement in the form of vibro-stone columns with reinforced strip foundations is to be utilised with the environmental acceptance of this form of ground improvement being based upon the recommendations by PBA.
