## **PRELIMINARY ECOLOGICAL APPRAISAL (BATS) AT 11 YARNTON CLOSE CAVERSHAM**

**Prepared for:  
Mr A Mukherjee  
11 Yarnton Close  
Emmer Green  
Reading  
RG4 8UW**

**13<sup>th</sup> March 2018**

**Ref: SPH/PEA-01/13.03**

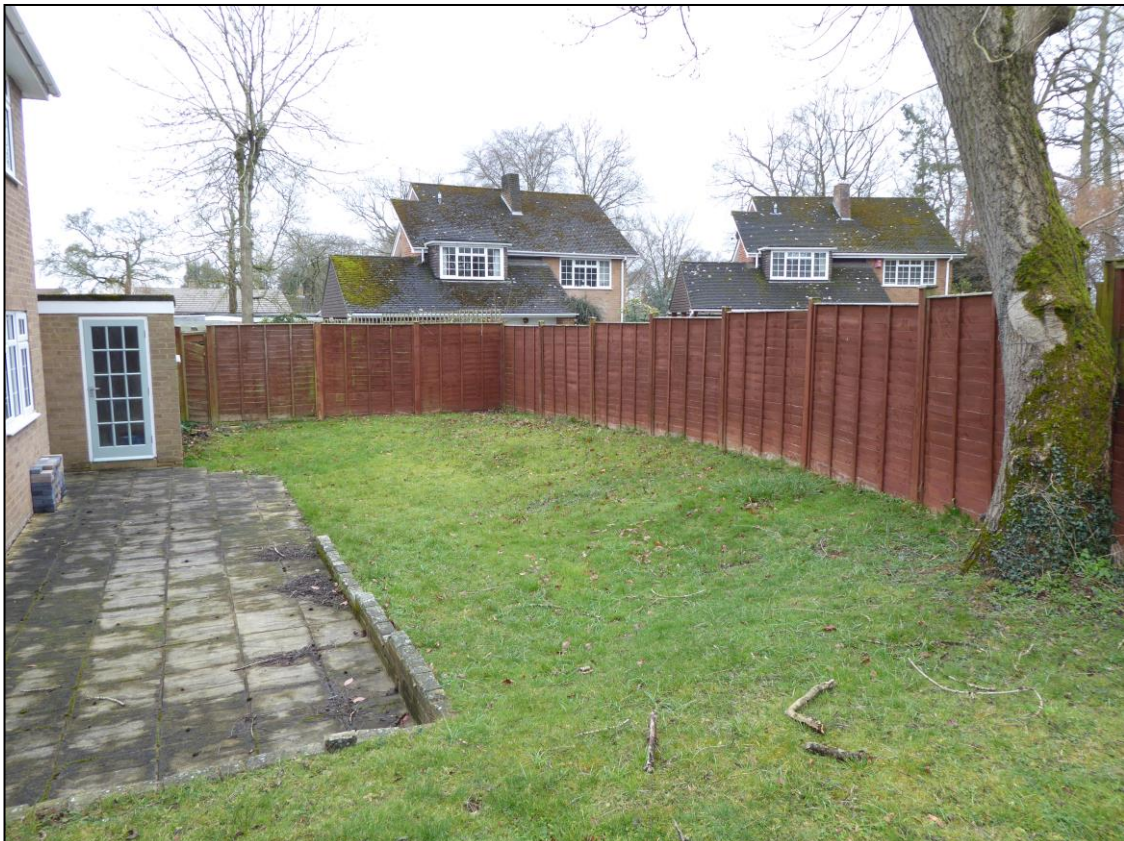
Figure 3. Rear garden, 11 Yarnton Close, Emmer Green. 13.03.18

The application site is set in an urban area of Emmer Green, to the north of the urban conurbations of Caversham and Reading. The site comprises a detached property with detached garage. The rest of the application site comprises a front driveway, a small front garden and a rear garden, laid mainly to lawn with a single tree, see Figure 3 below. The site itself offers limited foraging and commuting habitat for bats.

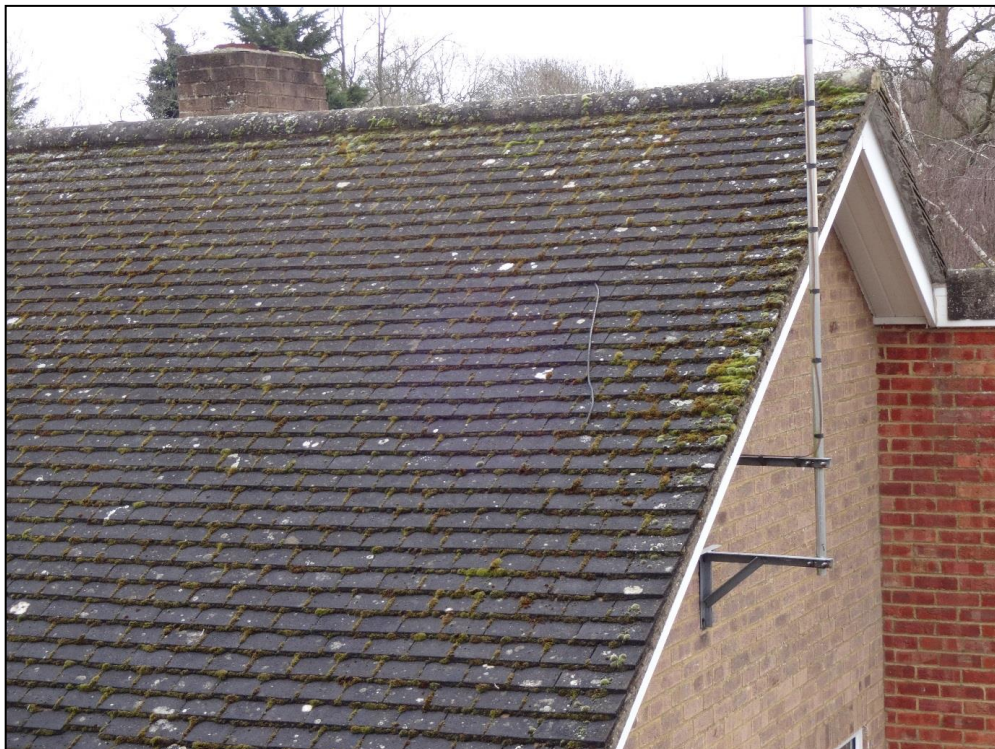
Figure 4. Close fitting roof and ridge tiles, 11 Yarnton Close, Emmer Green. 13.03.18

The property is a detached, brick built house and detached brick garage with flat bitumen roof, both of which are in a good condition externally. The main roof of the house is pitched and covered in composite, close fitting tiles, see Figure 4 below. A previously completed front extension added a flat rooved dormer window, Velux window together with roof over a car port, see Figure 5 and 6 on page 9. The hanging tiles on the dormer are close fitting and the bitumen flat roof is in good condition, see Figure 5 on page 9 and Figure 7 on page 10.

No bats or evidence of bats was recorded during the external inspection of the house and garage. Potential access and roosting opportunities for bats is restricted due to the refurbishment of the roof in the recent past.

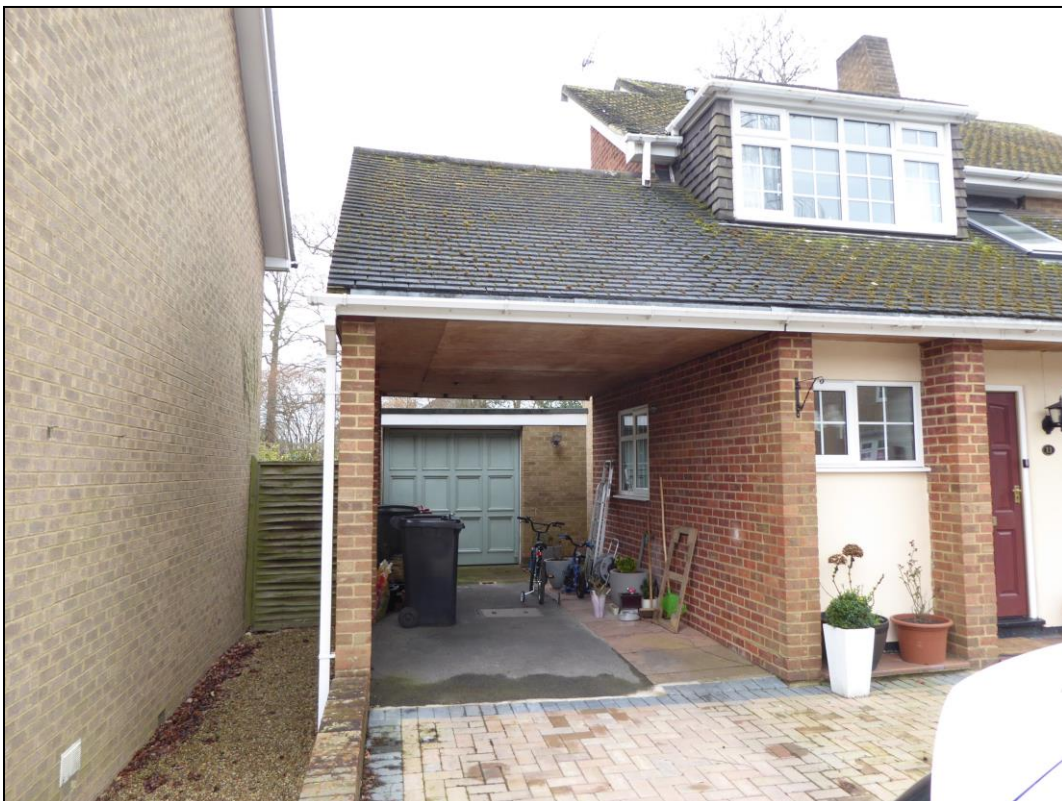
Figure 6. Roof over car port, 11 Yarnton Close, Emmer Green. 13.03.18

The detached garage is situated behind the car port, see Figure 6 on page 9. The uPVC windows, fascia's and soffits are in a very good condition with no gaps, see examples at Figure 7 and 8 on page 10. The verges are in a fair condition, see Figure 8 on page 10.

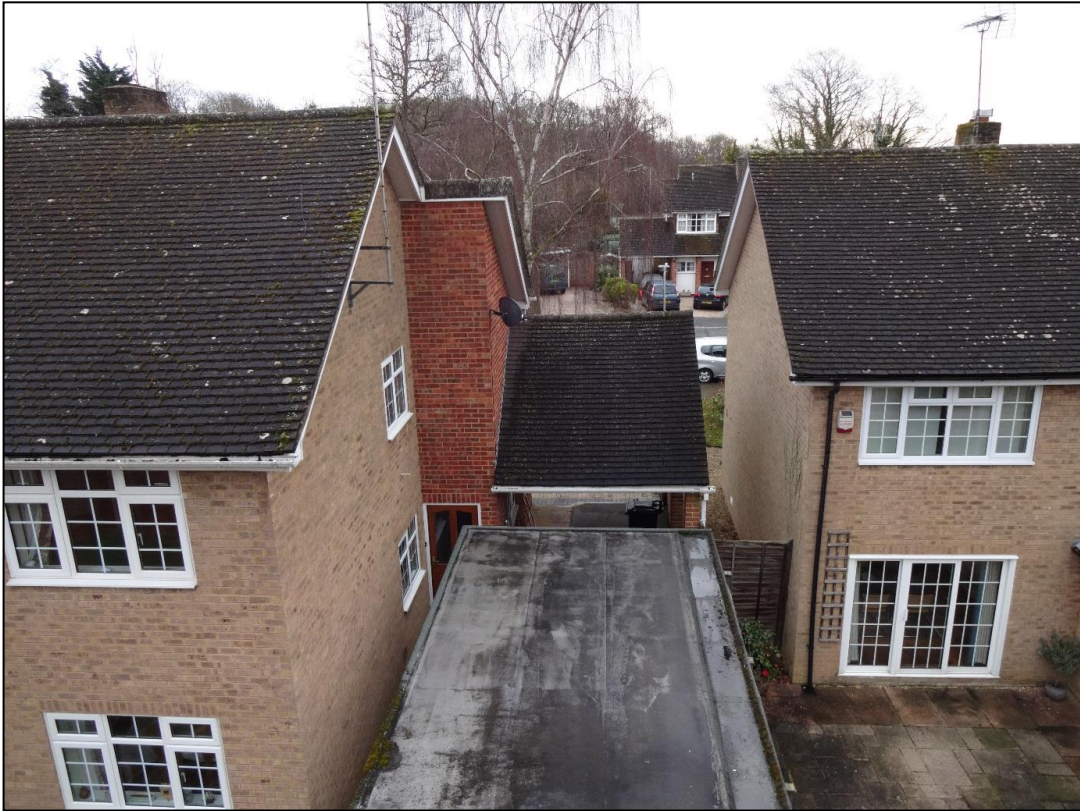
Figure 9. Bitum flat roof over garage, 11 Yarnton Close, Emmer Green. 13.03.18

The garage has a flat, bitumen roof with uPVC fascia's which are in good condition, see examples at Figure 9 and 10 on page 10.

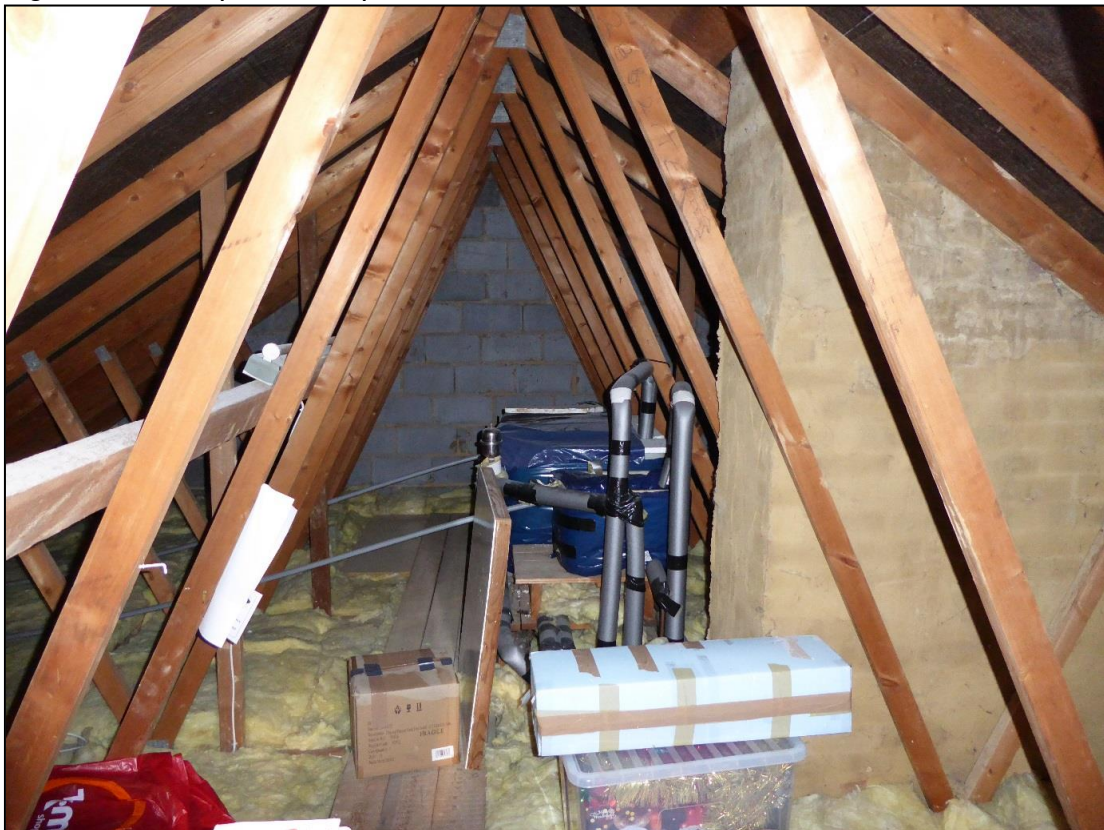
Figure 11. Example of loft space, 11 Yarnton Close, Emmer Green. 13.03.18

The loft of the main building was accessed via a hatch on the first floor using a telescopic ladder. The loft was lit, partially boarded and insulated, see Figure 11 below. The tiles were lined with bitumen felt (Figure 12 on page 13), which was in good condition.

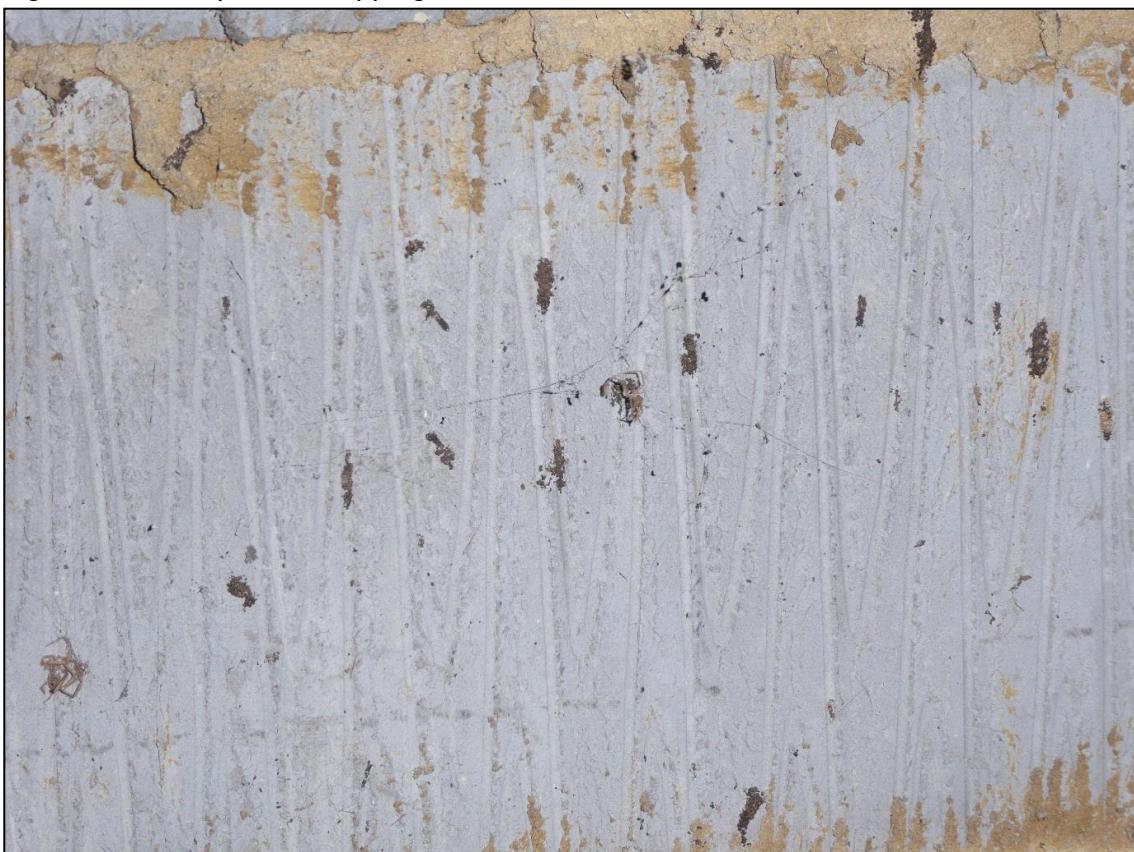
Figure 13. Example bat droppings. 11 Yarnton Close, Emmer Green. 13.03.18

Decomposed bat droppings were observed on the breeze block wall forming the northern gable end wall, see Figure 13 on page 13. A sample of the droppings was sent for DNA analysis, there was insufficient DNA for analysis, see Appendix 1. There are no obvious access points for bats internally.

There were no live or dead bats recorded during the survey, but the presence of droppings internally provides a high level of confidence that bats have historically used the building for roosting. The low number of droppings and location support the theory that the loft was used as a day roost for a low number of bats (<5). The building has a low potential to support roosting bats following repairs (re-pointing). Gaps remain in the roof and therefore further survey effort is required.

Based on the Bat Workers Manual and the Bat Surveys Good Practice Guidelines, it is recommended that one dusk emergence and/or return to roost survey are undertaken on the building between May and August, to assess the current status of roosting bats, in order to inform appropriate mitigation for the proposed works. Two surveyors will be required, in order to cover the entire building and all the potential roost locations.

If bats are recorded roosting during the survey two further activity surveys and an EPSL for bats will be required in order for the proposed development to proceed lawfully. If bats are not observed roosting within the building during the activity survey, the building works can proceed without the need for a bat license given the low impact of the proposed development provided that a method statement is prepared and implemented as part of any planning conditions.

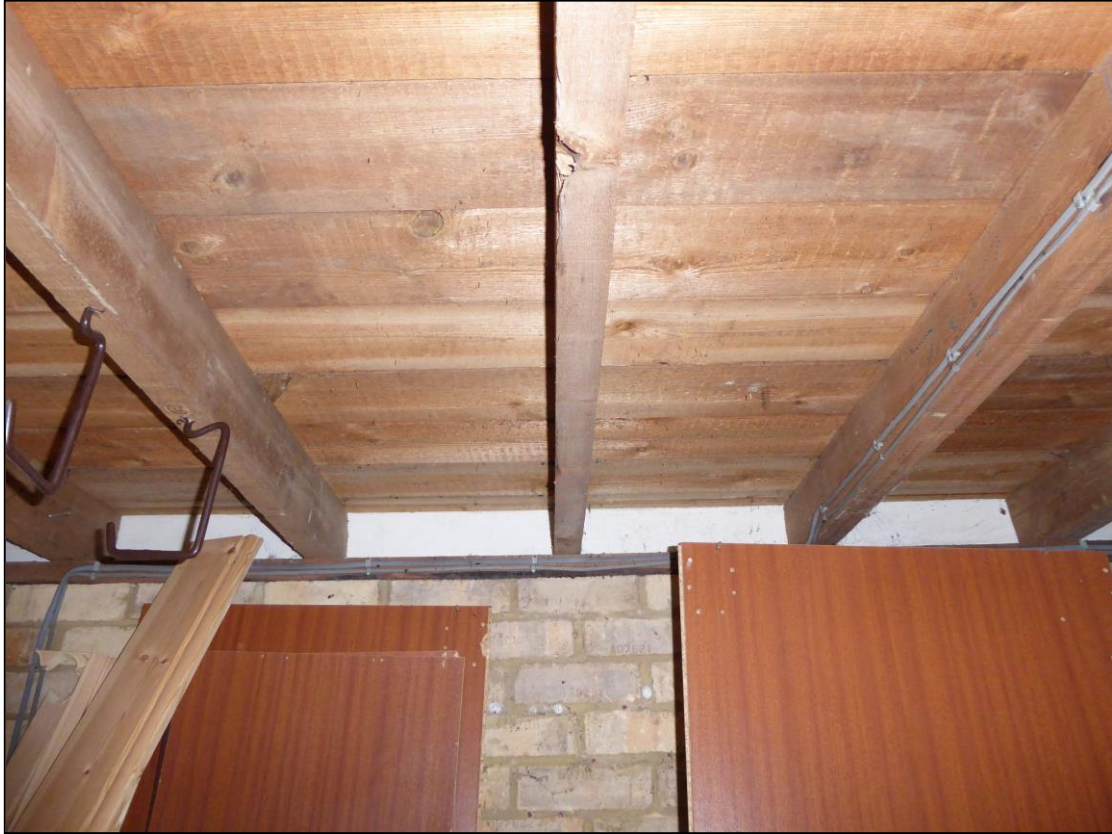
Figure 14. Garage interior, 11 Yarnton Close, Emer Green. 13.03.18.

Internally, the garage was cluttered with no loft space, see Figure 14 on page 14. The garage roof is open and is wood lined and does not afford any roosting potential for bats.
