**Bat Building Assessment**

**19 Grosvenor Road**

| <b>Report title:</b> | ARB782 Bat Building Assessment |

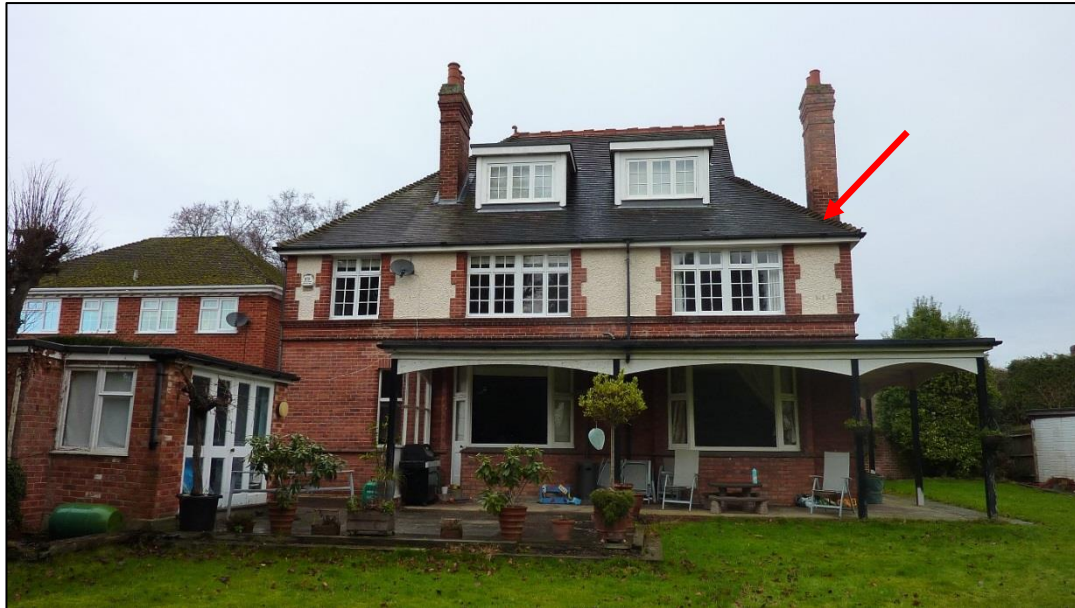
**Photograph 3:** South elevation

- 3.5 No evidence of bats was recorded externally. The roof and hanging tiles were tightly fitted with no discernible gaps with exception of one lifted roof tile on the southern roof pitch and one broken hanging tile on the lowest course of the half-gable on the eastern elevation (see Photographs 3 and 6 respectively). However, upon internal inspection within the roof void, it was evident that the roof tiles were fixed directly on to the sarking boards providing no gaps between the roof cladding and lining.
- 3.6 All eaves areas were tightly sealed with timber soffits and fascia boards. All lead flashings around chimneys were tightly sealed with no discernible gaps. No gaps were recorded around the roof dormer windows.

- 4.3 No bats or any evidence of bats was recorded during the assessment of the residential dwelling. However, all external structural features such as roof and hanging tiles were tightly fitted with no discernible gaps which could be accessed by roosting bats with exception of one lifted roof tile on the southern roof pitch and one broken hanging tile on the lowest course of the half-gable on the eastern elevation. Due to no gaps between the roof cladding and lining being present, it is considered highly unlikely that bats could roost under the lifted roof tile. The roof void of the residential dwelling was small, cluttered and had no access points which could be used by roosting bats. The residential dwelling was therefore considered to have **low suitability to support roosting bats**.

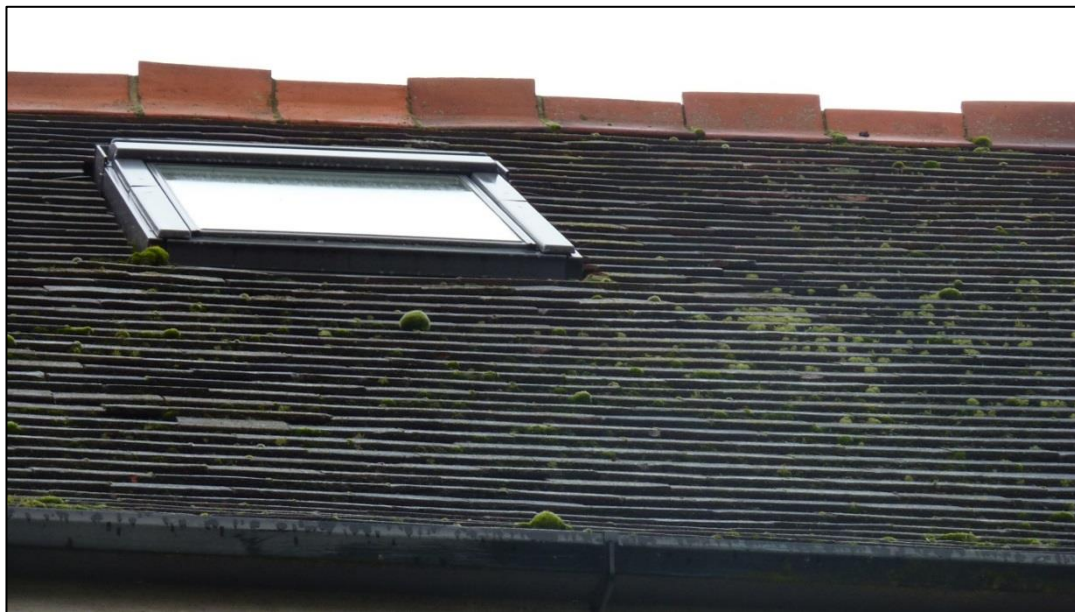
**Photograph 4:** Tightly fitted roof tiles

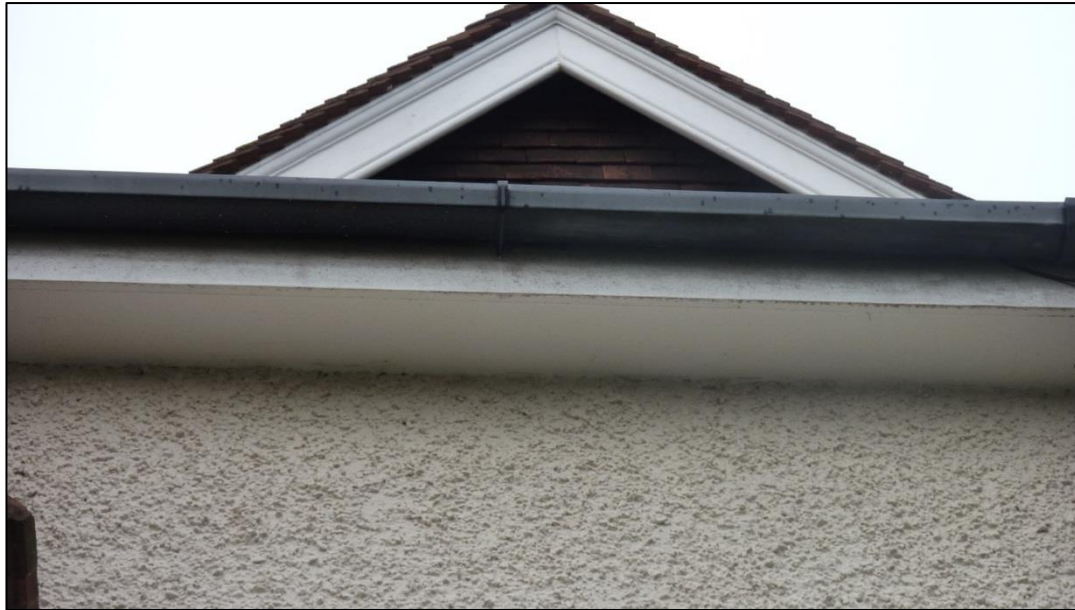
**Photograph 5:** Tightly fitted eaves

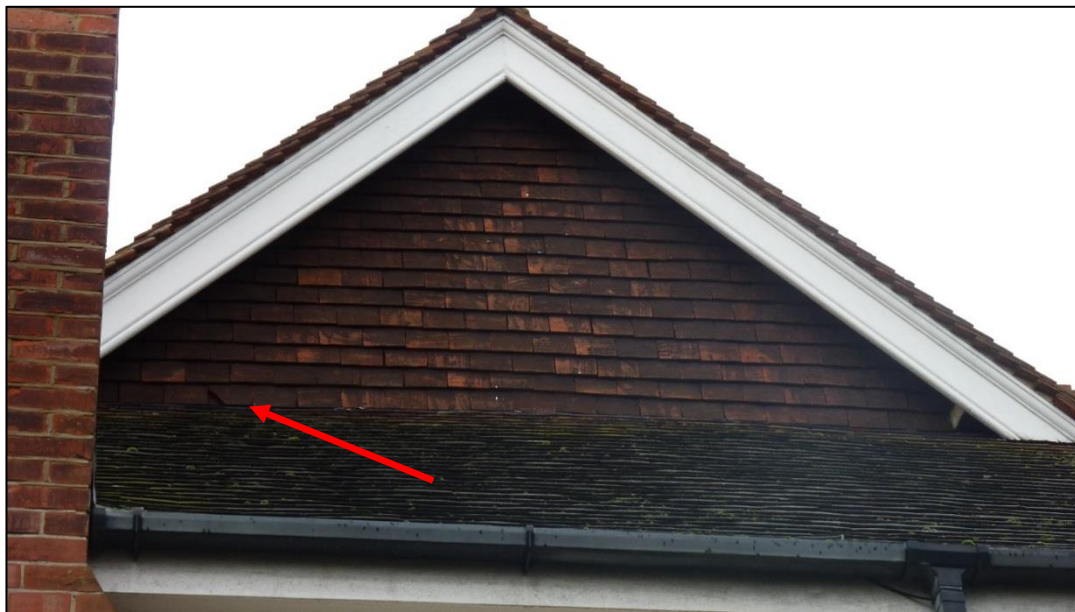
- 4.4 The proposed development will comprise a two-storey pitched roof extension on the eastern elevation. The ridge line of the extension will be approximately level with the highest part of the roof dormers which will result in the necessary removal of hanging tiles from the half-gable on the eastern elevation. It is therefore advised that these hanging tiles are removed by hand under the supervision of a licensed bat ecologist to ensure that any bats that may be unexpectedly present are not harmed.

**Photograph 6:** Tightly fitted hanging tiles with one broken hanging tile on lowest course

- 6.1 It is recommended that works to the area of hanging tiles on the half-gable on the eastern elevation are undertaken under a precautionary approach. This should include close inspection of the features prior to works by a licensed bat ecologist followed by hand removal of the hanging tiles under the supervision of the licensed bat ecologist. If bats are unexpectedly discovered, a Natural England European Protected Species Mitigation licence may be required for works to proceed.

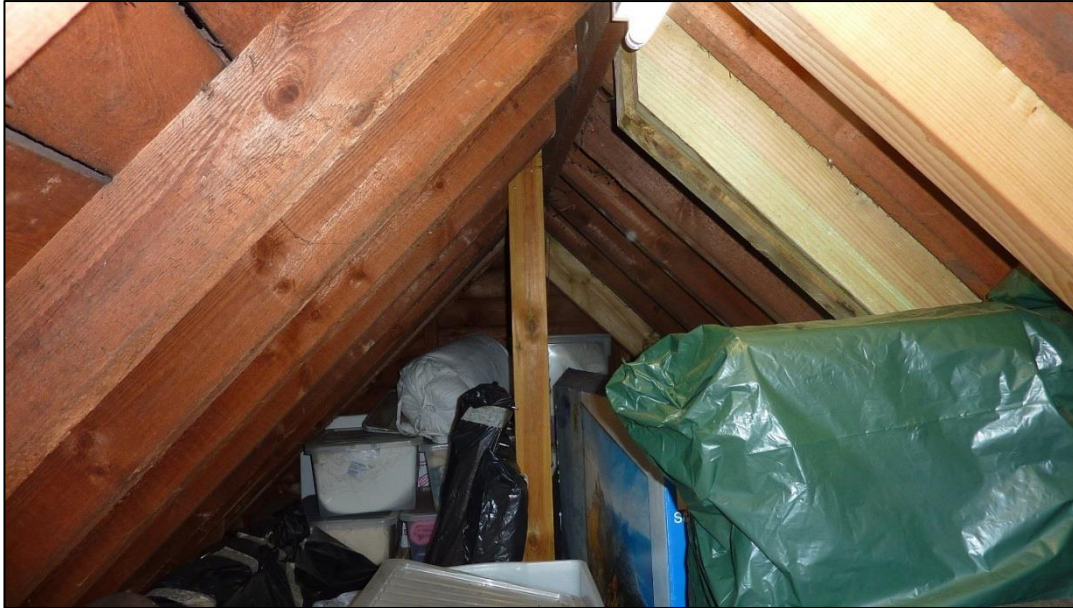
**Photograph 7:** Roof void

- 3.8 The roof void above the second floor was small and cluttered (due to stored items). No discernible potential access points were recorded that could allow bats to enter / exit the roof void. The timber sarking board lining within the roof void was tightly fitted to both the roof ridge and eaves areas.
