# **Construction & Environment Management Plan (CEMP): Biodiversity**

**Island Road (West), Reading**

Report ID 165-03

October 2017

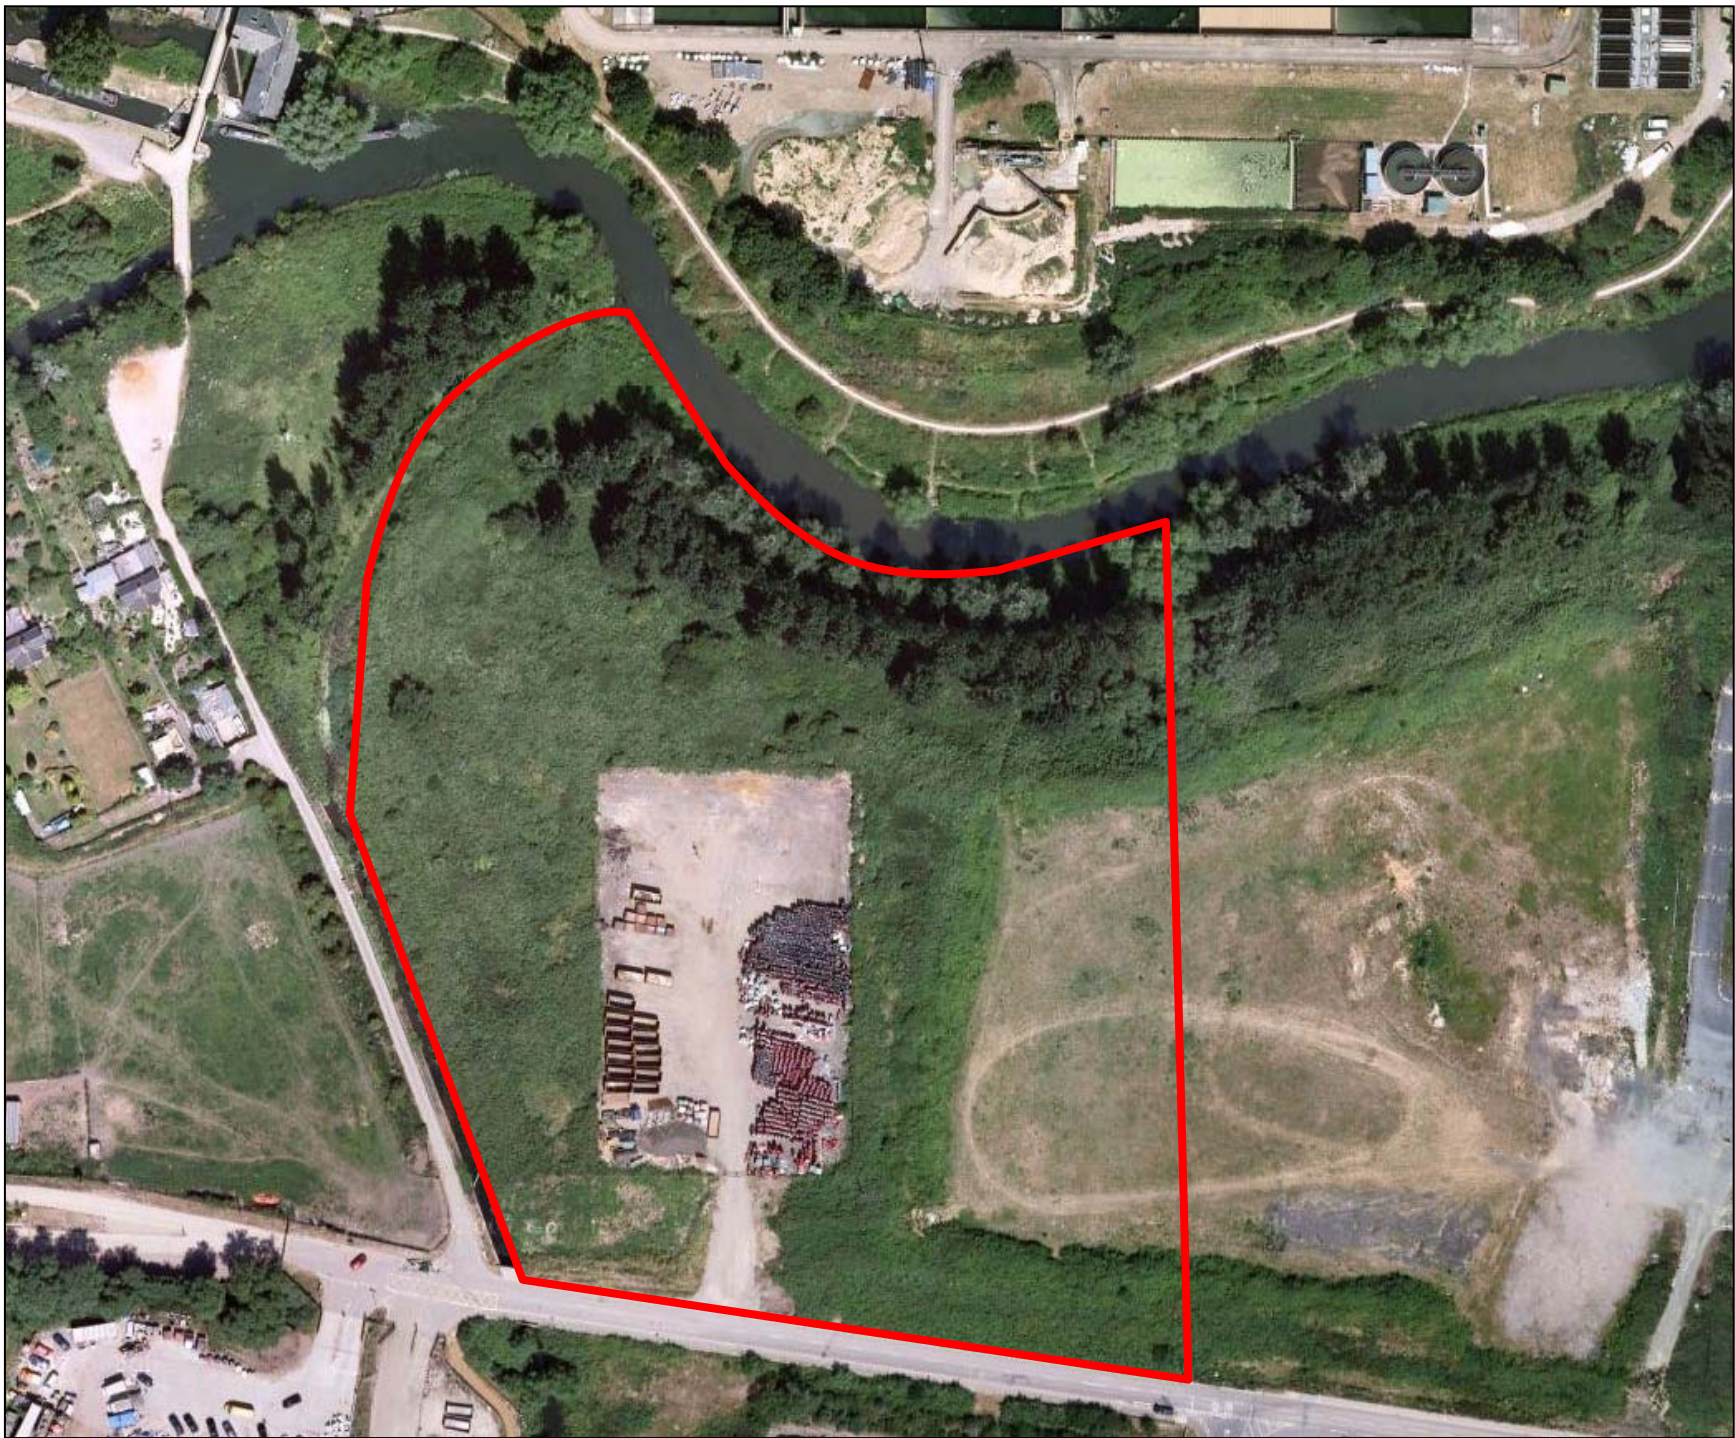
Figure 1

- 1.1.2. The applicant site is situated in Reading bordering south of the River Kennet centred at OS grid reference SU 706709. A location plan and site boundary are shown in Figure 1.
- 1.1.3. It is bordered to the north by the River Kennet which flows eastwards past the site. To the south it is bordered by Island Road. There is a commercial development to the east and the site is immediately adjacent to various drains to the west running north into the River Kennet.

Location

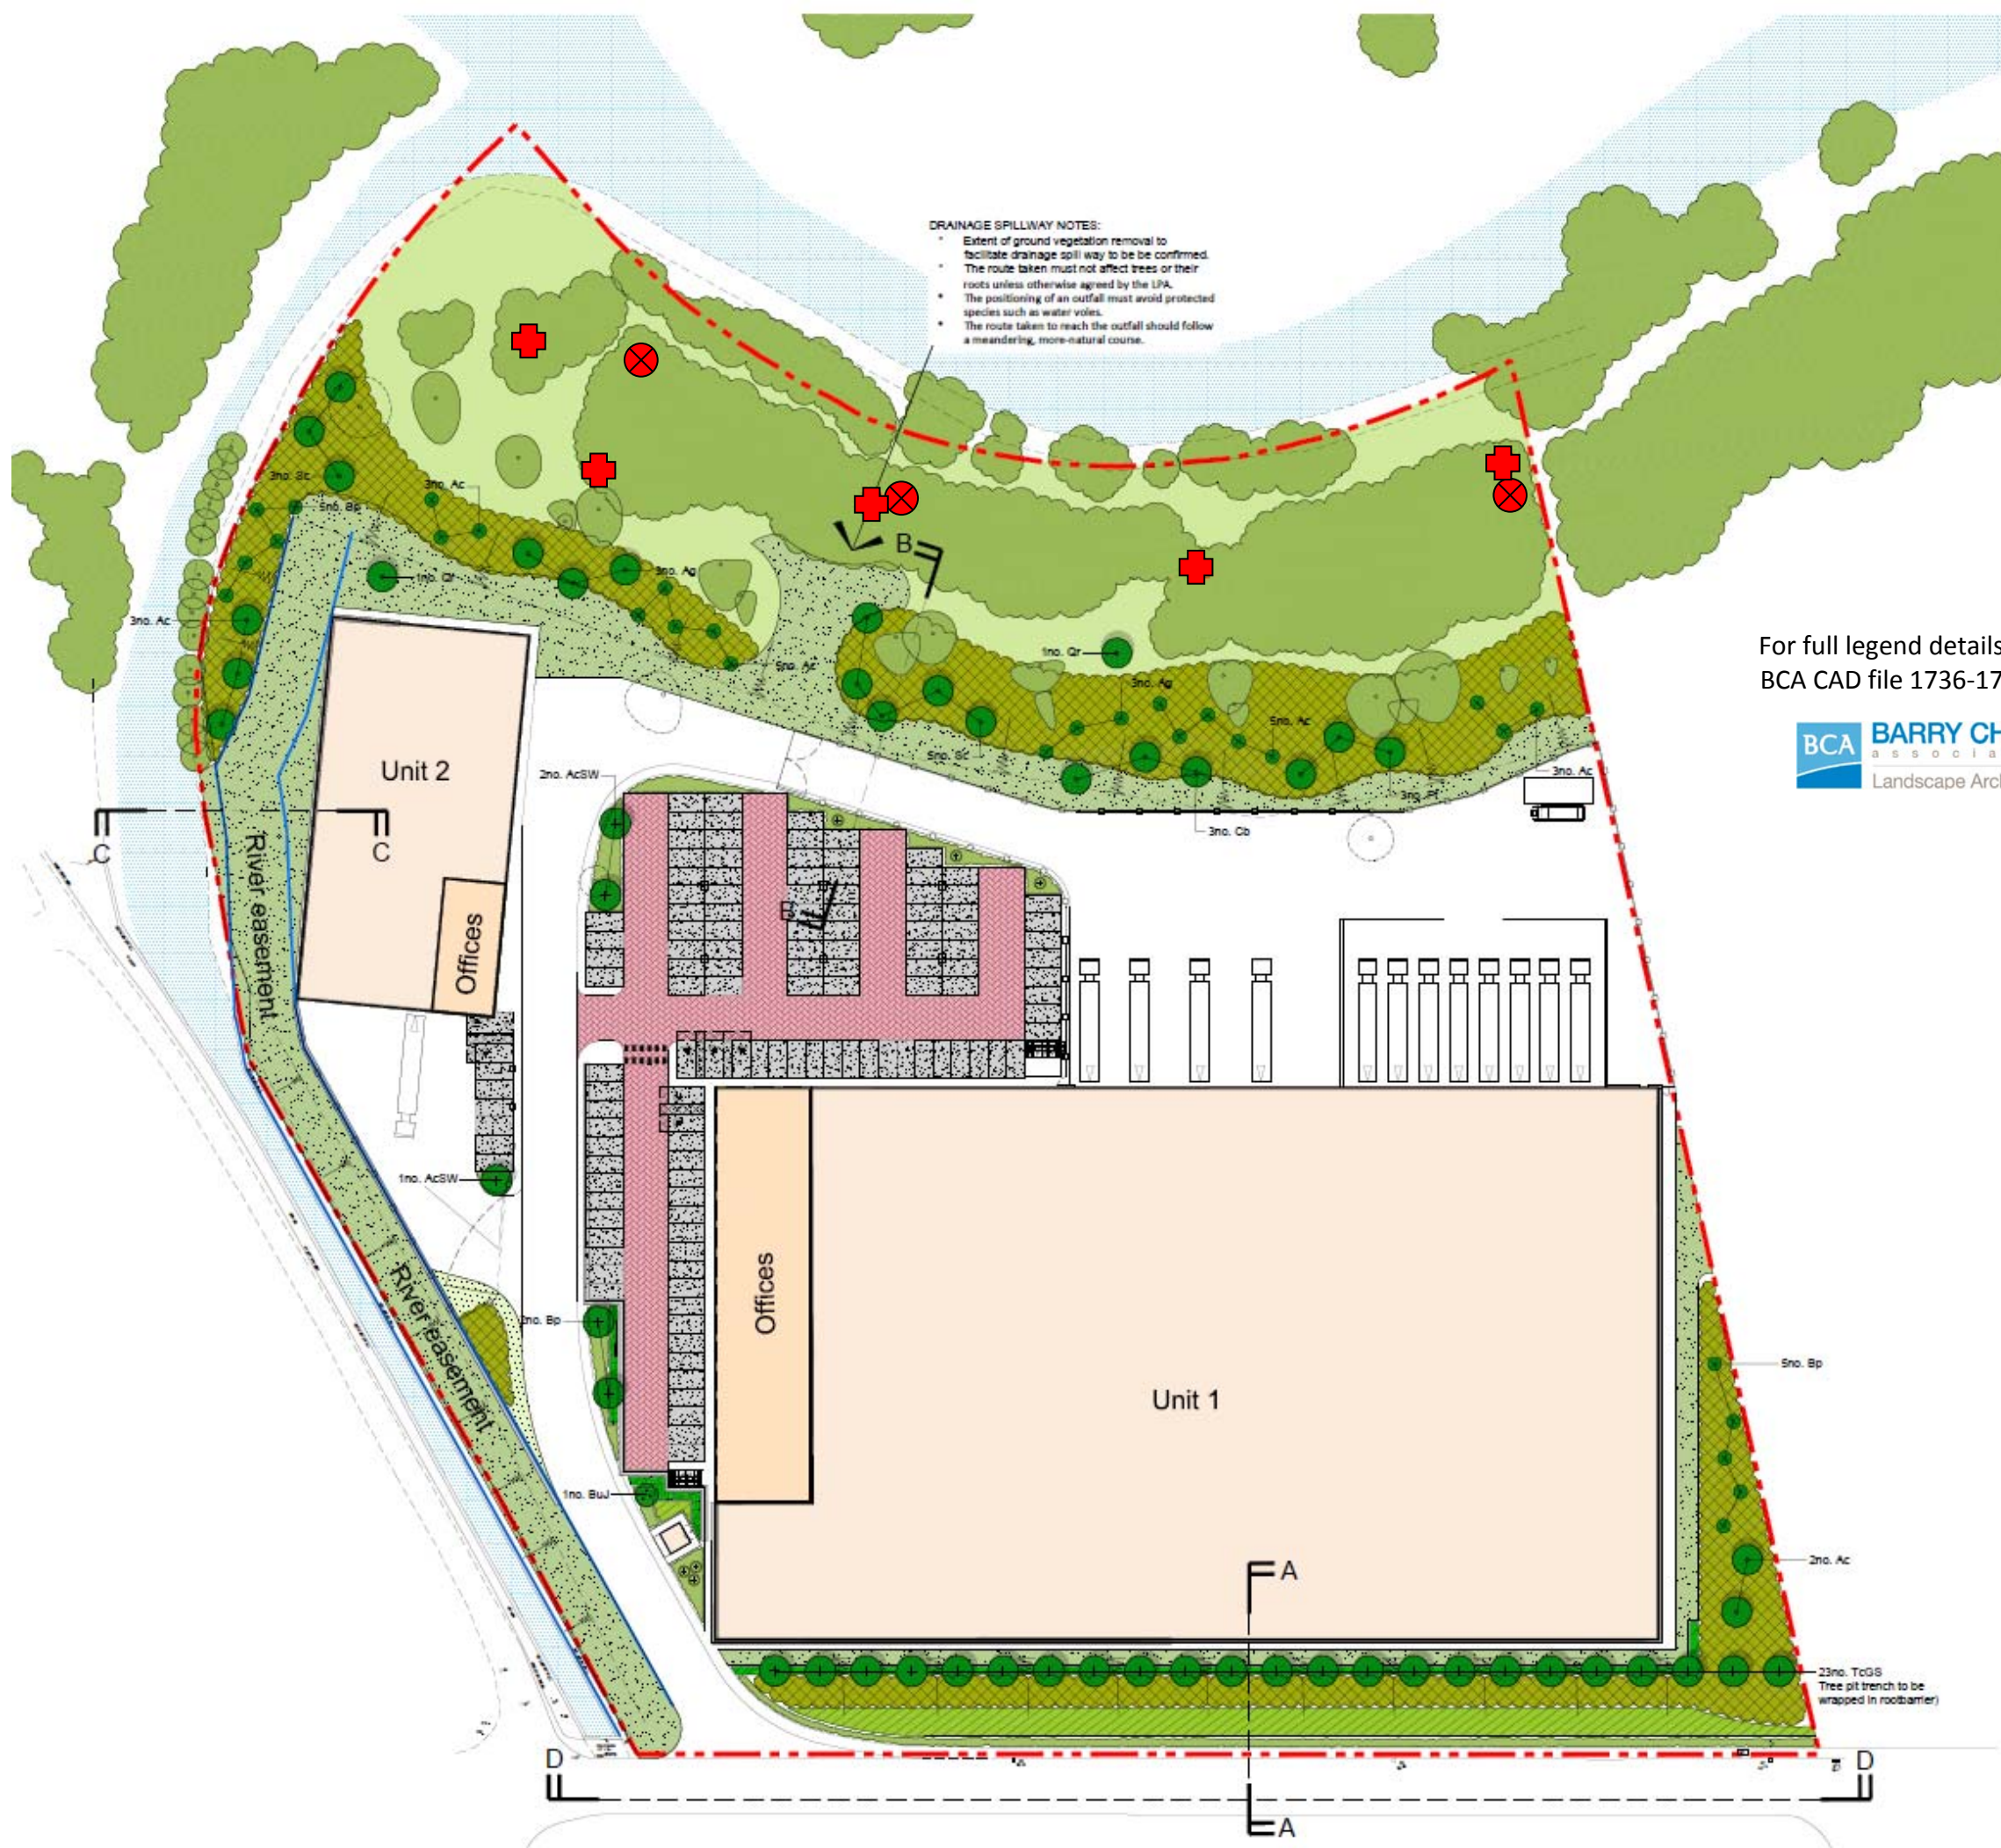
Figure 2

# Final Layout

## Legend

- 2.1.1. Reading Borough Council have granted full permission for the development of two units with associated landscaping & lighting. Surface water run-off drainage is proposed to run into the River Kennet. The proposals are shown in Figure 2. The planning reference is 170444.
- 2.1.2. The planning application included an Ecological Assessment (EP 2017<sup>1</sup>), which found that a small population of reptiles were present in the East of the site, which were relocated onto Fobney Island in 2016. This was completed on the 13<sup>th</sup> October 2016, moving 2 slow worms and 3 grass snake.

- 3.5.1. During the construction of the spillway and construction of the outfall.
- 3.5.2. During the post-construction installation of bat and bird boxes (refer to Figure 2).
