**Brock Keep, Reading  
Heritage Statement**

**A roof with a view**

**Heritage Lottery Fund  
OHOS, OpenHand OpenSpace Ltd**

**HLF Phase I**

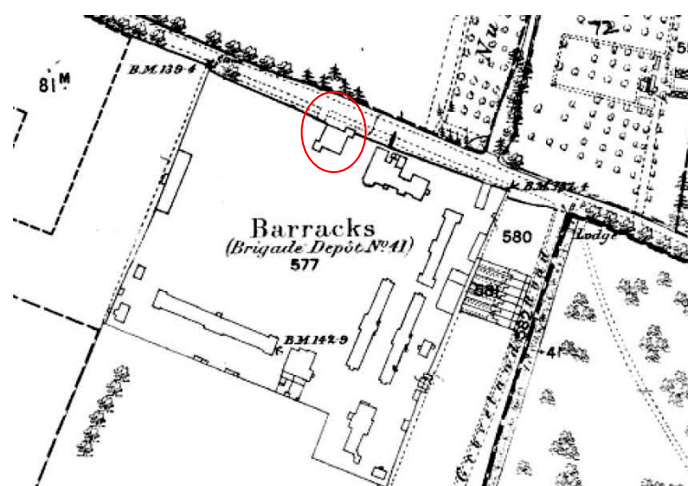
**Figure 2**

The Keep of the Brock Barracks, Reading

Ordnance Survey;  
County Series Berkshire Sheet  
XXXVII.2

Original scale 1:2500 (OS-1879)

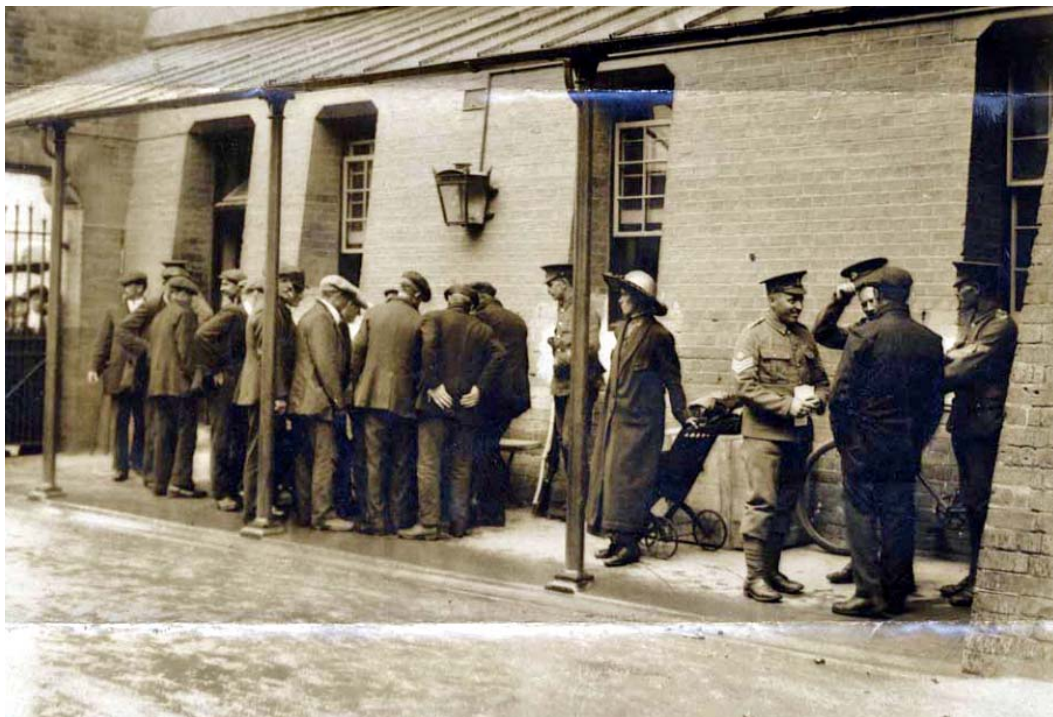
**Figure 5:** Veranda 1914

The Keep houses several functions that have significant roles in the functioning of any military unit. The guardroom and its veranda are an important focal point, both visually and ritually, at the entrance to a unit, be it Army, Navy or Air Force. The guard room whether part of another building, or a separate building is the one location that is manned continually. Its overt function is security of the site, it is also the first point of contact with the unit. For visitors of sufficient rank there would be a formal presentation of the guard, "Turning out the Guard", where the guard would parade on the veranda (possibly in full regalia) and be inspected by the visitor. The security element will be the "guard", a collection of personnel whose role is to secure the site. The guard is mounted each evening, normally with formal drill on the veranda, where the Orderly Officer inspects the new guard and gives them their orders for their period of duty.

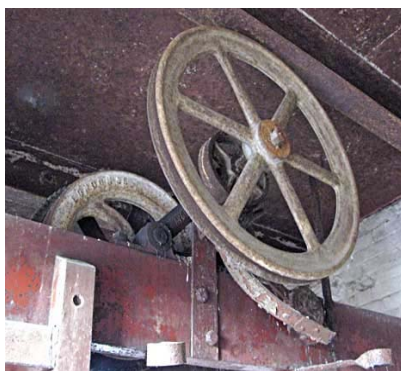
**Figure 12:** Victorian lift mechanism in the NE stairwell,

The remaining part of a dumb waiter originally had its rails, gears, weights and a car, like the Keep in Dorchester still in military use as a museum, which is a good source for our interpretation of uses, for instance the description of using one of the roof stores as a place to isolate and disinfect scabies mite sufferers.

The issue of appropriateness of preserving the lift mechanism has to be explicitly addressed after additional expert advice

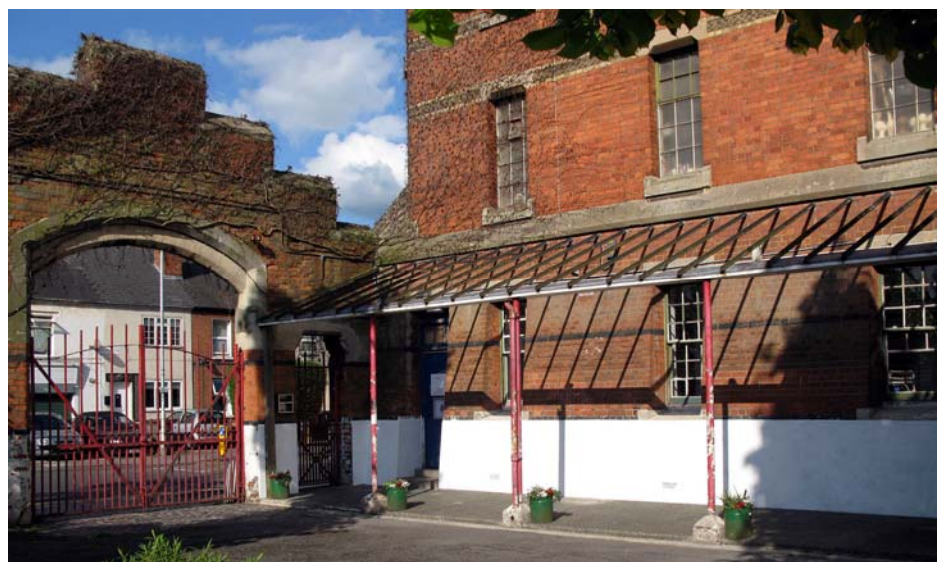
**Figure 13:** Veranda

Conservation of the original veranda is the only part of the ground floor incorporated in HLF Phase I

**Exterior:** 4 storeys, 5 window range. A regular, square block with opposite square stair towers rising above the roof, other two corners chamfered with raised parapets, with terracotta sill and lintel bands, dentil eaves and crenellated parapet. Battered ground floor to a weathered band, narrow metal-framed windows with stone lintels, stepped in threes to the stair tower. A glazed iron verandah to the guard house beside the entrance.

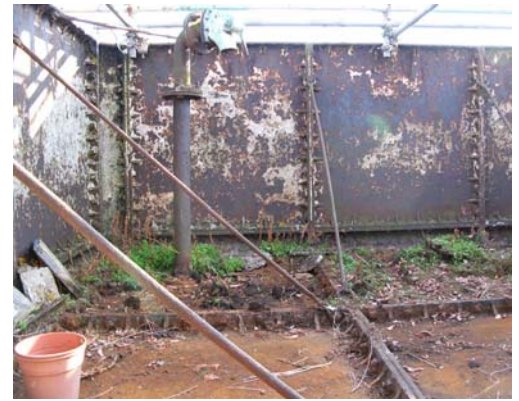
**Figure 14:** Interior of the cast iron tank

Each of the two turrets on the Keep's roof contains a Victorian segmental cast iron water tank within 1400 mm high brick parapet wall, as a part of the original fire-fighting system, each with a capacity of 22 400 l of water that could be delivered to floors 1, 2 and 3 via the riser pipes in the stairwells. The tanks are accessible by ladders and were most probably covered by a wooden cover.

Structural survey and report by MLDE suggested removal of the water tanks to allow deep re-pointing of parapet masonry and copings. It was considered as a first stage and the base for further specialist investigations.

The MA report suggested the same. Whilst it is appreciated that the tanks are a part of the building's heritage, it is also likely that corrosion to the tanks is causing significant damage to the supporting load-bearing structures and will potentially add further maintenance issues. Therefore, removing the tanks appears more appropriate for the structural and financial reasons, which will create an additional 16 sqm on each turret.

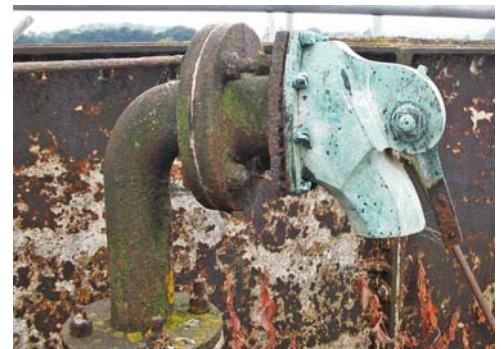
**Figure 15:** Water supply detail

Segments of the water tank with a water supply detail will be preserved

- a) a record and display in the car park area with information panels describing Brock Keep's fire fighting system, original location and value as a heritage object.
- b) a water feature/sculpture recycling rainwater from roof, creatively and ultimately watering plants in long narrow free-standing planting boxes along lower part of the east car park wall. This would improve roof drainage and reduce damp on the walls. Planters may have red plants to represent the flames from the original Douglas Gordon's artwork event.
