# **FORMER RED LION PUBLIC HOUSE & No. 38, SOUTHAMPTON STREET, READING**

## **Heritage Statement**

Bob Edwards

December 2017

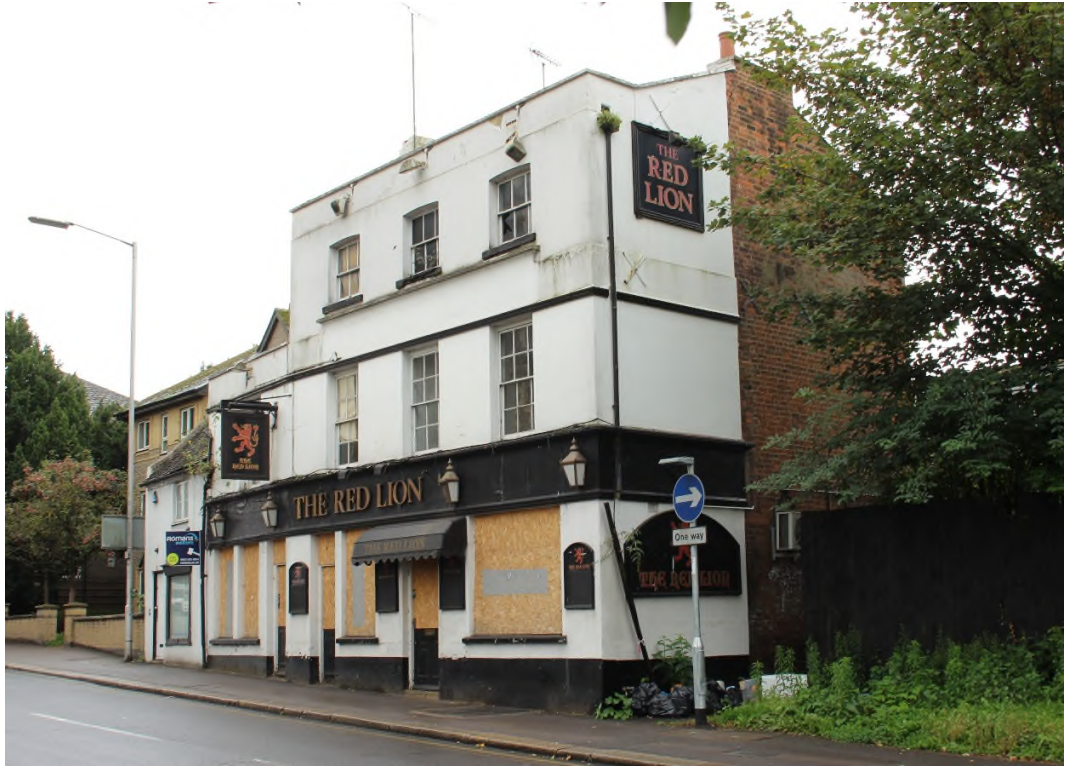
Figure 1 Front and north elevations

- 3.1 The principal element of the former Red Lion is a three-storey building of three bays with white painted render to the front elevation, the south gable end above a two-storey element and to the eastern part of the north elevation (Figure 1). The ground floor windows are currently boarded over; they are large openings that are probably later insertions. At first floor level there are six-over-six sashes and three-over-three sashes to the second floor, the latter having very shallow segmental arches over. Between the ground and first floor level there is a wide timber sign board across the whole of the front elevation and wrapping around the corner to the north elevation. The roof is a shallow pitched slate roof hidden behind a parapet to the front elevation and there are large stacks to each gable end.

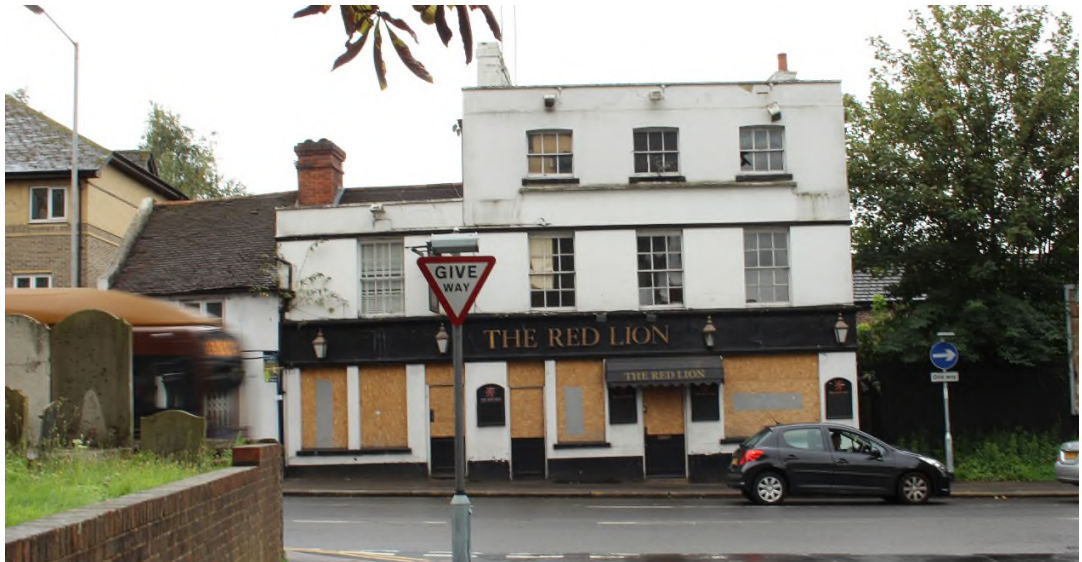
Figure 2 The former Red Lion, front elevation showing the two-storey element to the south of the principal block

- 3.2 To the south of the principal element of the building is a two-storey element which also has a painted render front with a parapet but this parapet conceals one bay of a pitched tiled roof, the second, southern bay forming part of a separate property, No. 38 (Figure 2). Between these two bays is a square ridge stack.

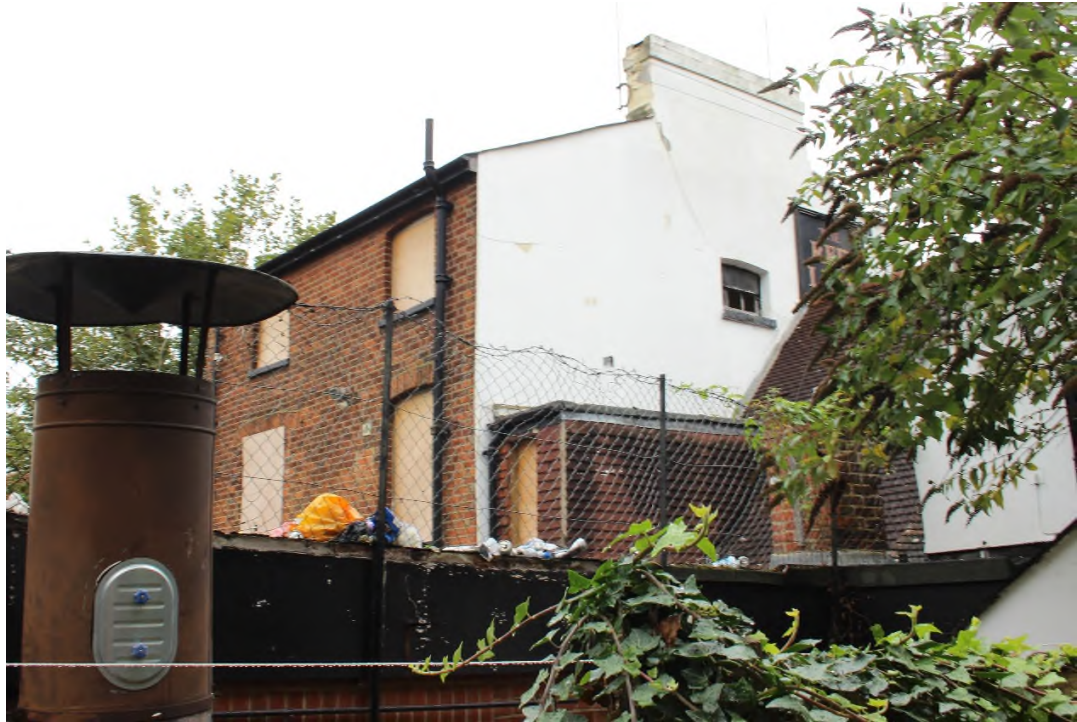
Figure 3 Rear elevation above the single storey extension with the rendered south elevation to the right.

- 3.3 The remaining part of the north elevation is of unpainted brick laid in Flemish bond, as is the rear elevation (Figure 3). The openings to the rear elevation have segmental arches over and there is some evidence for alteration to some of the openings. Across the whole of the ground floor of the rear elevation there is a flat-roofed single-storey modern extension.

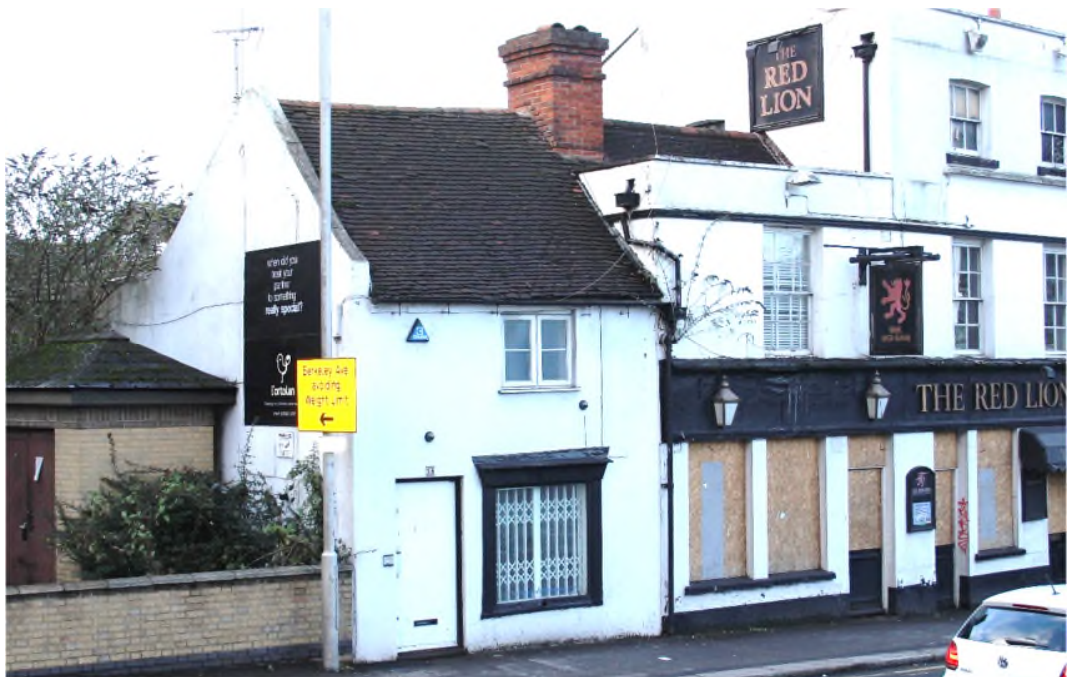
Figure 4 No. 38, front and south elevations.

- 3.7 No. 38 has a single bay rendered frontage and gable wall with a tile roof, gabled to the south (Figure 4). This element has been extended with various phases of two storey and single storey additions to the rear.

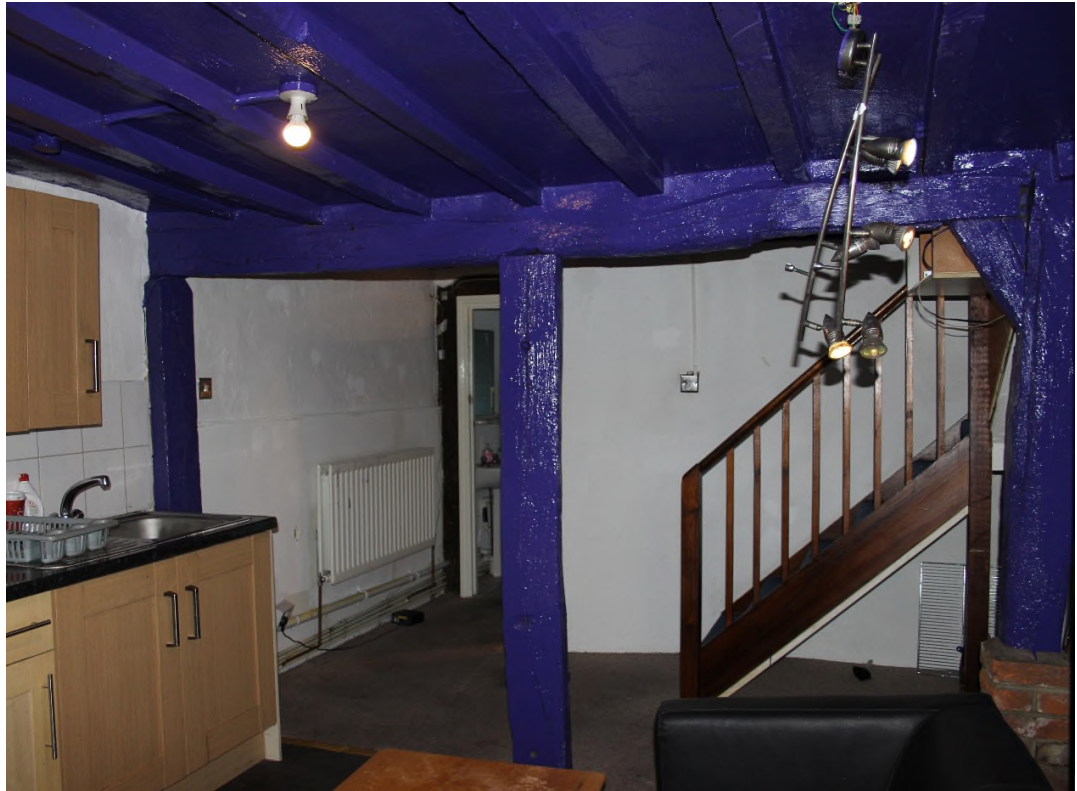
Figure 5 No. 38, front room with exposed ceiling joists.

- 3.8 Internally, the front door gives access to a lobby formed by modern partitions, the lobby being taken out of the main room. This room has a low ceiling with an axial spine beam and exposed joists ( $2\frac{1}{4}$  -  $2\frac{1}{2}$ " wide), all of which are heavily painted (Figure 5). The spine beam is chamfered and has a simple run out stop to the south. To the north the beam is set into a large stack which has been boarded over from floor to ceiling. The line of the original rear wall is marked by the girt beam which appears to be supported by three posts, the post to the north having a short brace up to the beam. Whilst this post is part of the primary build, the brace is not and is fastened by screws. The central post appears to be an insertion. Although there are peg holes in the area where the post stands, generally there does not seem to be the typical evidence for studs forming wall framing as would be expected for a rear wall. The modern stairs are set west of the line of the former rear wall. Beyond, to the rear are later elements with no features of architectural interest.

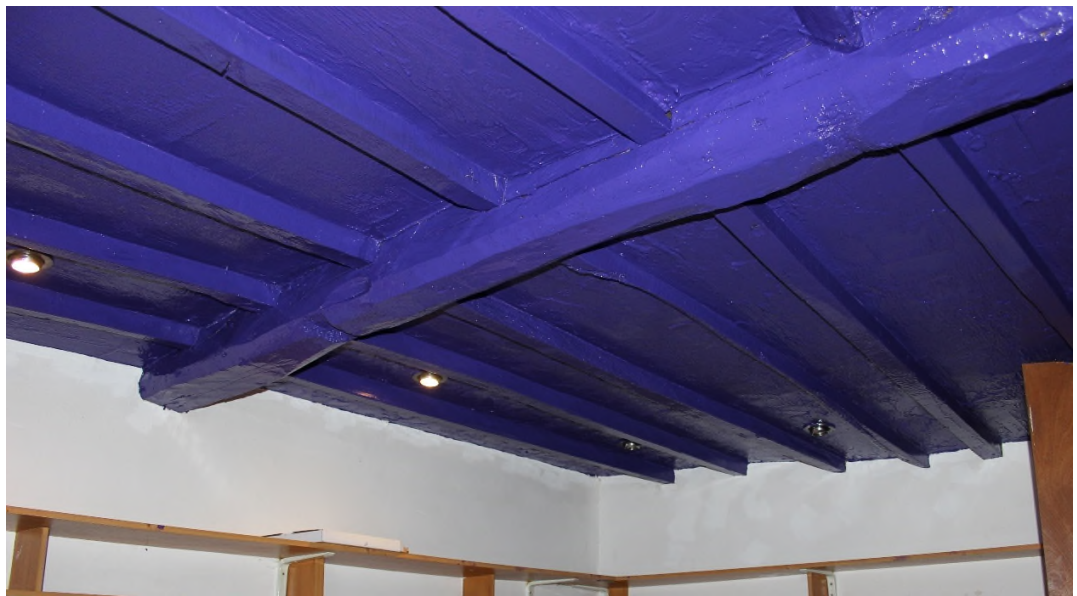
Figure 6 Ceiling beams to the first floor bedroom within the single bay of No. 38.

- 3.9 At first floor level there is also an historic ceiling with a spine beam and exposed joists. These joists are relatively narrow and the spine beam is a relatively irregular timber, probably due to the loss of sap wood. Remains of a chamfer survive at the northern end. There is not exposed framing in the walls.
