## Visual Bat Survey Report

49 Northcourt Avenue Reading RG2 7HE

March 2018

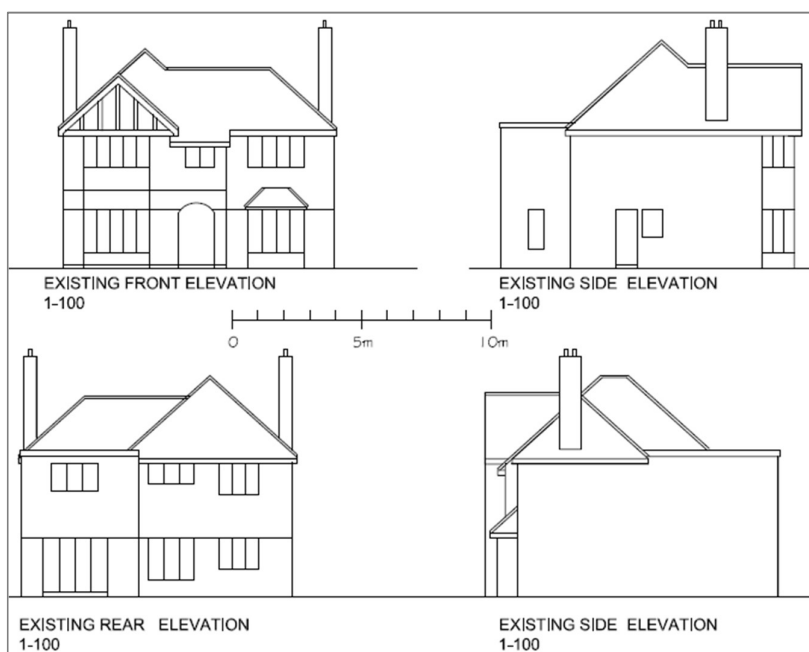
**Figure 1a – Existing elevations**

It is proposed to remove the existing flat-roofed extension and construct a part two-storey and part single-storey extension to the rear of the property. Figure 1 below shows existing and proposed elevations (from plans produced by Groom Design Ltd).

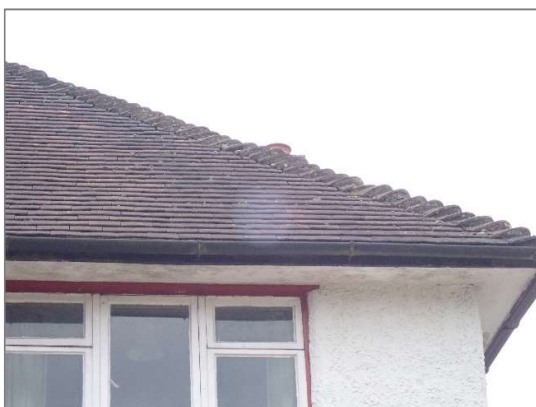
The tiled roof was generally found to be in a good condition with no tiles on the main roof faces noted to be missing or slipped (see Photos 1-4). The clay tiles are machine-pressed so do not have the natural curve typical of traditional clay tiles.

A small number of hip bonnets superficially appeared to have gaps to them where the bedding mortar had started to weather. However, inspection of these from ground level using binoculars found that the bedding mortar remained largely in place under the tile, and only the exposed face of these had weathered away (see for example, Photo

**Photo 1** – Roof tiles to rear roof pitch in good condition

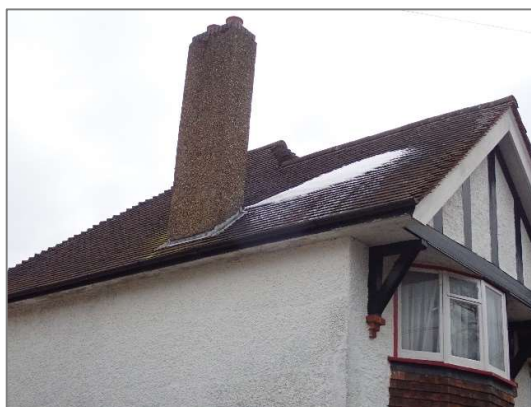
**Photo 2** – Tiles to side roof pitch in good condition

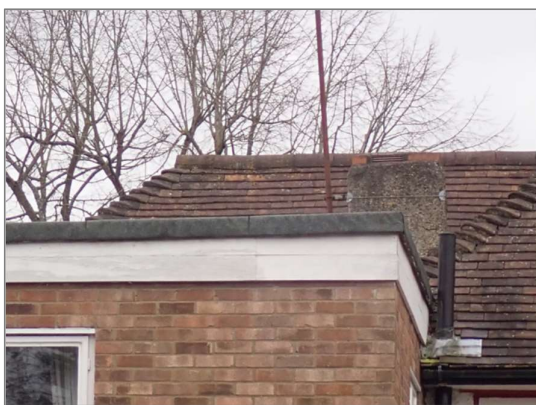
**Photo 3** – Rear of house showing flat roof extension and tiles to main roof

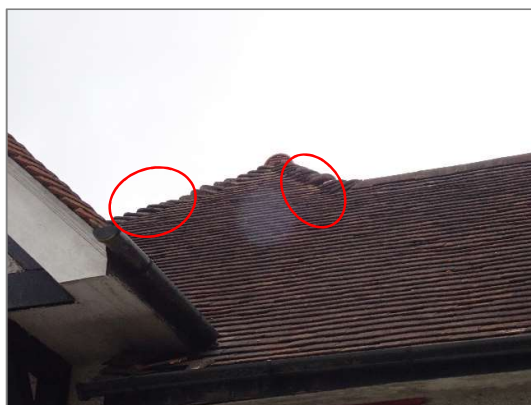
1). The exception to this is to the front of the house where there appear to be a small number of larger gaps to some of the hip bonnets (see Photo 4).

**Photo 4** – Gaps to hip bonnets to front of house

There are two main elements of the house that appear to provide bat roost suitability. The hanging tiles to the front elevation main bay window, and the small number of gaps to the hip bonnets towards the front of the house.

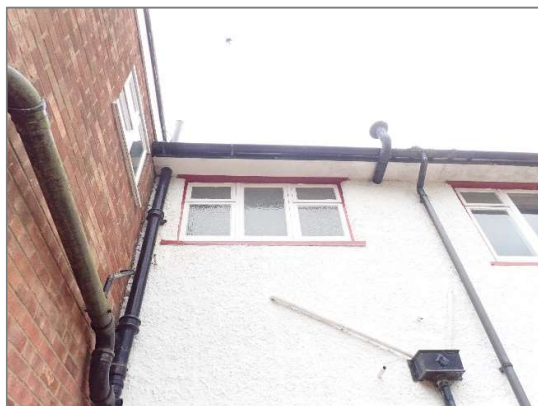
The soffits and fascias were in good condition and tight to the external walls with no gaps noted (Photos 5-6). There is a section of hanging tile to the front full-height main bay window to the left side of the front elevation gable. These are plain machine-pressed clay tiles with limited natural curve although there are some gaps between them that are suitable to support roosting bats (Photo 7). The smaller ground-floor bay window to the right of the front elevation has a small roof pitch, also of plain tiles and hip bonnets. The tiles are generally well fitting, although there is similar weathering to the bedding mortar of the hip bonnets as seen on some of the main roof bonnets (Photo 8).

**Photo 5** – Soffit to rear elevation

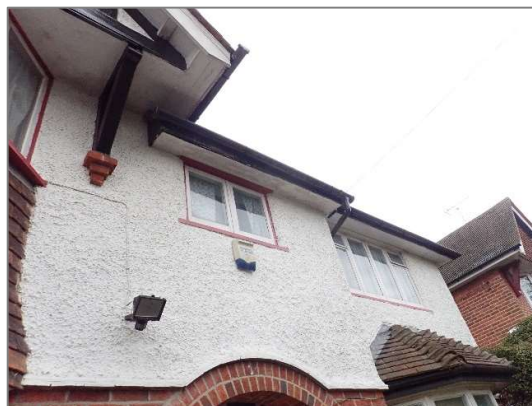
**Photo 6** – Soffits to front elevation

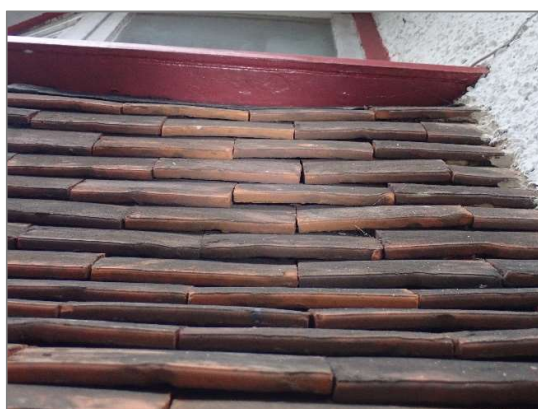
**Photo 7** – Hanging tiles to front bay window

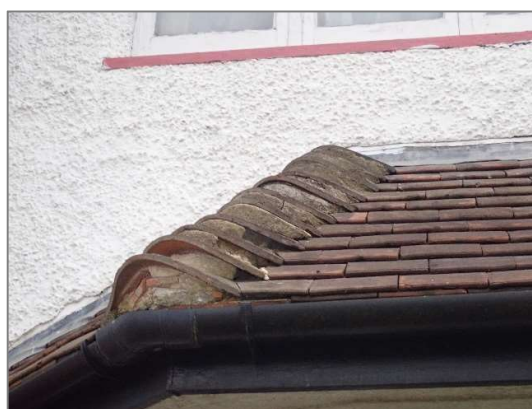
**Photo 8** – Tiles to front bay window

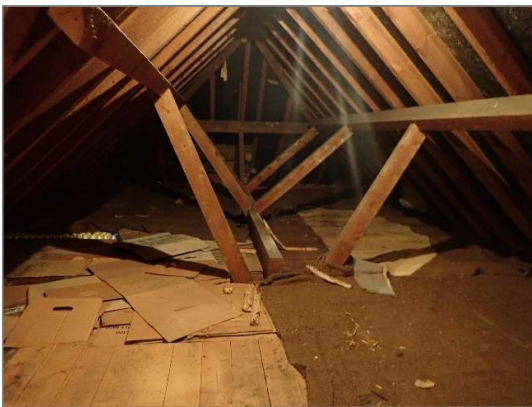
Internally, the loft was readily accessible and was well-boarded. A detailed examination of all surfaces, including internal timbers, floors and walls was carried out and particular attention was paid to features such as the ridge beam, the inside of the front gable end apex, and joints in the timber work. No evidence of bat activity such as droppings and / or urine splashes was found, and no live or dead bats were seen (Photos 9 and 10).

**Photo 9** – Loft internals

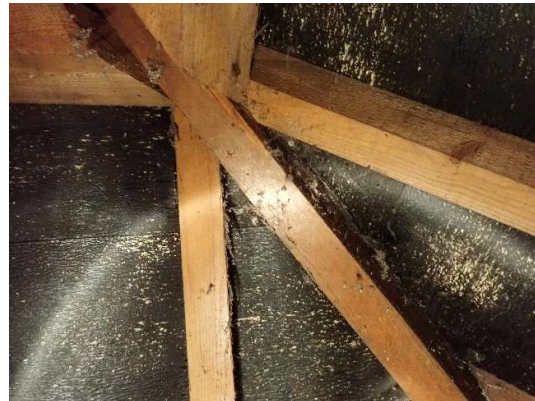
There were extensive cobwebs throughout much of the loft area. Spot checks beneath the various layers of insulation, newspaper, carpet and eggboxes revealed no historic bat droppings. The bitumen underfelt was found to be in good condition throughout.

**Photo 10** – Timberwork with cobwebs

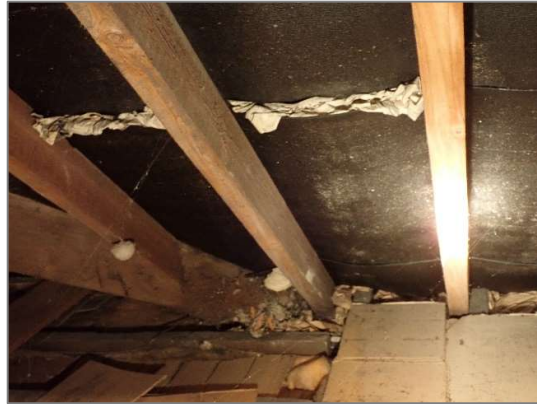
Notably, there were extensive amounts of newspaper (dating from the 1970s) tightly packed into all areas of potential access into the loft from the outside. There was packed newspaper found all around the eaves and also noted to be present packed into the space behind the roofing felt (Photos 11 and 12). It is not known how extensive the newspaper is within the void between the tiles and felt, but the visible areas appeared to be tightly packed.

**Photo 12** – Newspaper packed behind roofing felt
