# Bat Survey Report

## 2 Littlecote Drive, Reading

February 2018

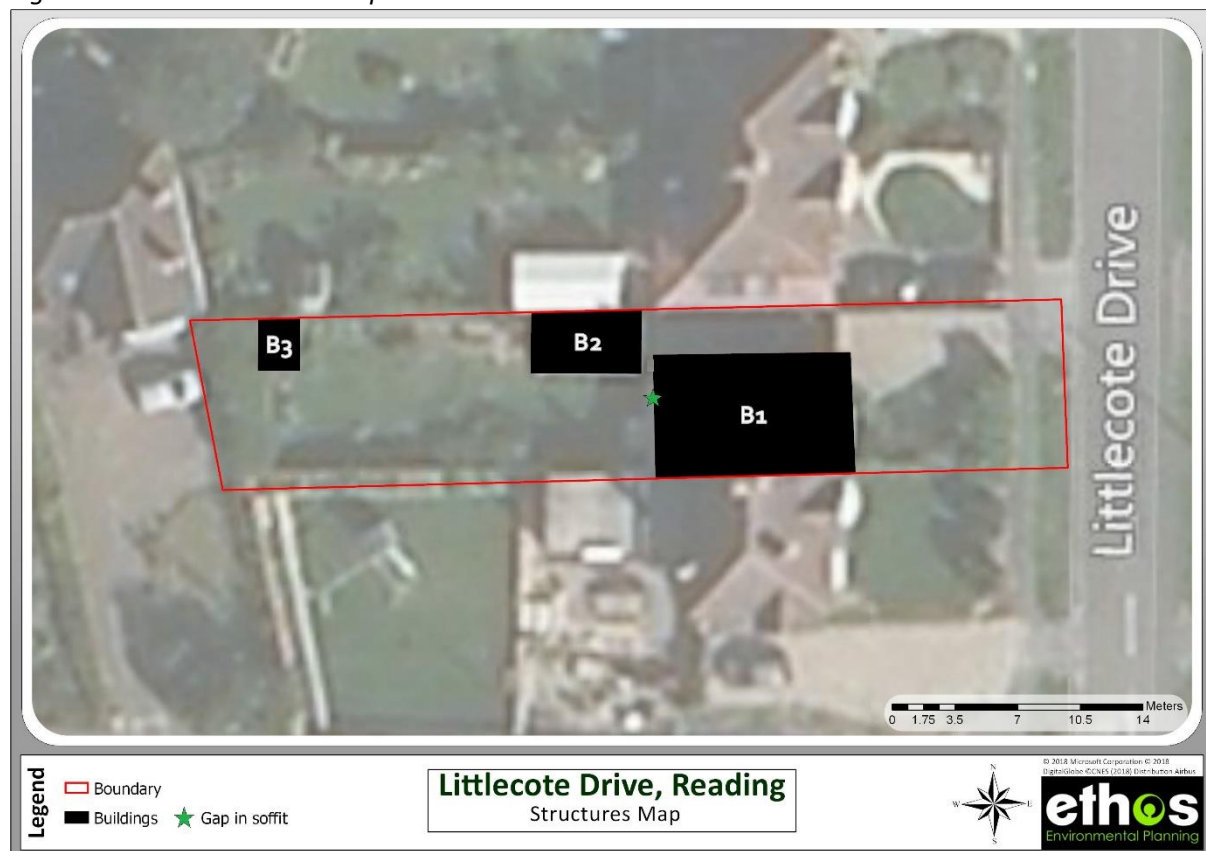
Figure 4 Structures Map

The site consisted of three structures comprising the main house (B1), a garage (B2) and a shed (B3). The locations of these structures are shown in figure 4 and described below.

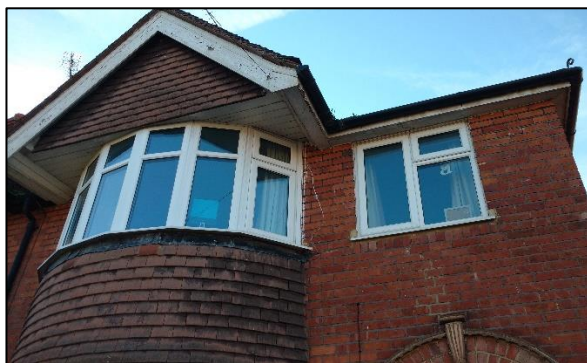
A two storey semi-detached house constructed from brick in very good condition. The hip roof consisted of composite tiles with two chimneys, the brickwork of which was in good condition and the lead flashing was tightly fitted. The roof tiles were in good condition tightly fitted and no gaps were noted. Wooden soffits were present which were in good condition with the exception of one area on the western elevation where a gap was present (see figure 4). The gap was inspected closely and no evidence of staining or droppings on the wall were noted and furthermore, cobwebs were present over the gap which indicated that it was not in use by roosting bats. On the eastern elevation of the house, a dormer window was present with hanging composite tiles which were tightly fitted with no gaps and wooden boards on the overhang which were noted to be in very good condition.

Photo 1: B1 Eastern elevation

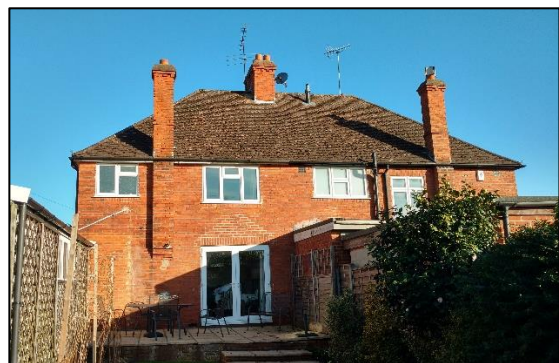
Photo 2: B1 Western elevation

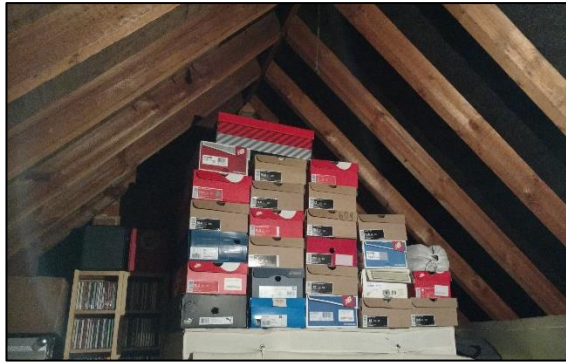
One loft void was present in the main house constructed from wooden rafters, with wooden purling and ridge beam all of which were tightly fitted with no gaps. Felt sarking was fitted and was damaged in three places leaving gaps. The void was in frequent use for storage and the loft space was noted to be cluttered with storage items which greatly reduced potential flight space for light sampling.

No evidence of bats was found and the structure was assessed to hold low-negligible potential to support roosting bats.

Photo 4: B1 Interior void

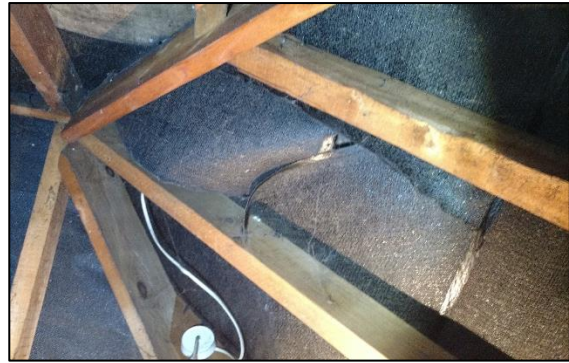
Photo 5: B1 damaged sarking

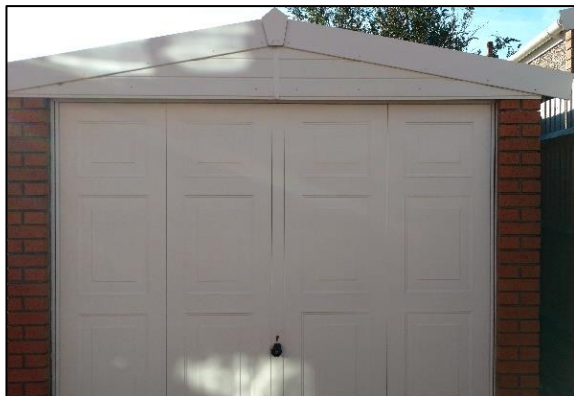
A single storey garage consisting of concrete and brick walls with a pebbledash exterior and a slightly pitched roof of corrugated asbestos over a wooden frame with a metal roof ridge. High light levels were present inside which entered through windows on the southern elevation. The structure was noted to be in regular use by the residents at the time of survey which resulted in moderate disturbance levels within the structure.

No evidence of bats was found within the garage and it was assessed to hold negligible potential to support bats.

Photo 6: B2 Eastern elevation

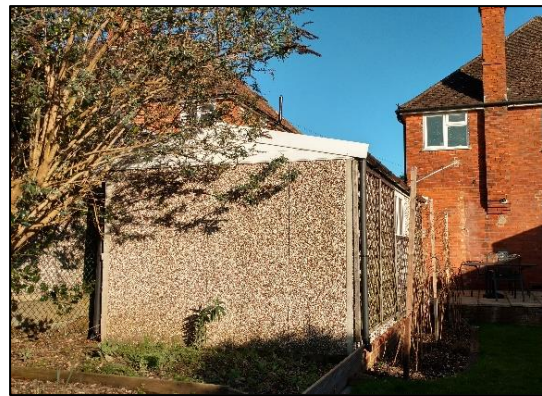
Photo 7: B2 Western elevation

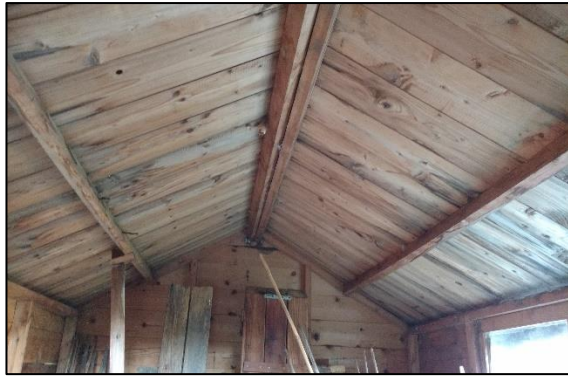
A wood panel shed with a pitched felt roof. The roofing felt was old but tightly fitted. The interior was composed of tightly-fitted wooden panels and no potential entry points were noted. No evidence of bats was found and the structure was assessed to hold negligible potential for bats. This structure is being retained within proposals.

Photo 8: B3 interior

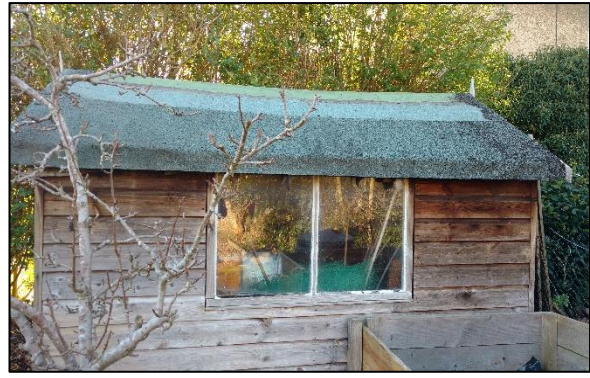
Photo 9: B3 Eastern elevation
