**3-5 Craven Road, Reading**

## **Bat Survey Report**

**10<sup>th</sup> October 2017**

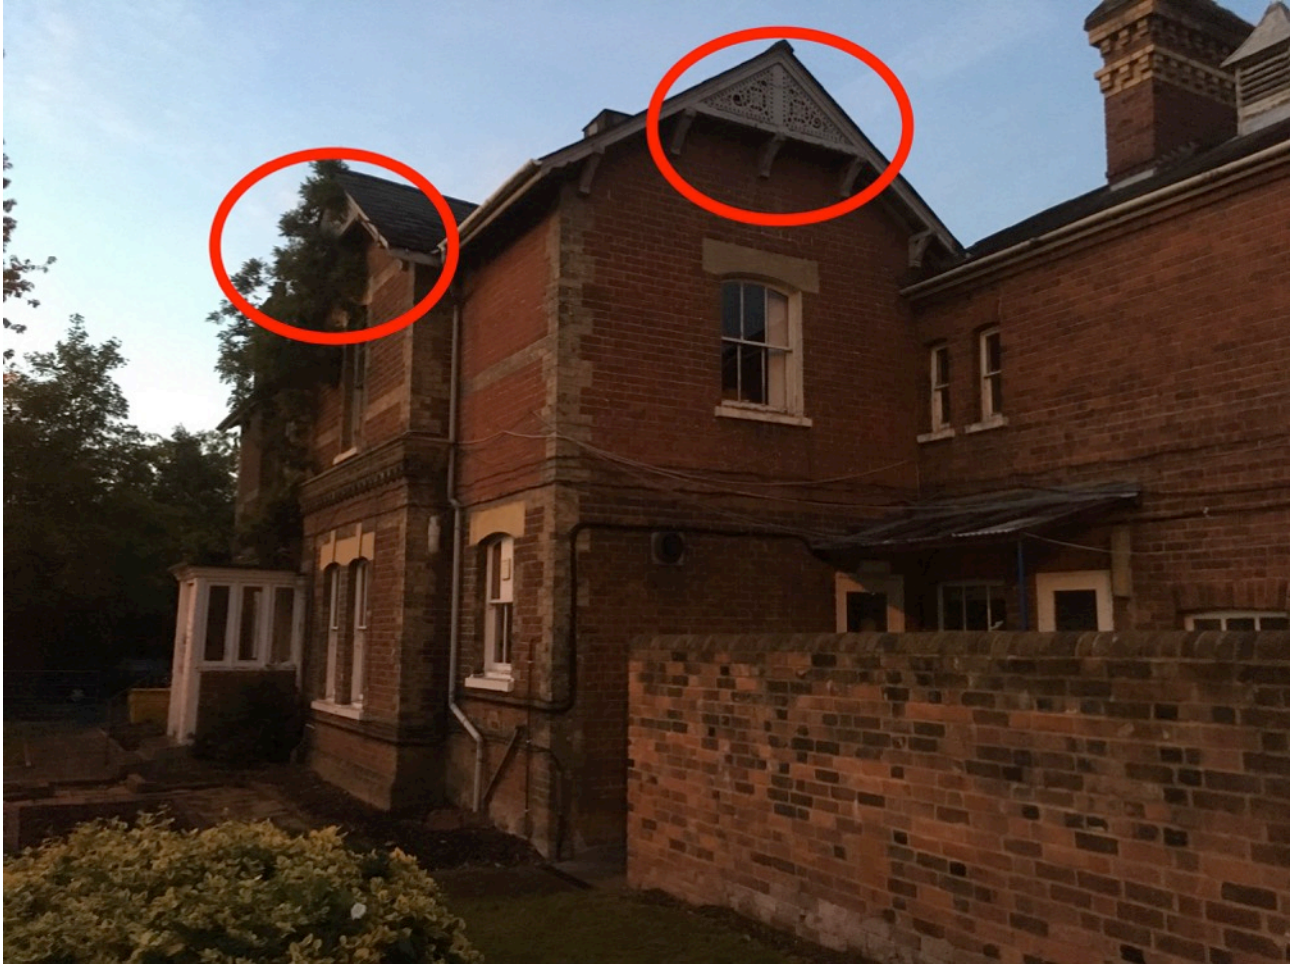
Appendix 1: Illustrating the areas to be carefully dismantled on a precautionary basis

Subsequently, the front gable of 3 Craven Road and the adjacent south-facing gable roof areas (since both locations are identified in the Innovation Group Environmental Services report) should be carefully dismantled under the supervision of a Natural England bat licence holder, from a Mobile Elevated Working Platform (MEWP) or scaffold. It is considered very unlikely that a bat will be present but if so, it will be captured by hand, placed inside a handling bag and relocated into one of the tree-mounted bat boxes that will already have been installed.
