**DEE PARK, READING, PHASE 2C**

**PRELIMINARY BAT ROOST  
ASSESSMENT**

Report No: RT-MME-124455-02

Date: March 2017

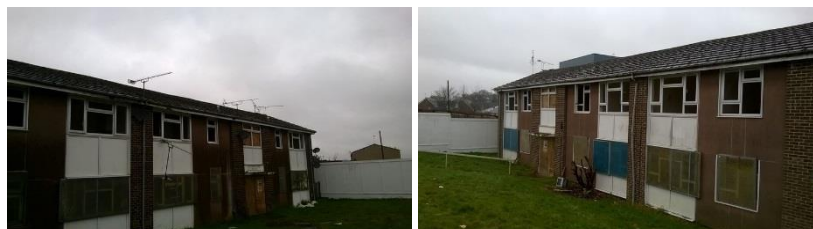
**Plate 4.1: View of Building 1 (Blocks 24 and 26).**

Building 1, was a two storey brick building with PVC and rendered walls (Plate 4.1). The building was in a moderate state of repair but some of the internal structure had been stripped and the glass panes of the windows either removed or boarded up. The building had a pitched slate tiled roof which was in a good state of repair with no missing, loose or misaligned tiles.

- Open windows (Plate 4.1 and 4.3)
- Broken ceiling (Plate 4.3)
- Gaps where the soffit has broken (Plate 4.2)

Buildings 1 and 3 have been identified as having moderate potential to support roosting bats. Bat Surveys: Good Practice Guidelines published by the Bat Conservation Trust (Collins, 2016) recommends that for structures with moderate bat roosting potential two separate survey visits (consisting of one dusk emergence and a separate dawn re-entry survey) be undertaken during the bat emergence/re-entry survey season to determine the presence/absence of roosting bats within the structures. The bat emergence/re-entry survey season extends from May to September. At least one of the surveys should be undertaken during the peak season for emergence/re-entry surveys between May and August.

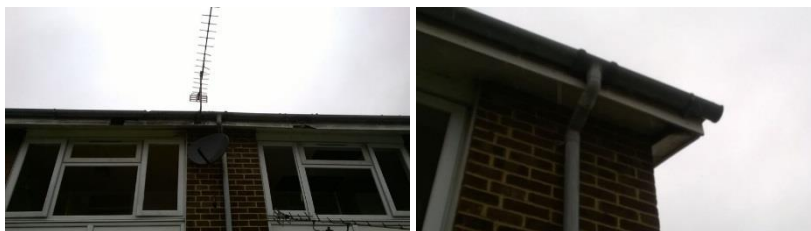
**Plate 4.2: Gaps were Present where the Soffits of Building 1 were Broken.**

There were a number of gaps where the wooden soffits had been broken allowing access to bats into potential roosting spaces (Plate 4.2). It was not possible to inspect these areas due to the height at which they were located and therefore their roosting potential could not be determined at the time of survey.

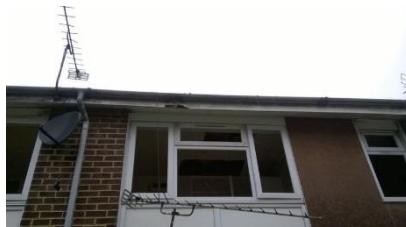
**Plate 4.3: Broken Ceiling of Building 1.**

The open windows allowed direct access into the building by bats which may use the open rooms for foraging. No evidence of bats such as droppings and feeding remains were found within the building. One area of the ceiling was broken allowing direct access into the loft space from nearby open windows (Plate 4.3).

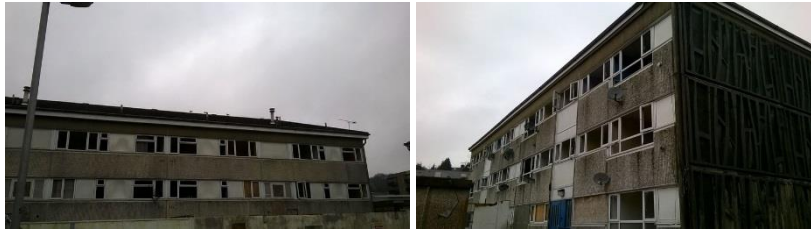
**Plate 4.5: View of Buildings 2 and 3 Respectively.**

Buildings 2 and 3, were three storey brick buildings with concrete and stone rendering (Plate 4.5). The buildings were in a moderate state of repair but some of the internal structure had been stripped and the glass panes of the windows either removed or boarded up. The buildings had pitched slate tiled roofs which were in a good state of repair with no missing, loose or misaligned tiles.

- Open windows (4.5).
- Gaps where the soffit has broken in Building 3 (Plate 4.6).

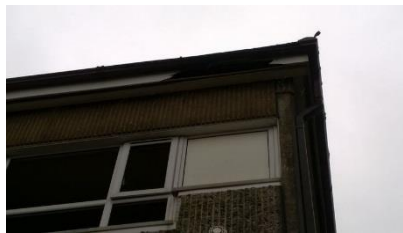
**Plate 4.6: Broken Soffit of Building 3 (Block 12).**

There was a large gap in the soffit of Building 3 (Block 12) allowing access to bats into potential roosting spaces (Plate 4.6). It was not possible to inspect this area due to the height at which it was located and therefore its roosting potential could not be determined at the time of survey.

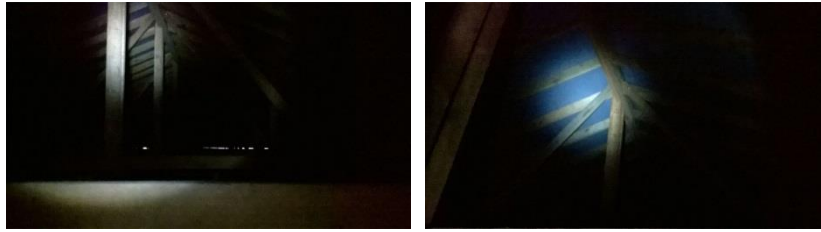
**Plate 4.8: Access into Building 3.**

Light was seen coming in from the top of the soffits in Building 3, allowing access for bats into the internal loft space (Plate 4.8).

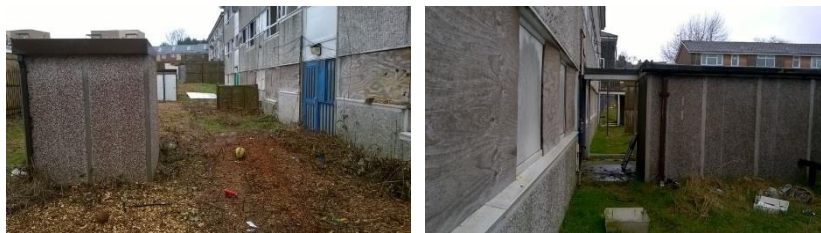
**Plate 4.9: View of the Outbuildings.**

Each of the blocks had a single storey concrete outbuilding used for storage (Plate 4.9). The outbuildings all had a flat felt roof which was in a good state of repair. Each of the buildings was fully assessed and no evidence of bats, e.g. droppings, urine staining, feeding remains or scratch marks, was recorded and no potential roosting features were identified.

The outbuildings onsite were fully inspected and no bat roosts were identified. These buildings had no potential for roosting bats. The survey data obtained for the site is valid for 12 months from the survey date. If development works to the surveyed structure have not commenced within this timeframe it will be essential to update the survey effort to establish if bats have colonised the structures in the interim. In the unlikely event that a bat is found during demolition works all works must immediately cease and a suitably qualified ecologist should be contacted.

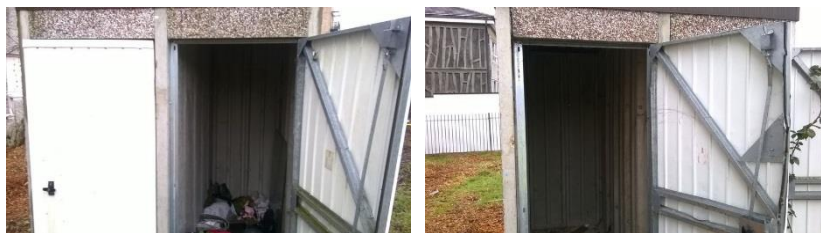
**Plate 4.10: Internal View of the Outbuildings.**

Internally, the outbuildings had no roof void (Plate 4.10). The internal spaces could be fully assessed and no evidence of bats, e.g. droppings, urine staining, feeding remains or scratch marks, was recorded.
