## **PRELIMINARY ECOLOGICAL APPRAISAL (BATS) AT 63 ALLCROFT ROAD READING**

**Prepared for:  
Mr & Mrs D S Mann  
63 Allcroft Road  
Reading  
RG1 5HN**

**22<sup>nd</sup> July 2017**

**Ref: SH/PEA-01/21.07**

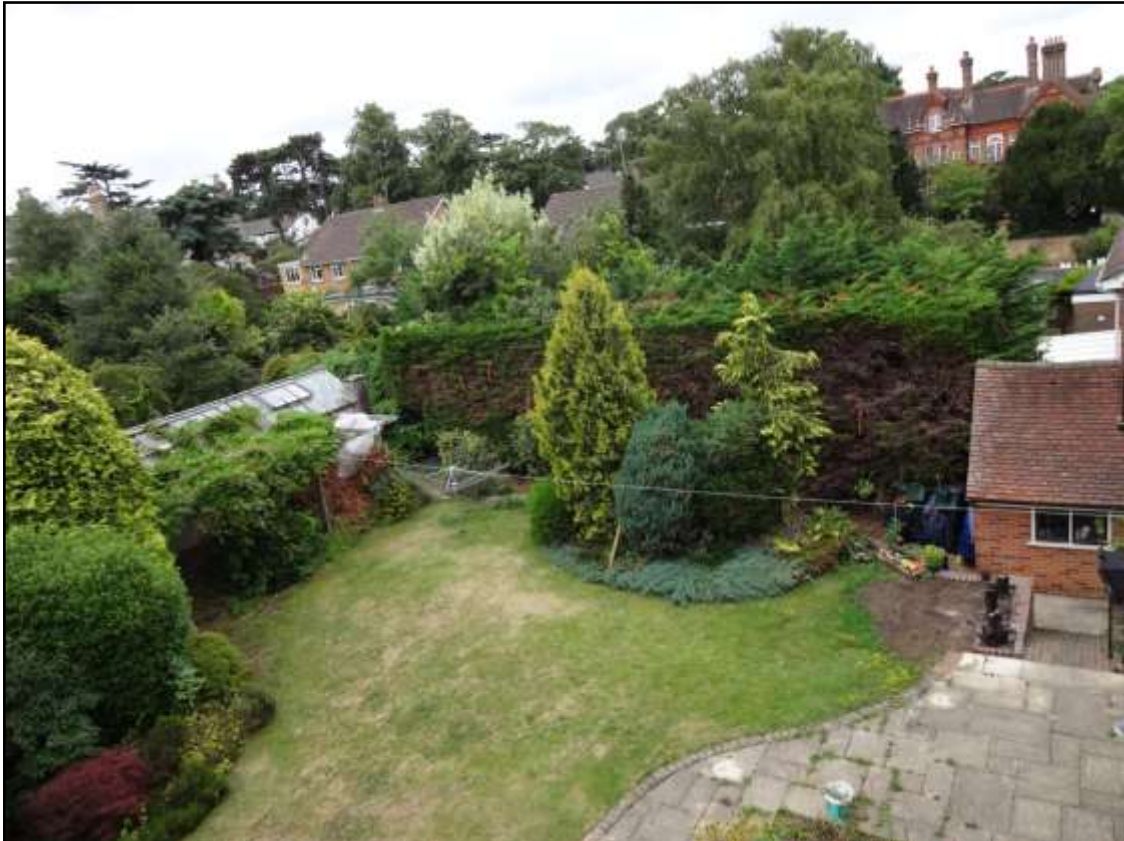
Figure 3. Rear garden at 63 Allcroft Road.

The application site comprises a two storey detached, brick property with a complex pitched roof design together with a detached brick built garage on the west of the house. The property is set close to central Reading. The garden and surrounding habitat consists of lawns and mature trees and bushes, see Figure 3.

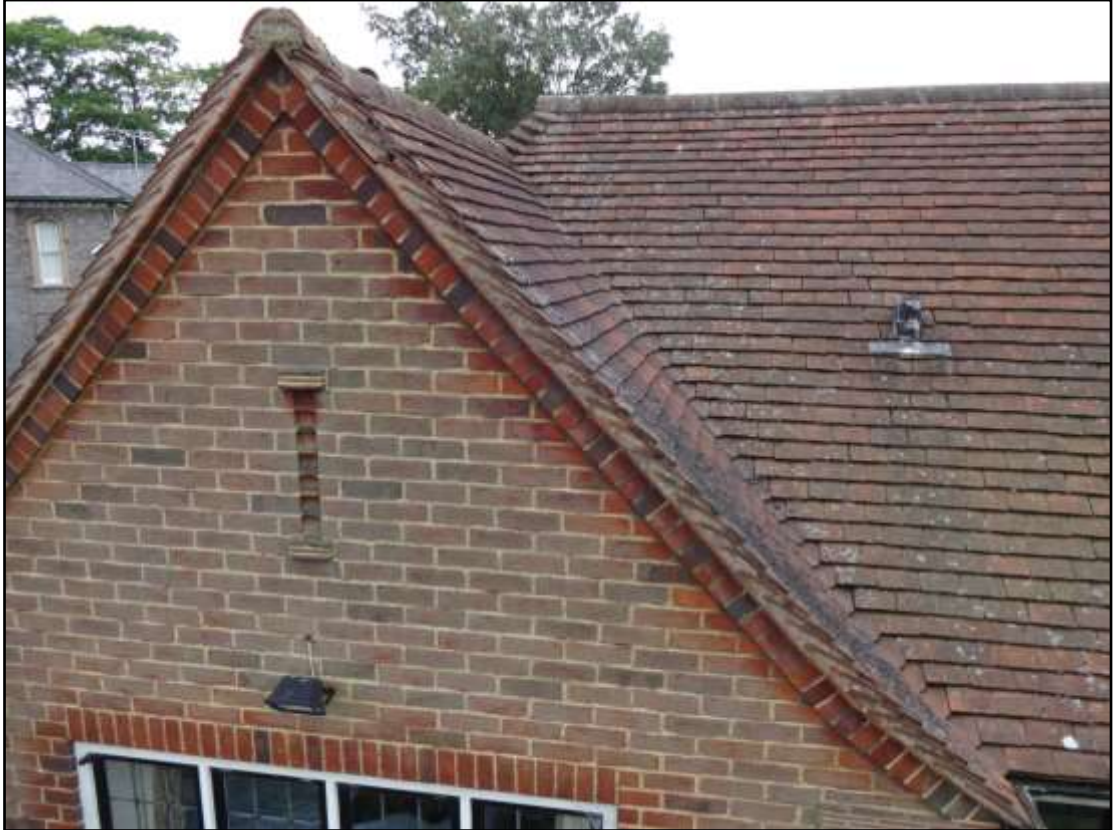
Figure 4. Example of roof verges and ridge at 63 Allcroft Road. 21.7.17

The property is of a standard brick construction with a traditional pitched roof which is in good condition. The house roof is covered with close fitting clay tiles with only one broken tile and the ridges and hips are in good condition with no gaps along the verges, see Figure 4. The garage roof has some gaps in tiles towards the front of the building, see Figure 5, which were examined using the endoscope. The roof line comprises several parts, see Figure 6.

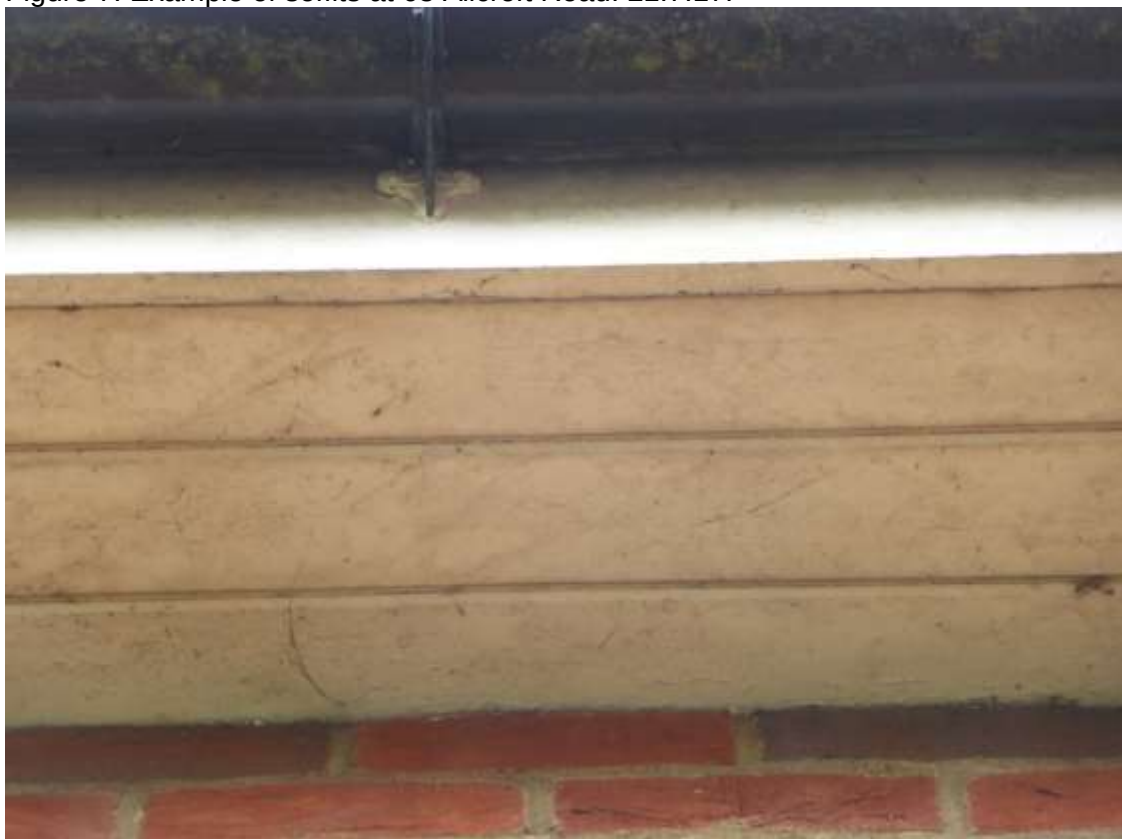
Figure 7. Example of soffits at 63 Allcroft Road. 21.7.17.

The wooden fascias and soffits on both rooves are close fitting with no gaps for bats to access, see Figure 7. No evidence of bats was recorded during the external inspection of the building.

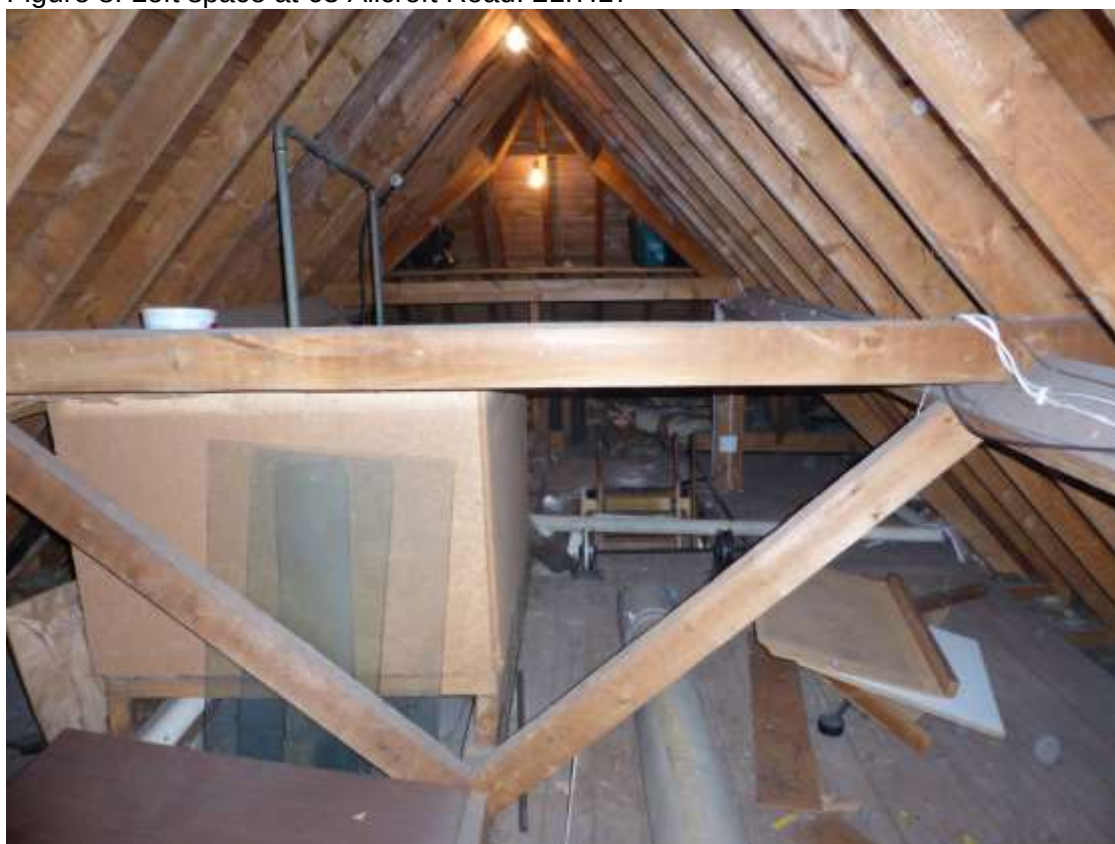
Figure 8. Loft space at 63 Allcroft Road. 21.7.17

The loft is large, partly boarded and partly lit, see Figures 8 & 9. The tiles are lined with sarking boards and are in good condition.

There was no evidence of bat droppings on the brick work on the beams, wall plate or on the flooring and no bats were observed.

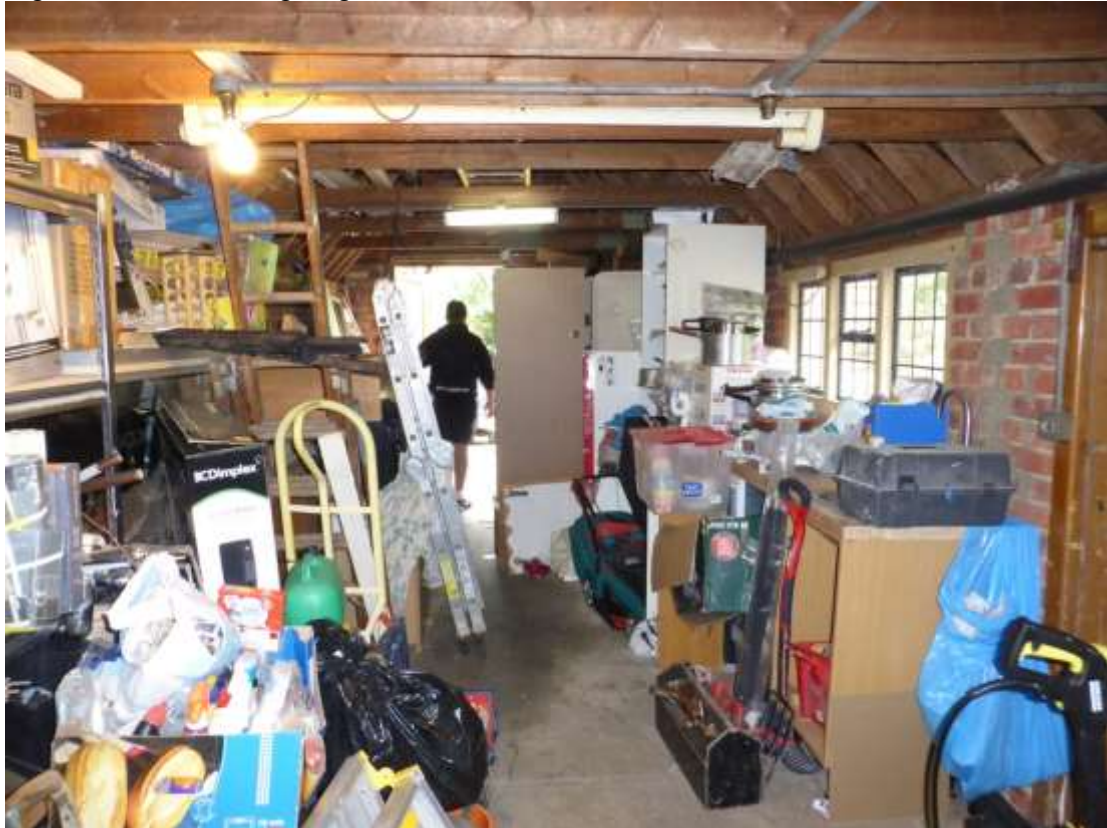
Figure 10. Interior of garage at 63 Allcroft Road. 21.7.17

The garage is in good condition and well lit, see Figures 10 & 11. The tiles are lined with bitumen felt which is in good condition. The gaps in the tiles were inspected with an endoscope but no evidence of bats was found, see Figure 12.

There was no evidence of bat droppings on the brick work on the beams, wall plate or on the flooring and no bats were observed.
