# Remediation Verification Report

## Armour Road, Tilehurst, Reading

Report Reference: **BRD210736-OR3-A**

Date: **January 2018**

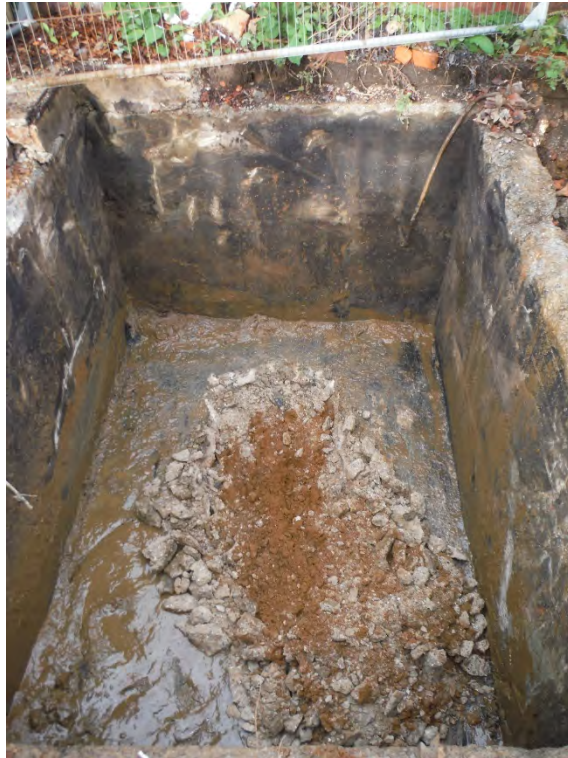
Plate 1: Waste oil tank concrete chamber following removal of tank. Concrete base broken out and underlying soils exposed.

- The internal walls of structure were thoroughly cleaned, removing all evidence of oil staining.
- The base of the structure was broken out using a hydraulic breaker to allow for the infiltration of water.
- A hand dug pit was then excavated below the base of the structure followed by confirmatory sampling of the soils to determine if any contamination present.

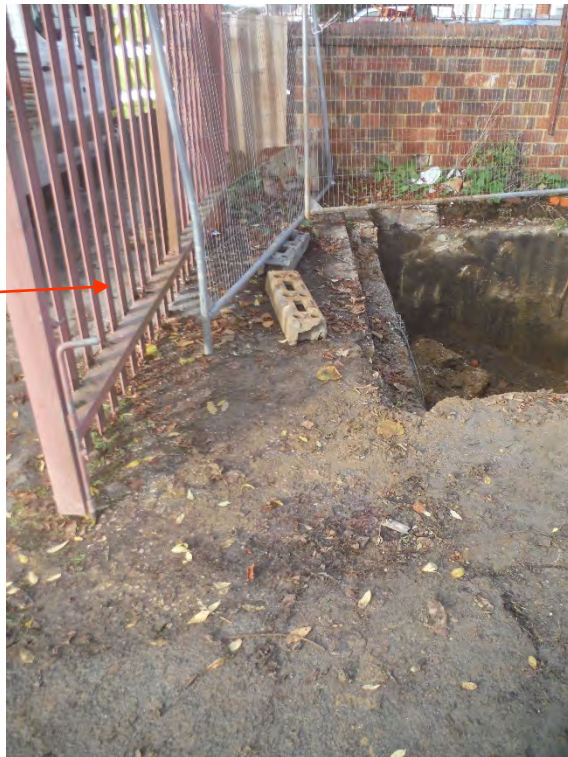
Plate 2: Photograph showing proximity of concrete chamber to site boundary and public footpath.

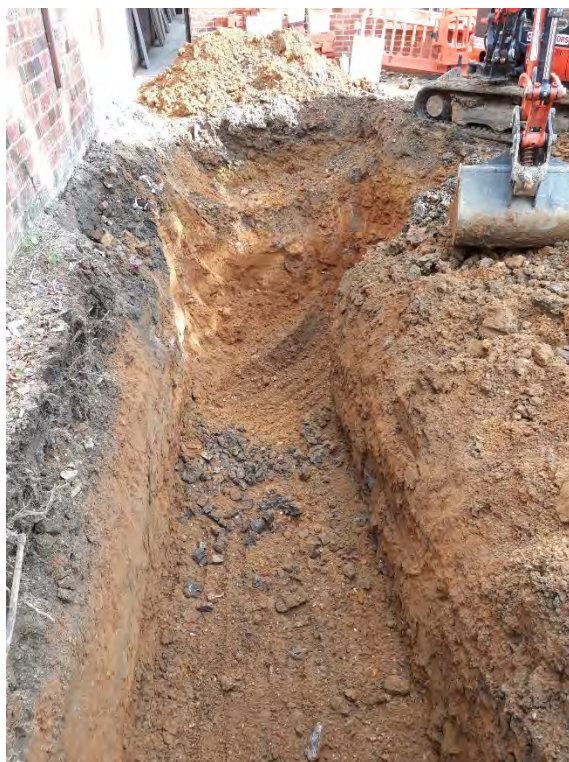
Plate 3: Excavation of contaminated soils adjacent to boundary wall looking north east.

| <b>EXCAVATION WORKS</b> | <p>The contamination had been identified as a distinct layer of hydrocarbon stained soils at a depth ranging from 0.6m to &gt;2.7m bgl in trial pits TP04, TP07 and TP08. The surrounding exploratory holes encountered no contamination.</p> <p>The excavation and removal works were completed using both visual identification of contaminated soils as well as the use of a PID.</p> <p>Due to limited space for stockpiling and the proximity of the adjacent boundary wall, the excavation works were completed over two days.</p> <p><u>Day 1 – 18.9.2017</u></p> <p>On the first day of works, soils adjacent to the boundary wall were excavated to a depth of approximately 2.0m bgl and until the soils displayed no evidence of contamination both visually and through the use of the PID. These contaminated soils were then stockpiled and removed from site by a grab lorry.</p> <p>This section of the excavation was then backfilled with lean mix concrete so as to prevent collapse of the adjacent boundary wall, which was then left to harden over the next 24 hours before the remainder of the contaminated soils could be removed.</p> <p><u>Day 2 – 20.9.2017</u></p> <p>On the second day of works the remainder of the contaminated soils were excavated and removed from site with excavation continuing to a maximum depth of 2.9m bgl. These contaminated soils were also then stockpiled and removed from site by a grab lorry.</p> |

| <b>OBSERVATIONS</b> | <p>During the excavation works the most significant hydrocarbon staining and odours were located surrounding underground pipework in the location of Trial Pit TP08, with only limited staining and odours adjacent to the tank structure.</p> <p>It is considered that a leak from the pipework was the most likely cause of the soil contamination.</p> |

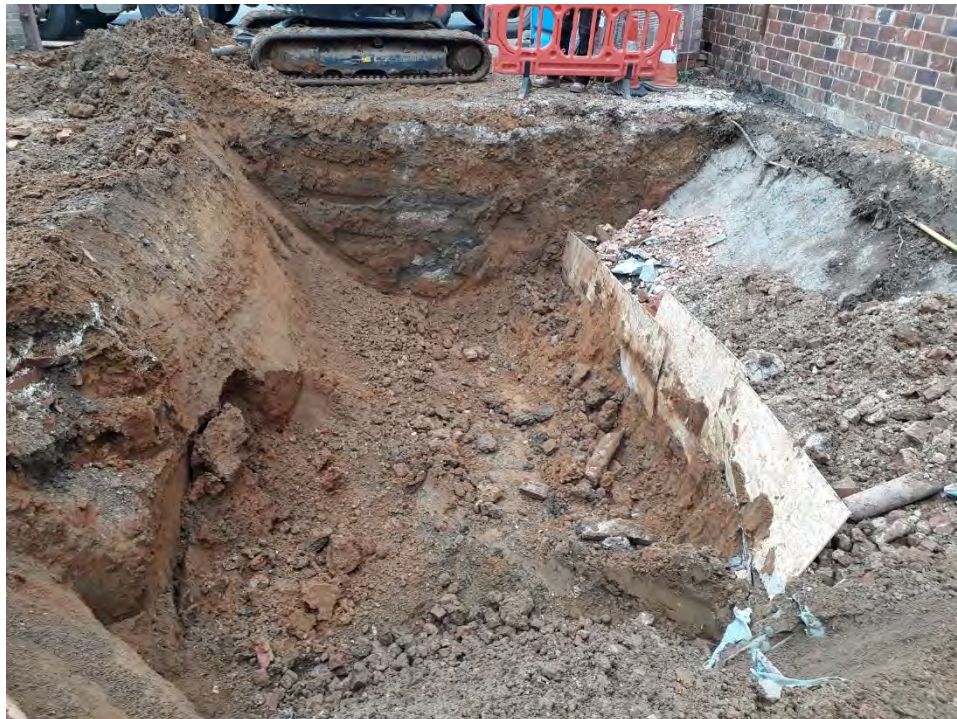
Plate 4: Photograph of completed excavation looking south west.

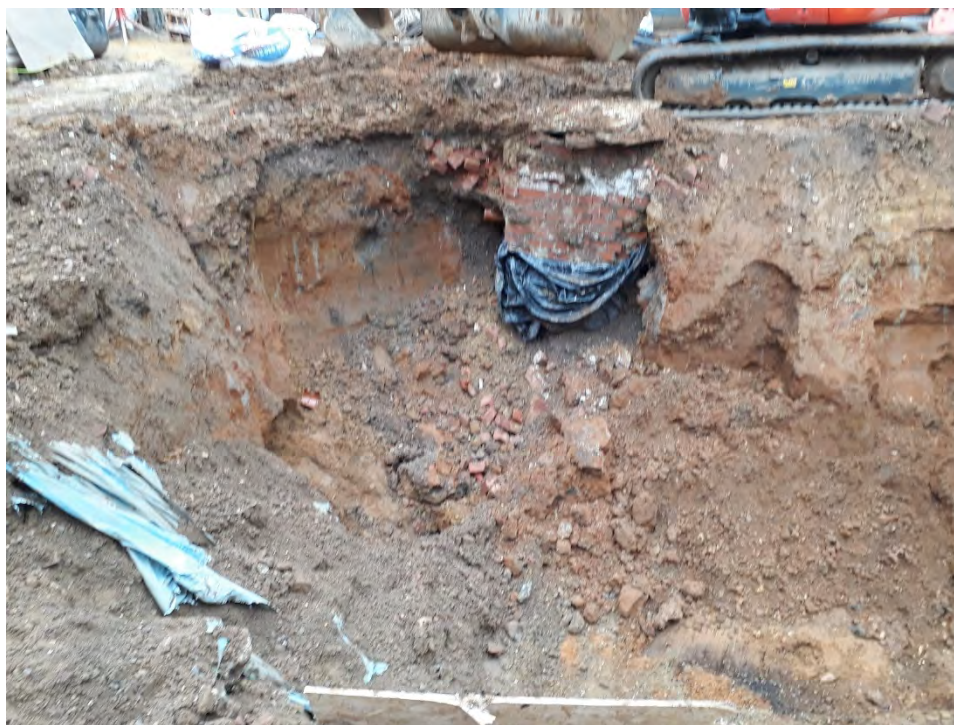
Plate 5: Photograph of excavation - Face (F3)

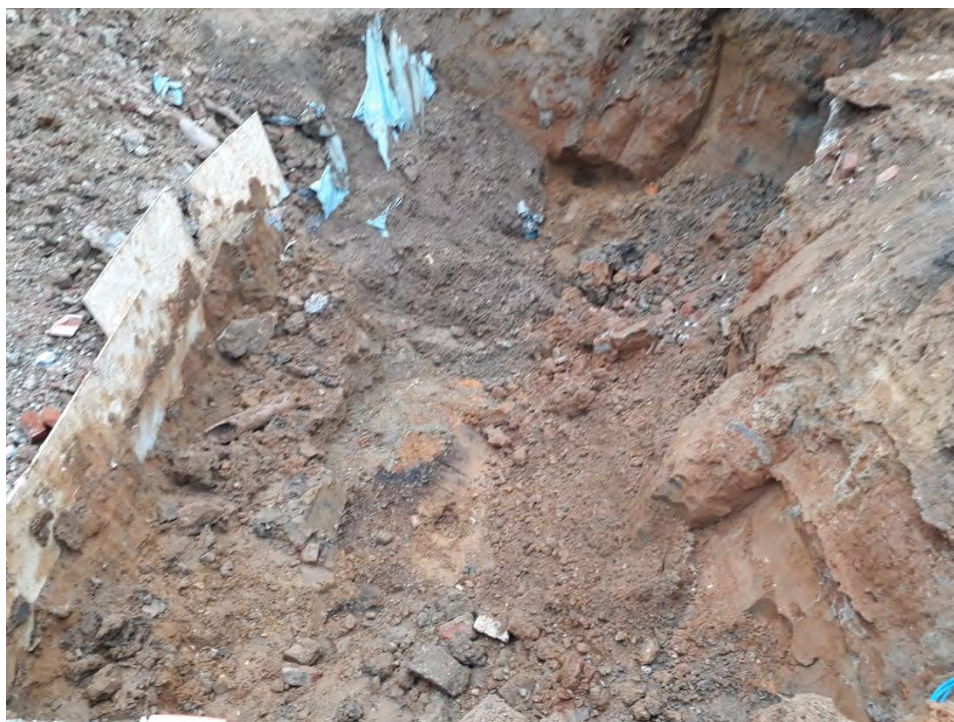
Plate 6: Photograph of excavation looking north east

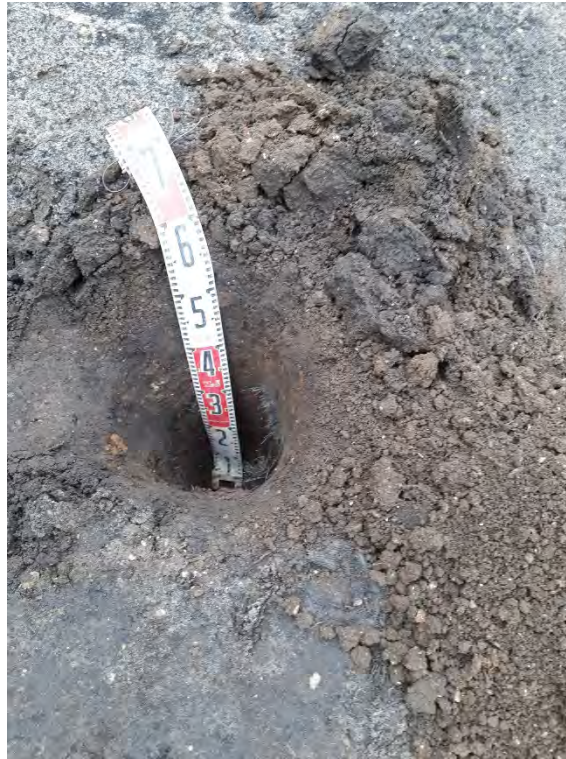
Plate 7: Hand dug pit HD01 confirming placement of 600mm of capping in Plot 4.

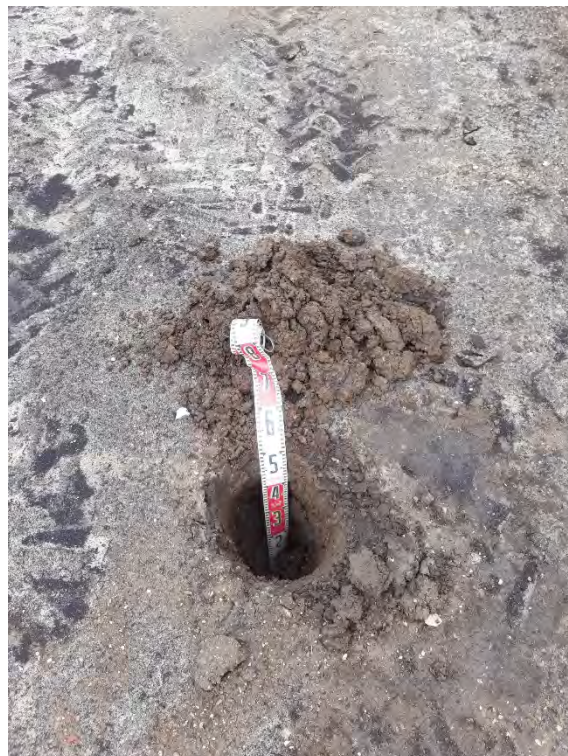
Plate 8: Hand dug pit HD02 confirming placement of 600mm of capping in Plot 4

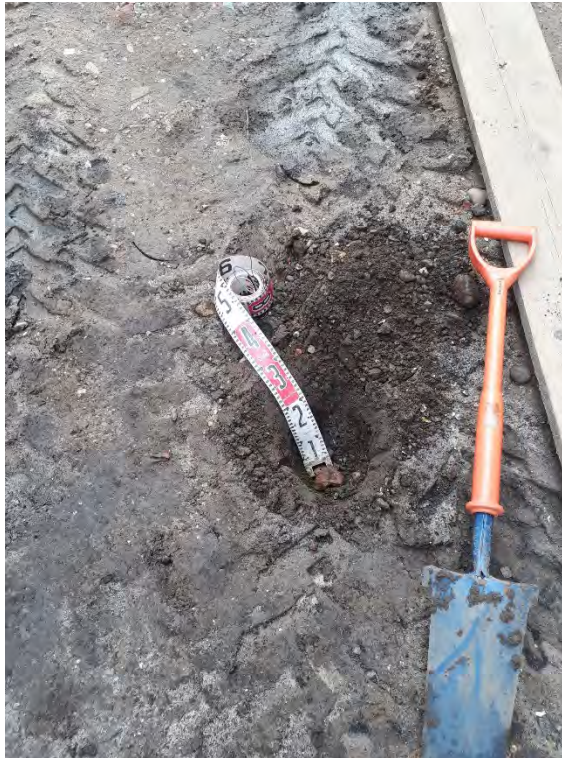
Plate 9: Hand dug pit HD03 undertaken in Plot 2 / 3, confirming 300mm of capping.

The samples of the exposed soils in the landscaping areas of Plots 1-3 (inclusive) have not recorded any elevated concentrations of contaminants. It is therefore concluded that the shallower capping layer of 300mm of imported topsoil is acceptable as the underlying soils are uncontaminated. It should also be noted that these areas will be typically used for decorative purposes only given their small size and unlikely to be used for growing vegetables. The potential for any direct contact with the underlying soils below the 300mm imported topsoil is therefore significantly reduced.

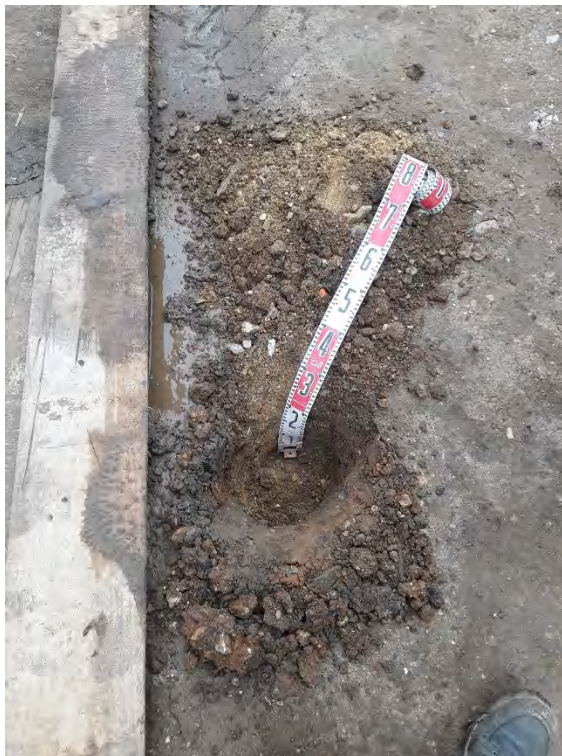
Plate 10: Hand dug pit HD04 undertaken in Plot 1, confirming 300mm of capping

Hand dug pit HD04 was undertaken in the landscaping at the front of Plot 1 which was also the location of the former substation. The soils encountered were described as 'Firm orange brown very gravelly clay. Gravel is fine to coarse subangular to subrounded flint and brick' and no visual evidence of contamination was observed within these soils.

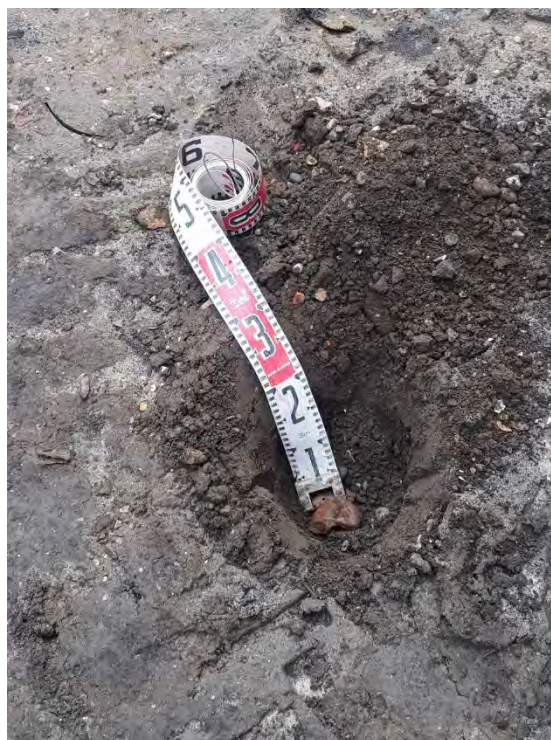
Plate 11: Hand dug pit HD05 undertaken in Plot 3, confirming 300mm of capping.

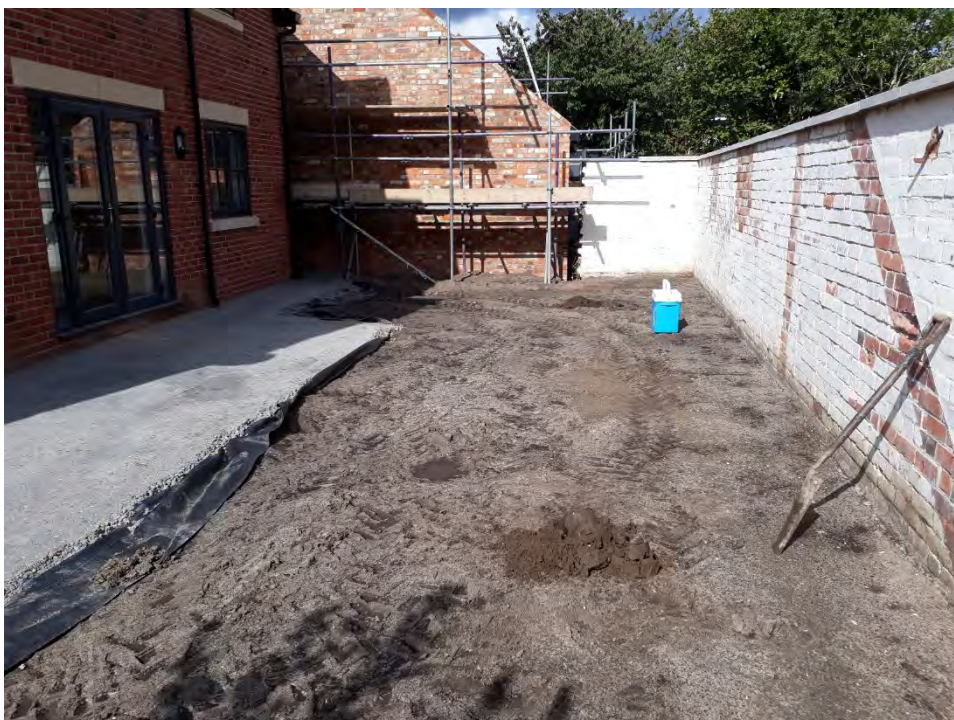
Plate 12: view of the finished garden Plot 4.

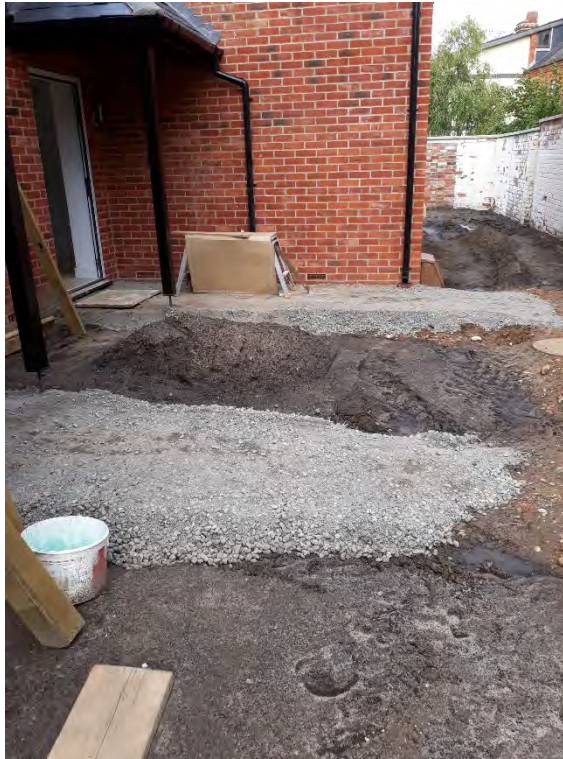
Plate 13: Front garden of Plot 3.

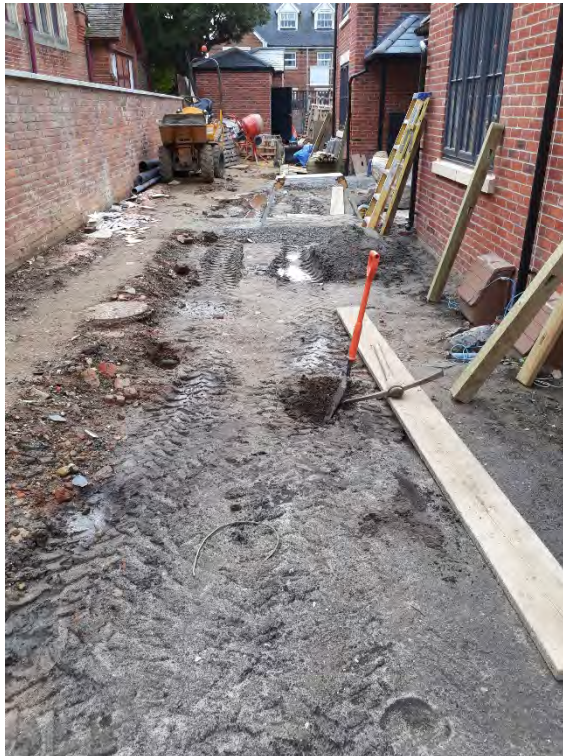
Plate 14: Photograph showing garden areas of Plots 1-3 (inclusive).

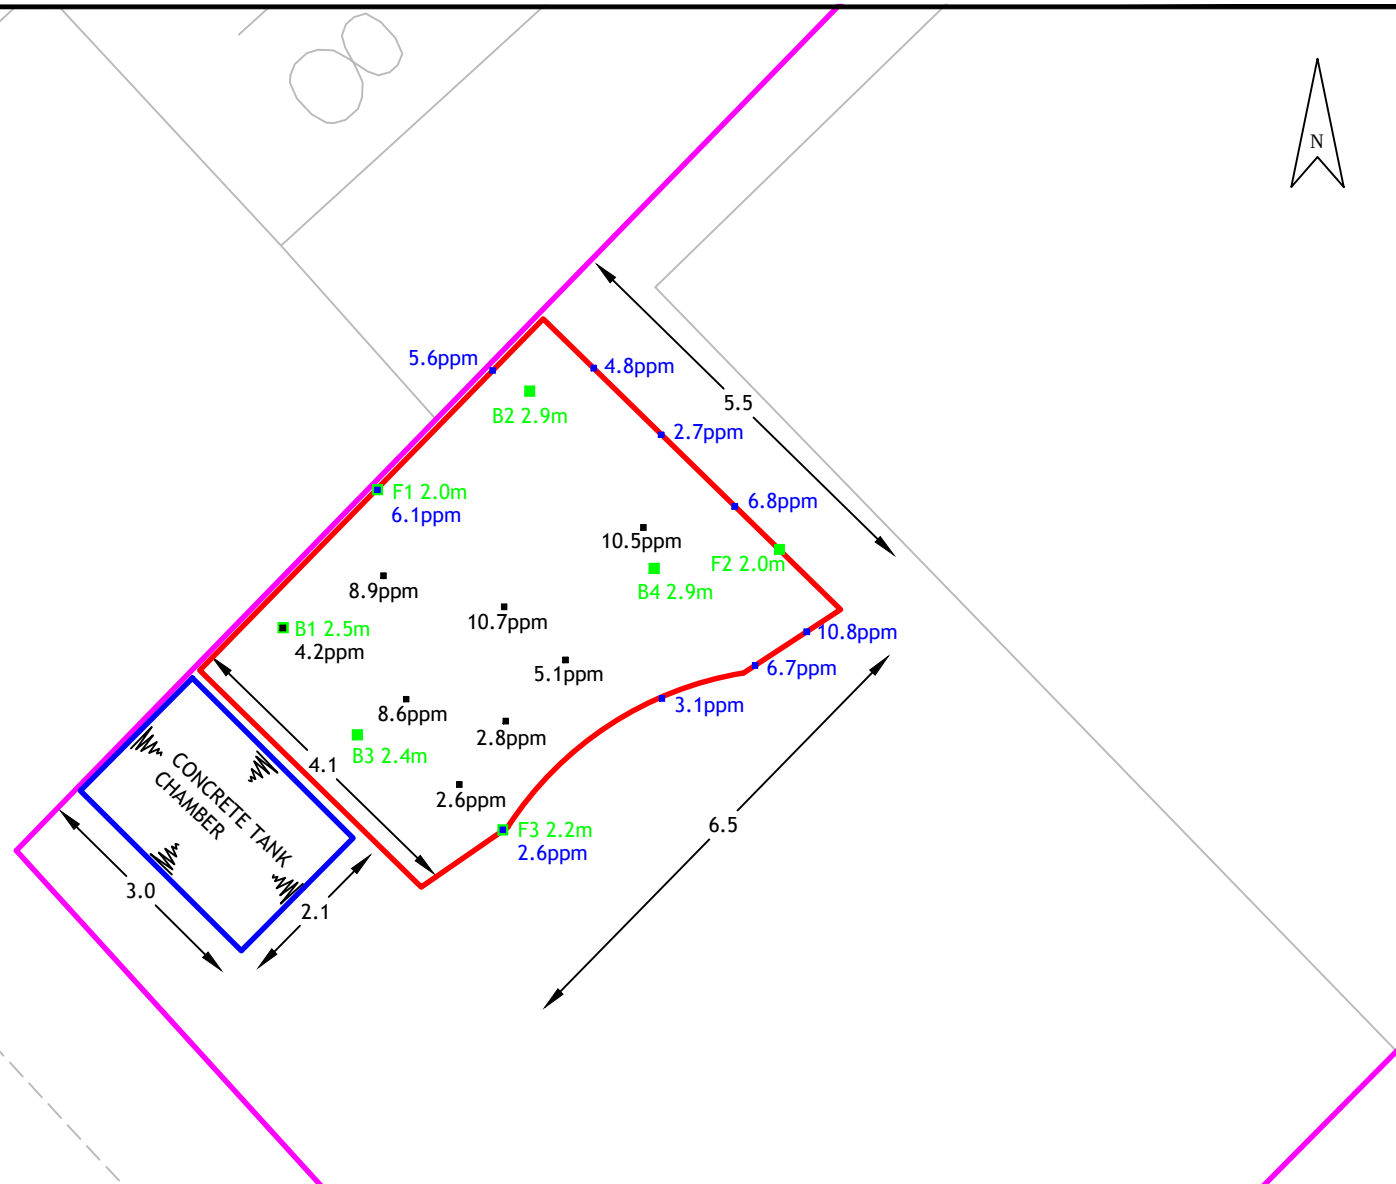
| Project title<br><b>ARMOUR ROAD, READING</b> | | | Drawing title<br><br><b>REMEDATION EXCAVATION PLAN</b> | |

The location of the contamination excavation and concrete chamber have been positioned by tape measurement.

The location of the verification samples and PID measurements are approximate.

Location of  
excavated  
hydrocarbon  
contamination

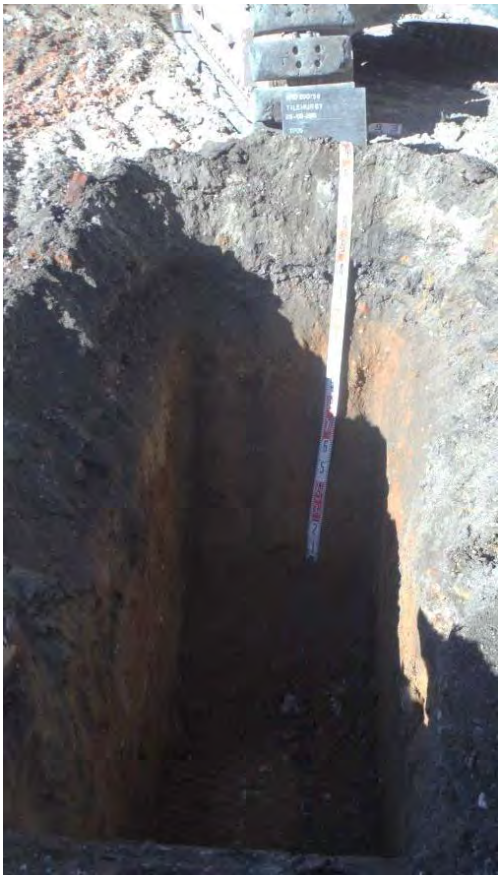
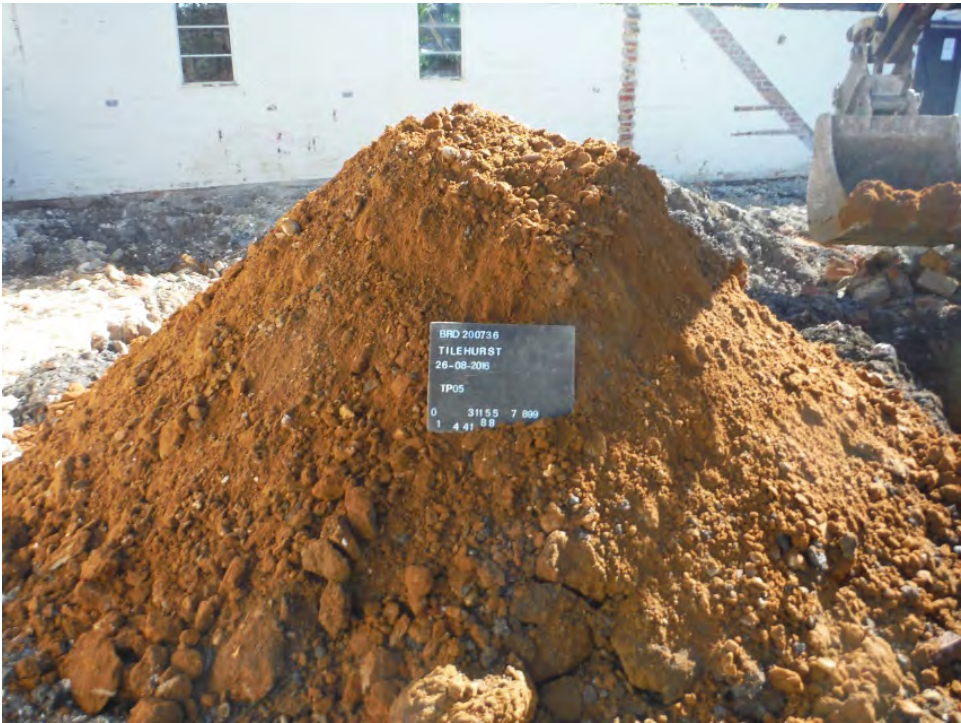
In trial pit TP05 at the rear of the site the near surface Made Ground was encountered to a depth of 0.5m bgl and was typically described as 'Loose, black gravelly, ashy sand. Gravel of medium to coarse, subangular to angular brick, clinker, ceramic and glass with occasional metal'.

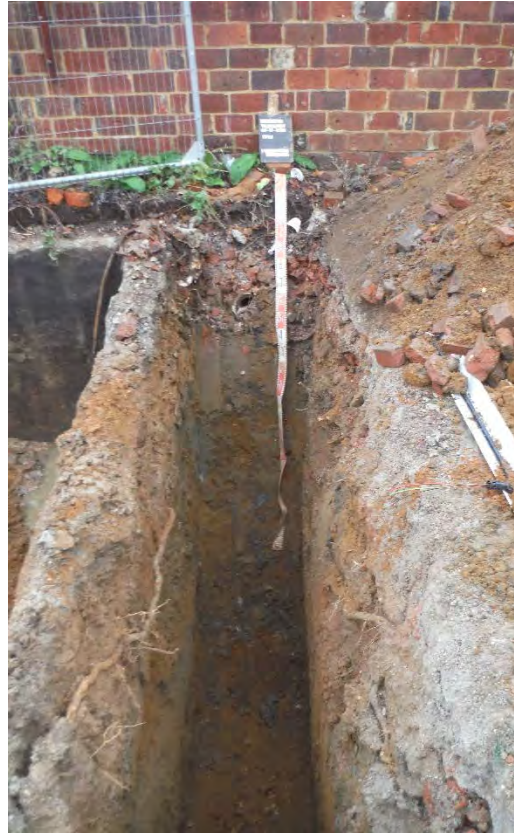
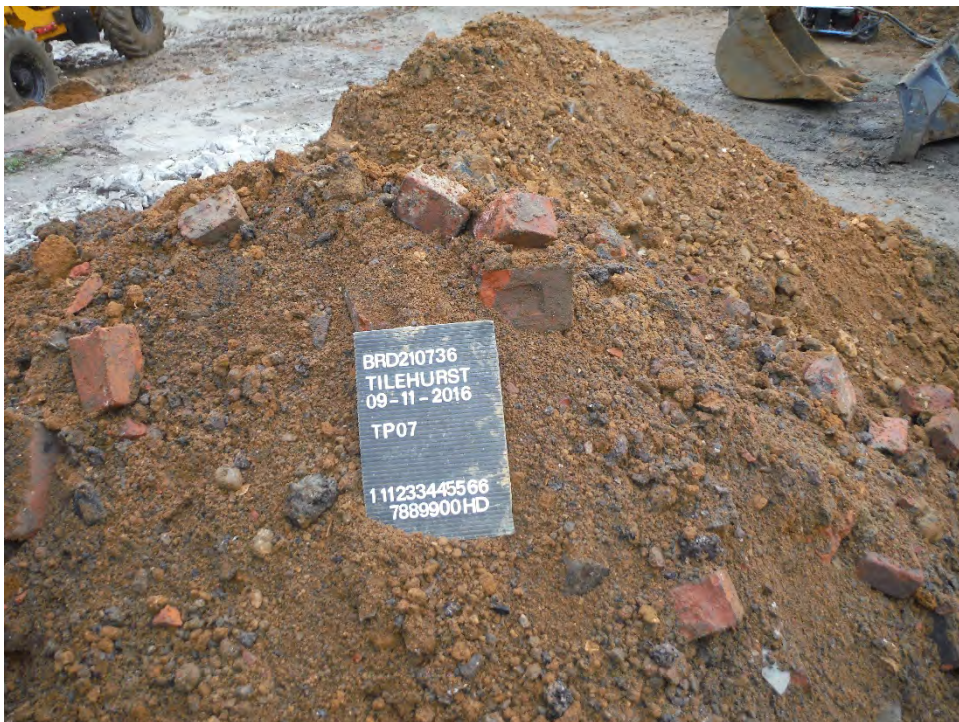
In the trial pits TP07 to TP08 at the site around the waste oil tank the Made Ground was proven to a maximum depth of 0.8m bgl and was typically described as 'Loose to medium dense, slightly clayey, sandy gravel. Gravel is medium to coarse with cobbles, subangular to subrounded flint, concrete, brick with half and whole bricks'.

In trial pits TP07 and TP08 hydrocarbon staining and odours were encountered at depths ranging from 0.6m bgl to 2.5m bgl. The presence of contamination from 0.6m bgl suggests that the cause of the leak was faulty pipe work rather than from the base of the underground tank. No contamination was identified in trial pit TP09 and TP10 confirming the hydrocarbon contamination to be isolated to the south western corner of the site.

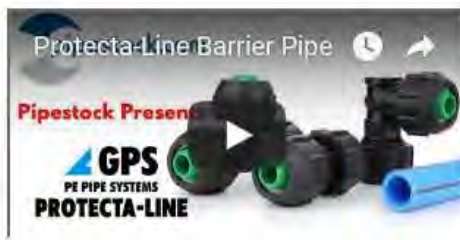
## *Key Features / Tech Specs:*

- Award-winning, multi-layer barrier pipe
- Material: polyethylene inner and outer core, aluminium inner barrier layer
- Suitable for use in contaminated brownfield site
- Lightweight and flexible
- Quick and easy to install
- WRAS approved (complete system approval)
- Pipe conforms to BS 6572 or WIS 4-32-17 / BS EN 12201
