**Bat Survey Report for  
Riverside Dental Practice,  
20 Bridge Street,  
Caversham,  
Reading, RG4 8AA**

**NKM Associates**

**9<sup>th</sup> May 2017**

**Report Number: 21017 – 01 NKM Assoc**

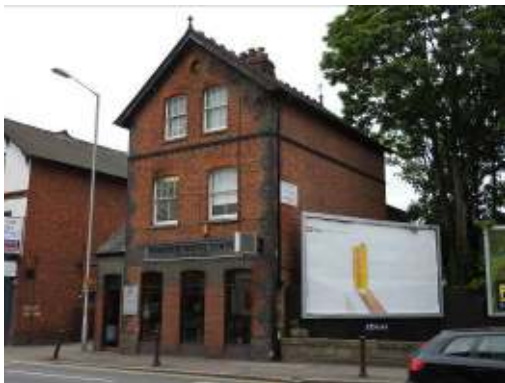
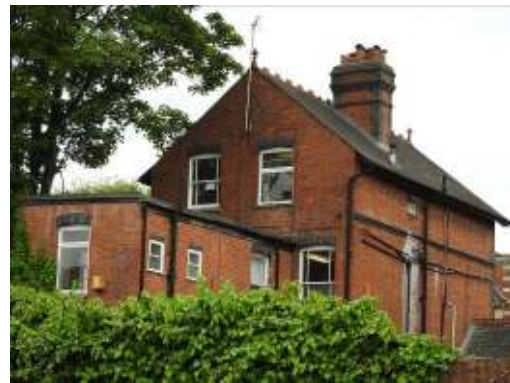
The survey site comprised a detached pitched roofed building with a flat roofed extension to the rear (Figs. 1 and 2).

**Figs. 1 & 2 Front and rear views of the building**

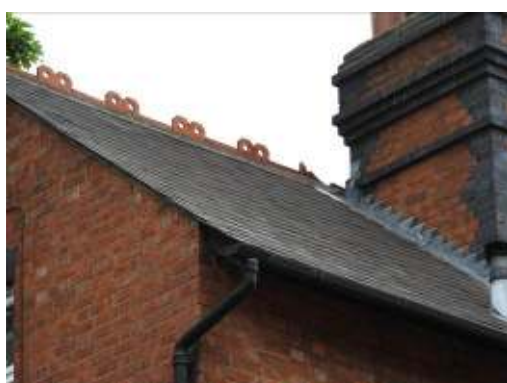
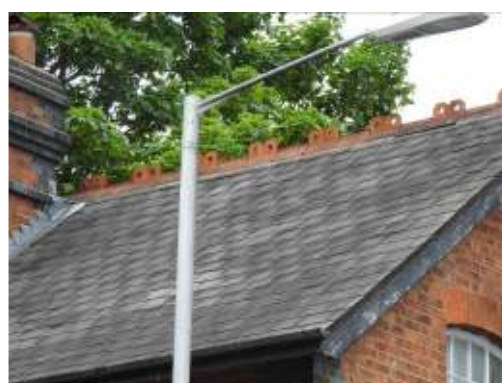
The decorative ridge of the pitched roof was fully intact and sealed with no gaps or crevices the ridge tiles observed. All the roof slate tiles were tightly overlapping with none broken, dislodged or missing (Figs. 6- 9).

**Figs. 6 & 7 Ridge and roof tiles to the south**

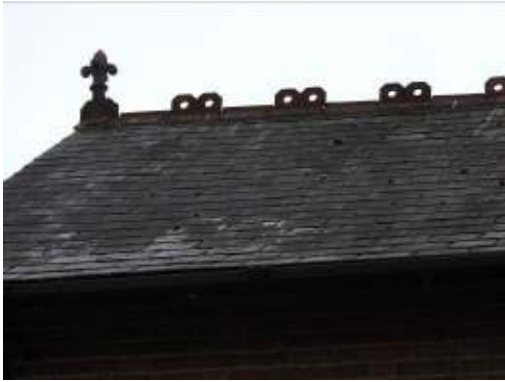
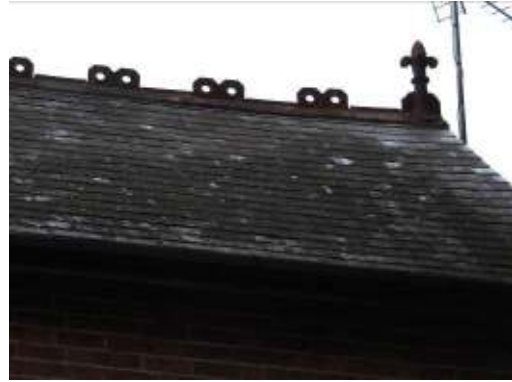
**Figs. 8 & 9 Ridge and roof tiles to the north**

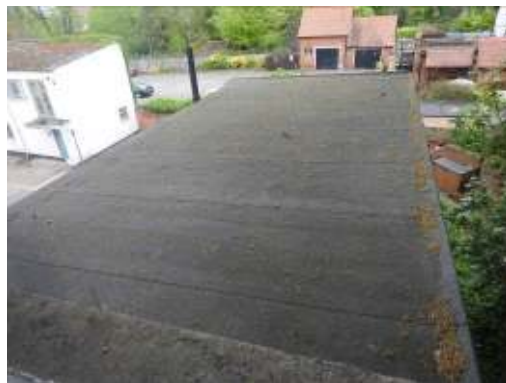
The flat roof was finished with tarred felt in good condition with no holes or tears (Fig. 10).

**Fig. 10 Sealed flat roof**

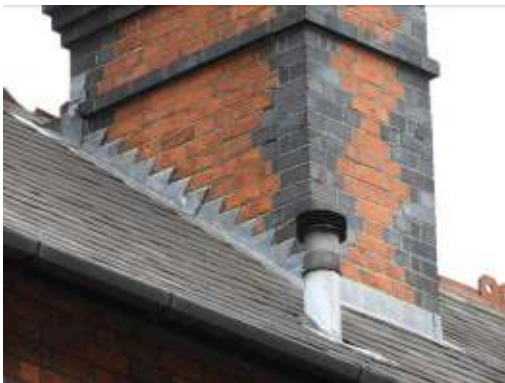
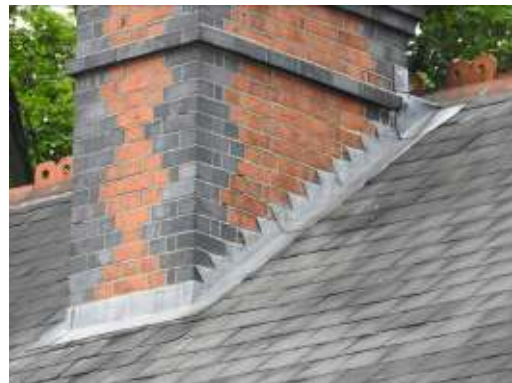
The chimney was finished with tightly moulded lead flashing all round (Figs. 11 and 12).

**Figs. 11 & 12 Tightly moulded lead flashing**

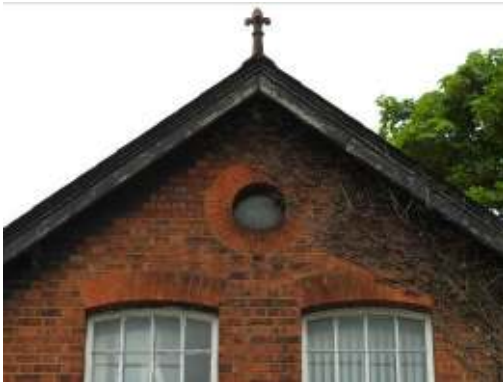
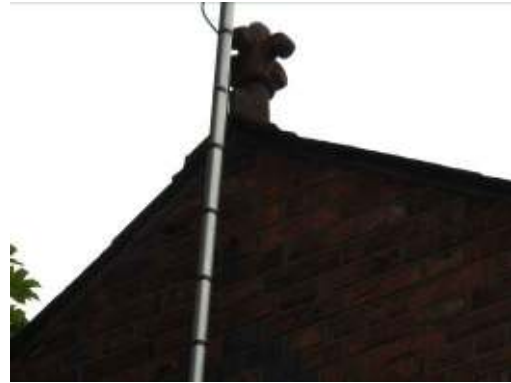
The gable to the front was finished with the roof ends cement sealed to the wooden barge board, the roof was tightly fitting against the gable wall plate; the gable to the rear was finished with the roof ends cement sealed to the wooden fascia boards (Figs. 13 and 14).

**Figs. 13 & 14 Sealed gables**

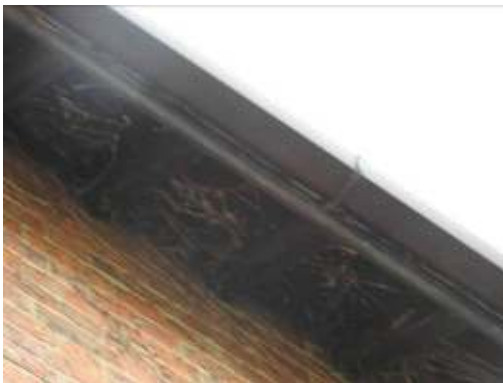
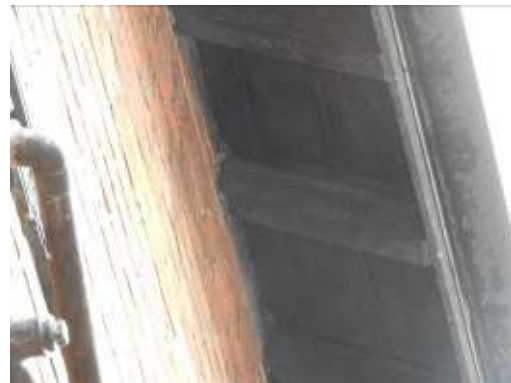
The eaves of the pitched roof were finished with the roof verge tightly fitting against the wall plates all round (Figs. 15 and 16).

**Figs. 15 & 16 Sealed pitched roofed eaves**

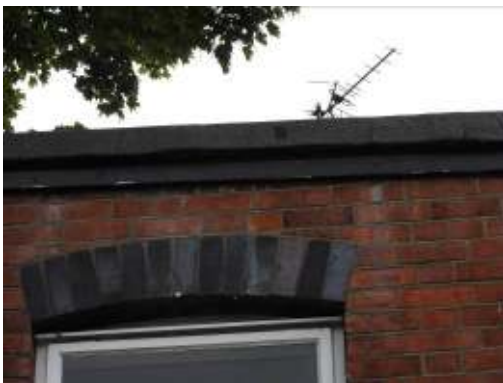
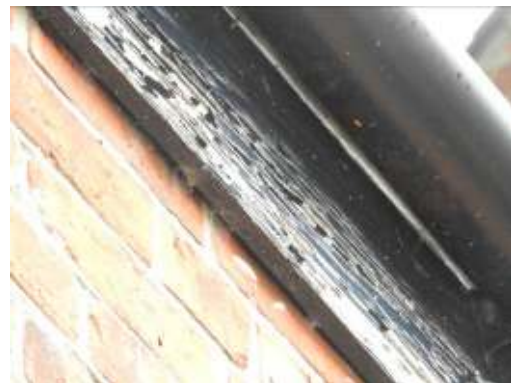
The eaves of the flat roof were finished with the tarred felt folded over the roof edge and sealed to the wooden fascia boards (Figs. 17 and 18).

**Figs. 17 & 18 Sealed eaves of the flat roof**

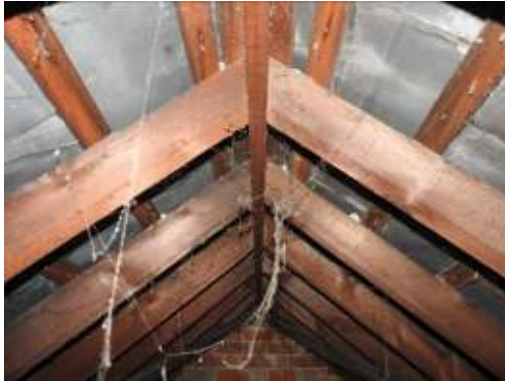
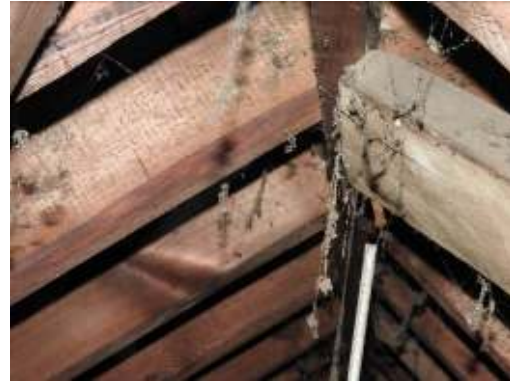
Internally the roof void of the pitched roof was unlined and heavily cobwebbed, vertical cobwebs were observed (Figs. 19 – 22).

**Figs. 19 & 20 Heavily cobwebbed ridge**

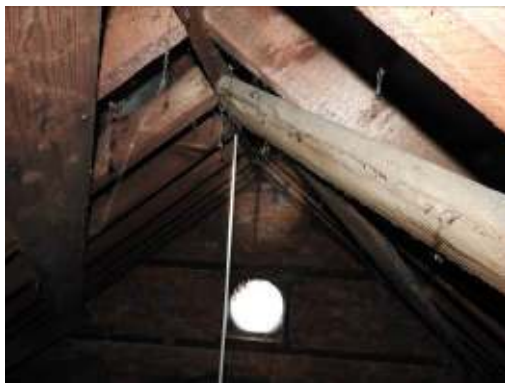
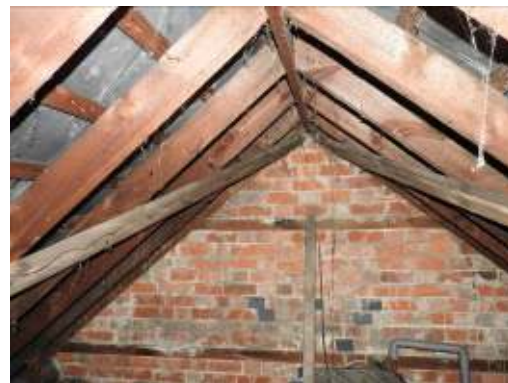
**Figs. 21 & 22 Cobwebbed gable ends**

Light penetrated the roof void through the round window in the front gable wall (Ref. Fig. 21).
