**Bat Building Assessment**

**39 Brunswick Hill**

**Reading**

| <b>Document ref:</b> | ARB1079 39 Brunswick Hill Bat Building Assessment |

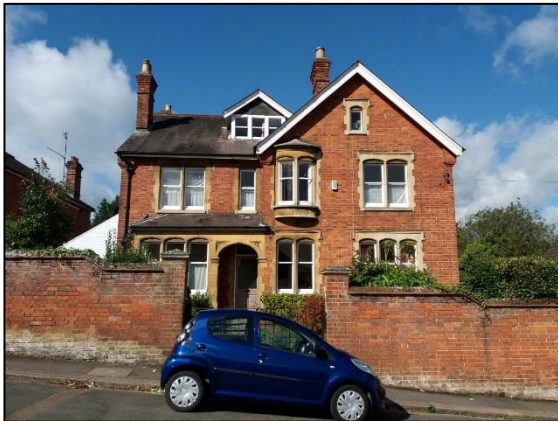
**Photograph 1:** Eastern elevation

- 3.3 No evidence of roosting bats was recorded during the external building inspection.
- 3.4 No suitable roosting features or access points for bats were recorded during the external building inspection. The dormer windows were in good condition and well-sealed, the roof was well sealed with no gaps recorded between tiles or in the mortar. The roof tiles were in place with no lifted tiles and the eaves were sealed with the soffits intact.

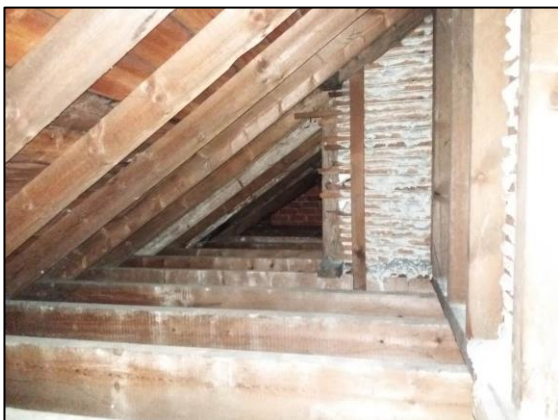
**Photograph 5:** Crawl space at eaves

- 3.5 The loft had previously been converted into living space and only crawl spaces at the eaves remained, used as storage space at the time of survey. The maximum height of these areas was 1 m. The void was draught free and well-sealed due to the presence of sarking boards throughout. Felt underlay was also present on top of the sarking boards.
- 3.6 No bats, bat droppings or any other evidence of bats was recorded during the internal building inspection.
