## **BAT SURVEY AT THE WIRE MILL SOUTHCOTE MILL**

**Prepared for:  
Mr G Puddephatt  
Southcote Mill  
Southcote Farm Lane  
Reading  
RG30 3DZ**

**16<sup>th</sup> September 2015**

**Ref: SPH/PBS-01/04.10**

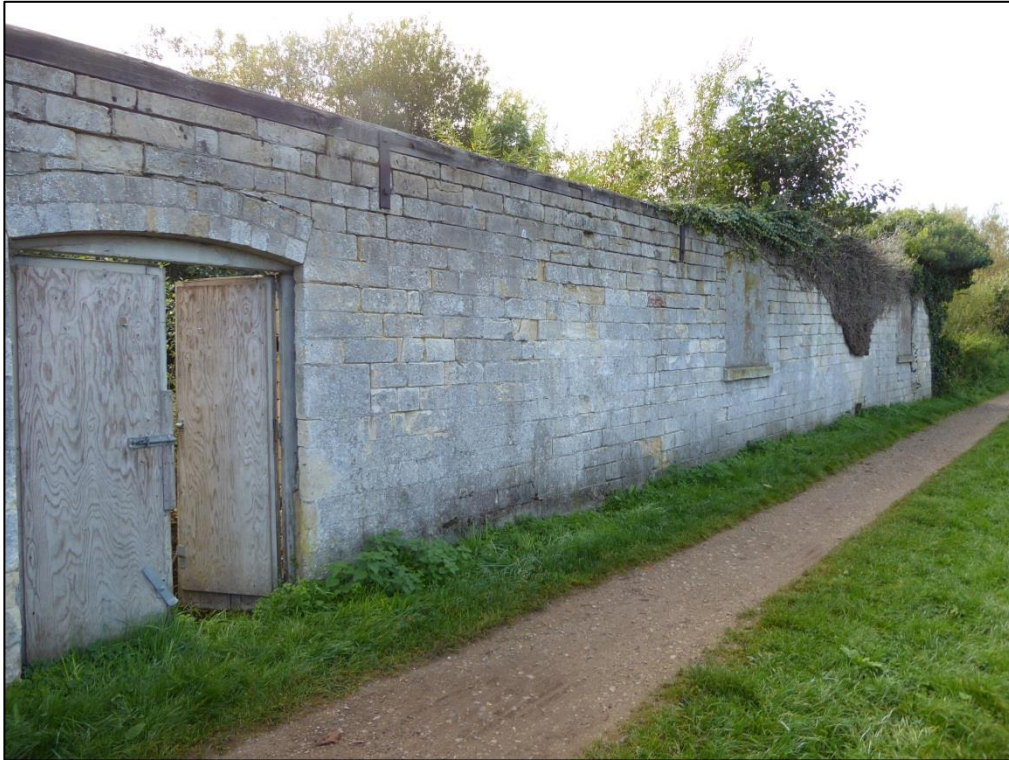
The application site is the former wire mill and is situated on an island opposite Southcote Mill, see Figured 3 and 4.

Figure 3. Exterior of the former wire mill, Southcote Mill. 16.09.15.

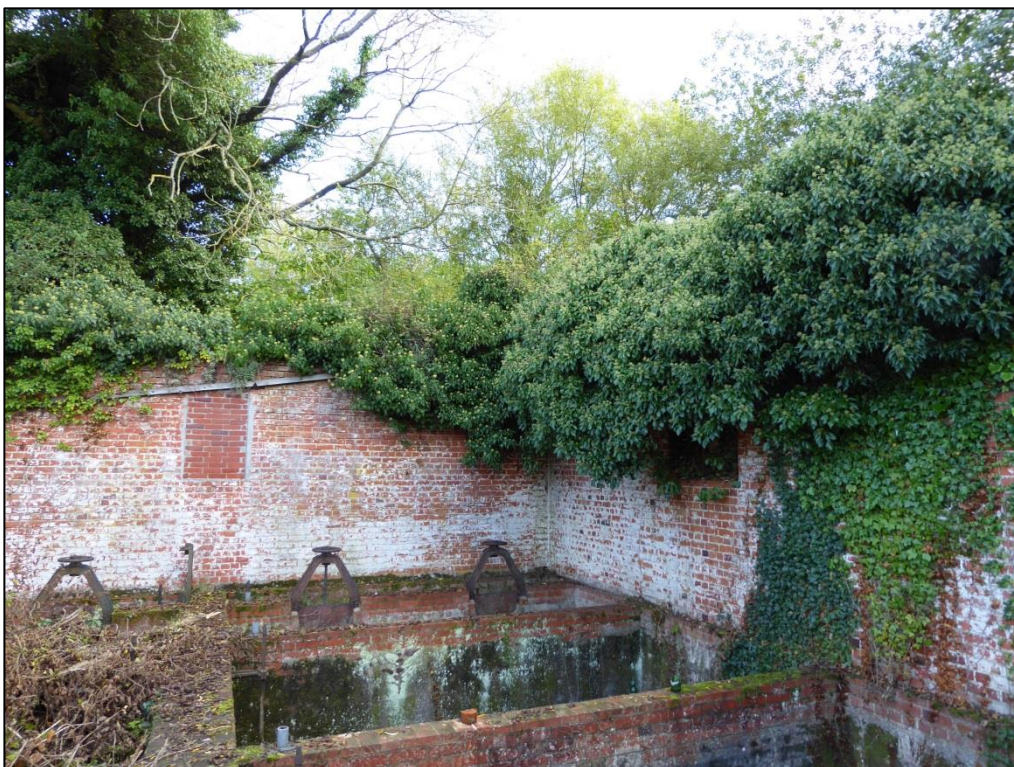
Figure 4. Interior of the former wire mill, Southcote Mill. 16.09.15.

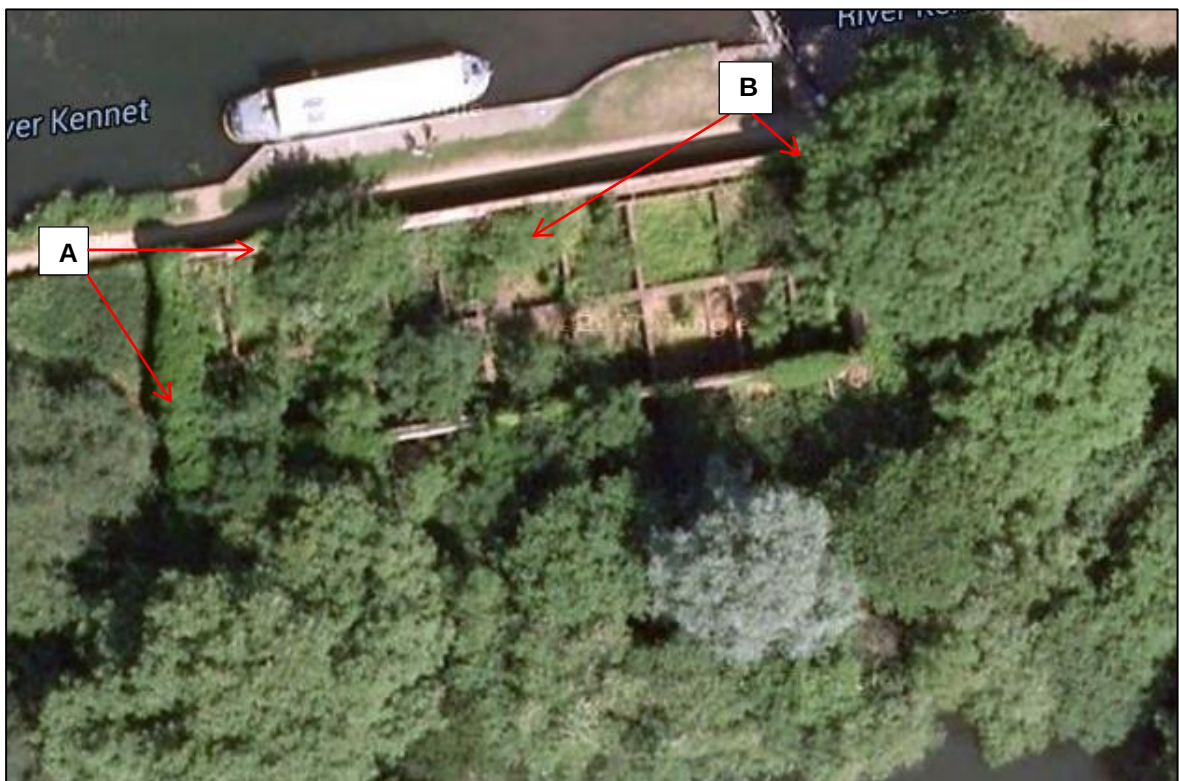
The surveyors were stationed as indicated in Figure 5, to ensure that possible emergence areas (areas of concern) could be observed.

Figure 5 – The wire mill, Southcote Mill. Surveyor locations during the emergence survey.

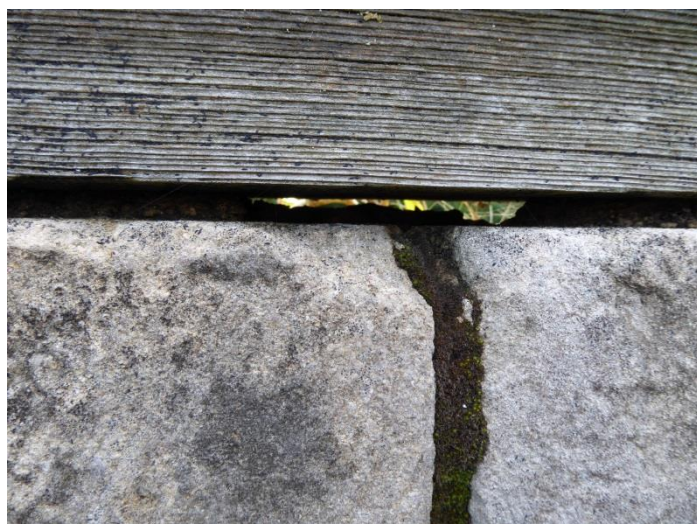
The property inspected is of a red brick construction with external a stone facade. There was no roof. Aside from the ivy other features which may provide roosting features for crevice dwelling species included missing mortar and gaps where the timber wall plate rests on the walls, see Figure 6.

Figure 6. The wire mill, Southcote Mill, timber frame on top of walls. 16.09.15.

During the external survey no sign of historic bat use was found.

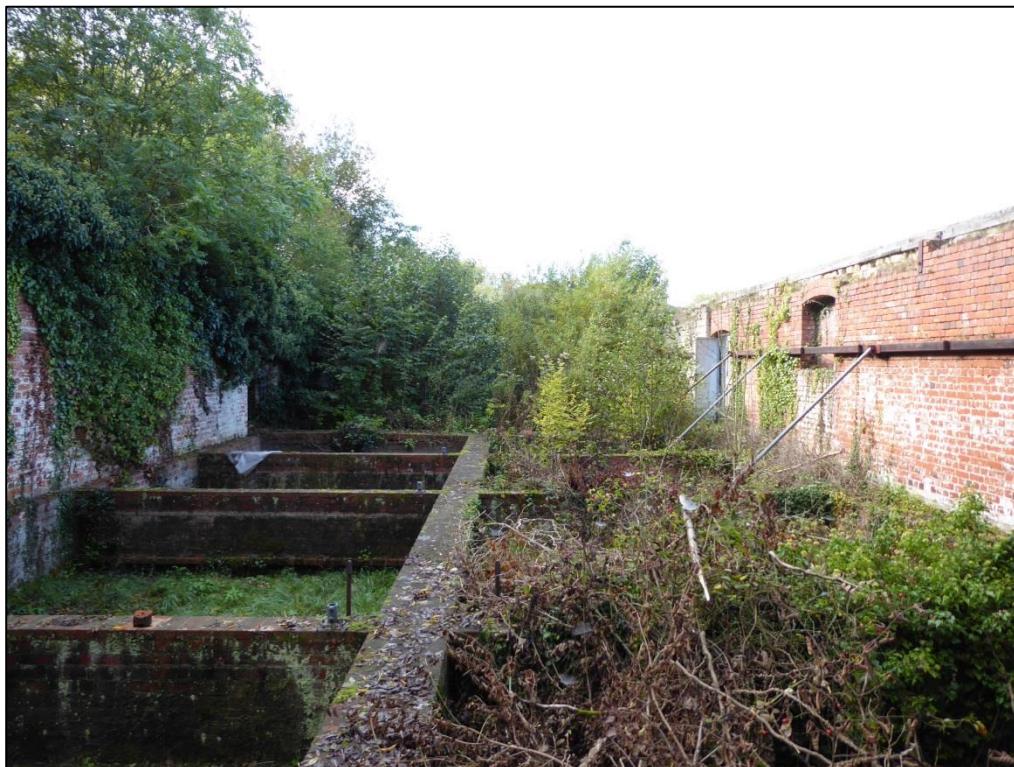
An internal inspection of the building was carried out, see Figure 7.

Figure 7. Interior of the wire mill, Southcote Mill. 16.09.15.

The interior was inspected with close focusing binoculars and a thermal scope, all visible areas of the brick work were inspected and no signs of bats were observed.

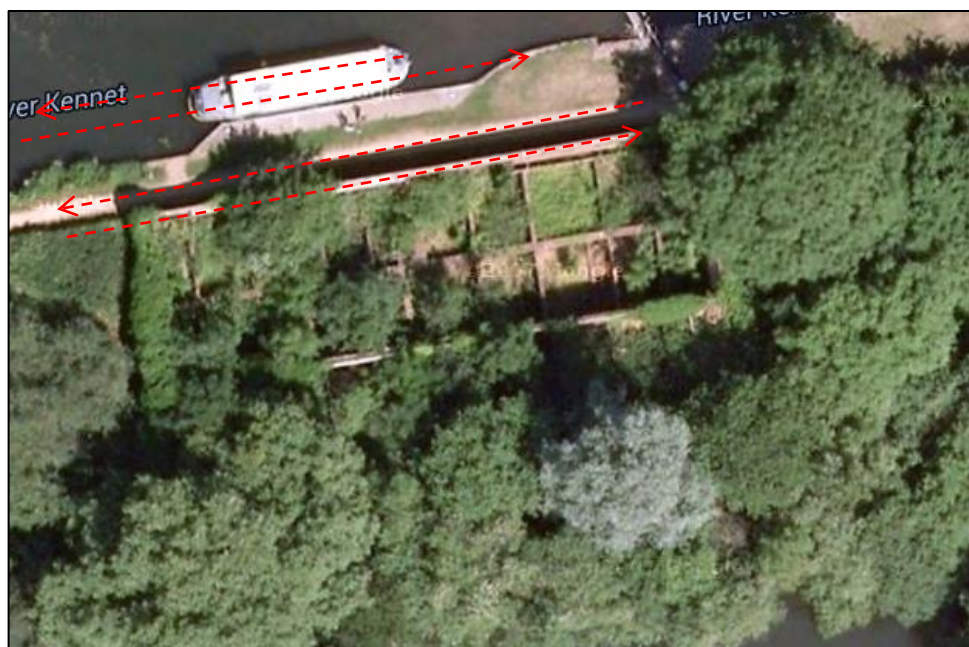
During the dusk survey no bats were seen emerging from or returning to the building to roost. In total three different species were recorded foraging within the vicinity of the building and commuting across the site. Bat passes were good around the site, however most activity was centred approximately 100 metres west along the canal, a simple summary of the bats recorded can be seen in Table 2 on the next page and the most frequently used flight paths are shown in Figure 8 on the next page.

**Figure 8.** Commonly used bat flight paths at the wire mill, Southcote Mill. 04.10.15.
