**THE PROPOSED HEIGHTS PRIMARY SCHOOL  
MAPLEDURHAM PLAYING FIELDS, UPPER WOODCOTE ROAD, READING  
RG4 7LH**

**PHASE 1 PRELIMINARY RISK ASSESSMENT AND PHASE 2  
ENVIRONMENTAL AND GEOTECHNICAL SITE INVESTIGATION REPORT**

**Our Ref:** HLEI48086/001R

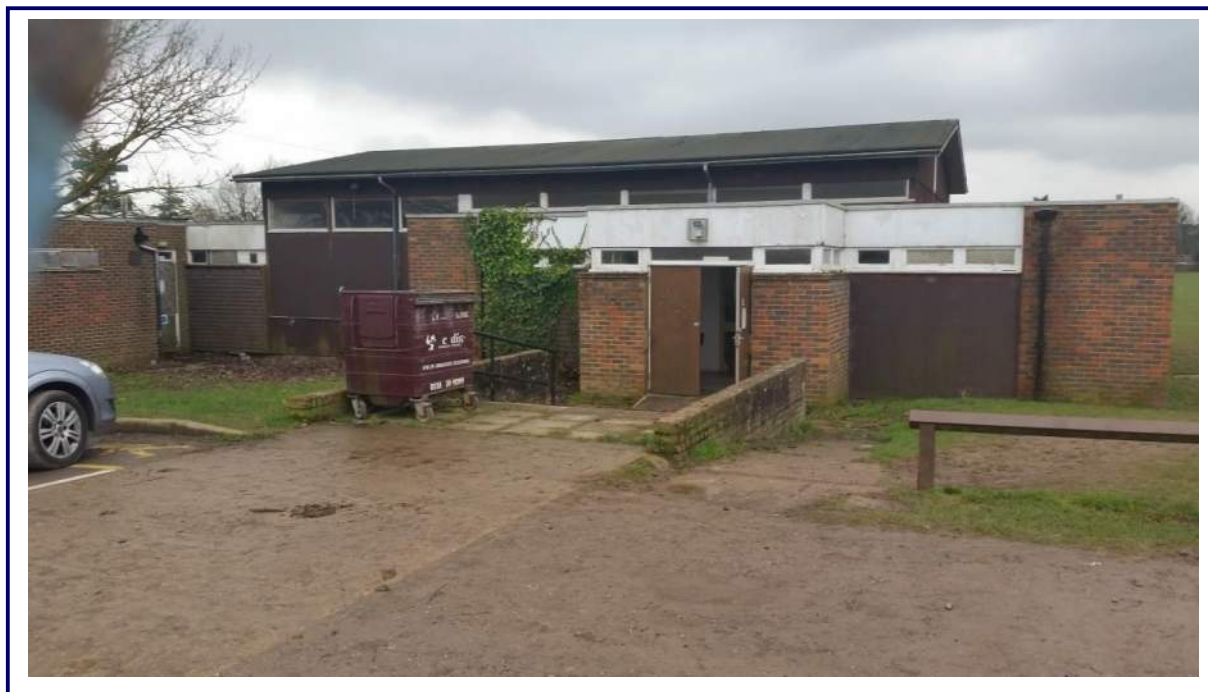
*General view of the site (facing west). Further Photos are included within Appendix B.*
