**Bat Survey Report**

**21 Hawthorne Road**

| <b>Document ref:</b> | ARB645 21 Hawthorne Road Bat Survey Report |

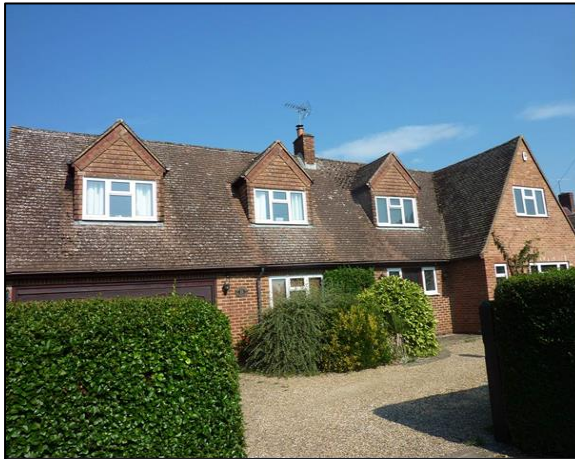
**Photograph 1:** Front of house, south facing.

- 3.1 The building is a double storey residential dwelling with a rear north facing elevation clad with hanging tiles. The roof is pitched, cross-gabled and clad with clay tiles with roof dormer windows to the front and back of the house (see Photographs 1 and 2 in Appendix 2). A roof void spans the length of the building and is obstructed in places by water tanks and chimney stacks. At its apex, the roof void measures approximately 1 m in height and is of simple timber frame construction with tie-beams and struts supporting purlins and rafters with a bitumen underlay.

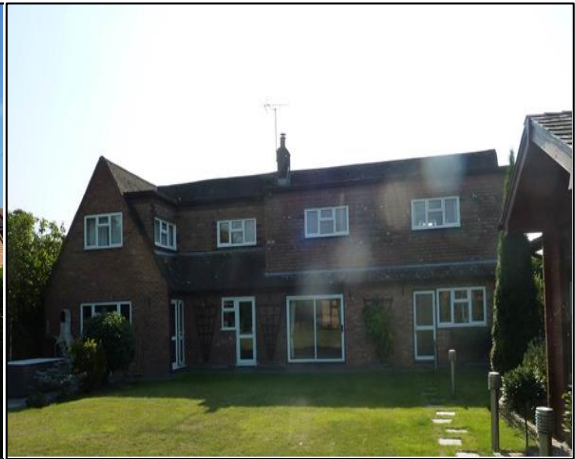
**Photograph 2:** The rear of the house, north facing.

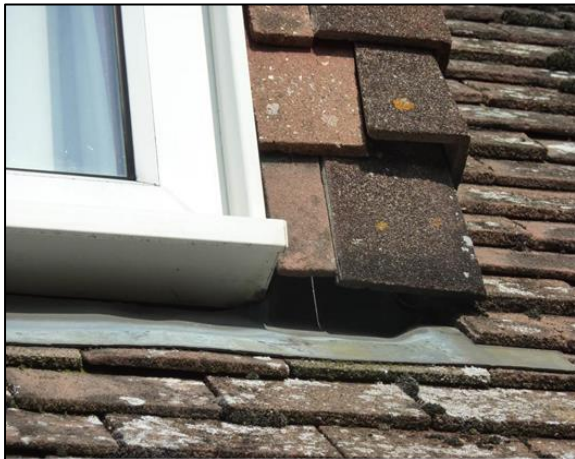
- 3.2 Only a low number of structural features with the suitability to support roosting bats were recorded during the external inspection. The features included gaps beneath the hanging tiles on the rear elevation to the north of the property, small gaps underneath roof tiles where mortar was missing at the north-east gable end and lifted tiles in some areas of the rear north-facing valley meeting points (see Photographs 3-5 in Appendix 2).
- 3.3 A low number of bat droppings (<50) were recorded on the lead flashing beneath a roof dormer window on the rear elevation (see Photograph 6). A sample of the droppings were sent to the University of Warwick for DNA analysis and were confirmed as being from a common pipistrelle bat *Pipistrellus pipistrellus* (see Appendix 3).

**Photograph 3:** Gaps beneath hanging tiles around the roof of the property.

- 6.2 Common pipistrelle bats are known to frequently roost within newer buildings behind hanging tiles, between roofing felt and roof tiles and behind soffit and barge and eaves boarding (Bat Conservation Trust, 2010). Therefore, it is recommended that any new areas of roof / hanging tiles where new bat roost features are installed are lined with 'bat-friendly' Monartile 1F bituminous roofing underlay.

- 6.4 Suitable access/egress points will need to be incorporated into the roof to allow bats to enter/exit the roost. These could comprise bat access roof and/or ridge tiles to allow crevice dwelling bats to gain access to spaces between the roof tiles and the roof lining.

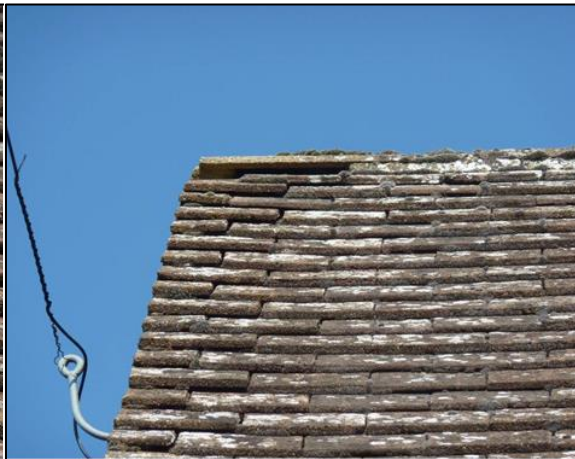
**Photograph 4:** Gaps within the mortar of the ridge at the gable end to the west of the property.

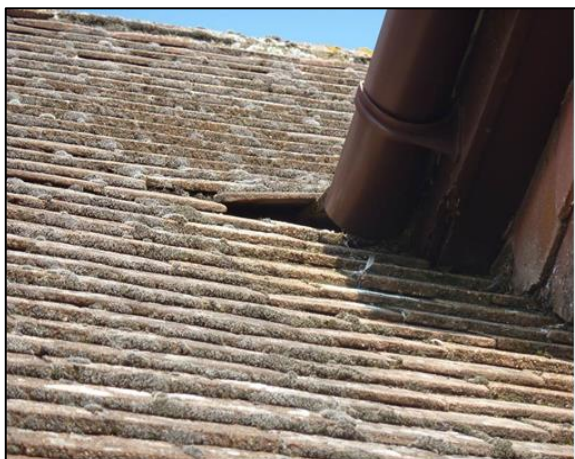
**Photograph 5:** Gaps between hanging tiles by the valley meeting point to the rear of the north facing property.

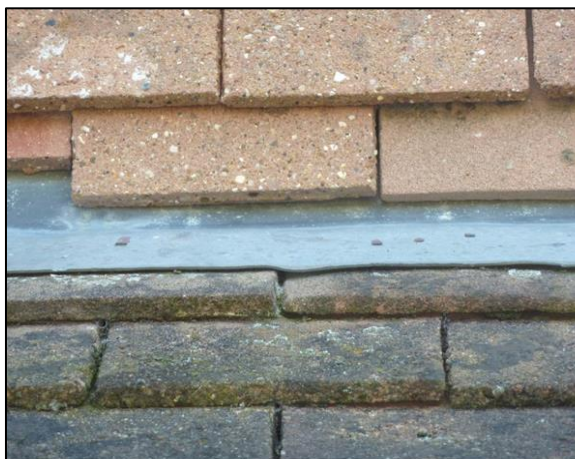
- 4.2 The bat building assessment recorded droppings deposited by a common pipistrelle bat externally beneath the rear roof dormer window to the north of the property and a small number of external structural features suitable to support roosting bats.

**Photograph 6:** Droppings recorded on the lead flashing beneath a roof dormer window on the rear elevation.

- Ensuring that any works to the roof of the building are done by hand under the direct supervision of a licensed bat ecologist with any tiles/slates carefully removed, turned over and checked for bats prior to disposal;

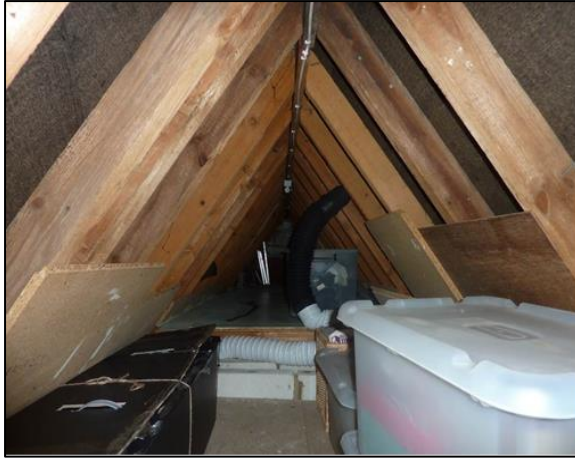
- 3.4 The roof internally had no obvious structural features suitable for roosting bats and no droppings were found. The bitumen underlay was in good condition and the loft was draught free with no discernible obvious access/egress points (see Photograph 7 in Appendix 2).

**Photograph 7:** Internal roof void.
