**Report reference**  
17-229.01

**Prepared by**  
Aviron Associates Limited

| <b>Project Name</b> | 12 Shaftesbury Road, Reading, RG30 2QP | | |
| <b>Project Title</b> | Phase I Geo-Environmental Risk Assessment | | |

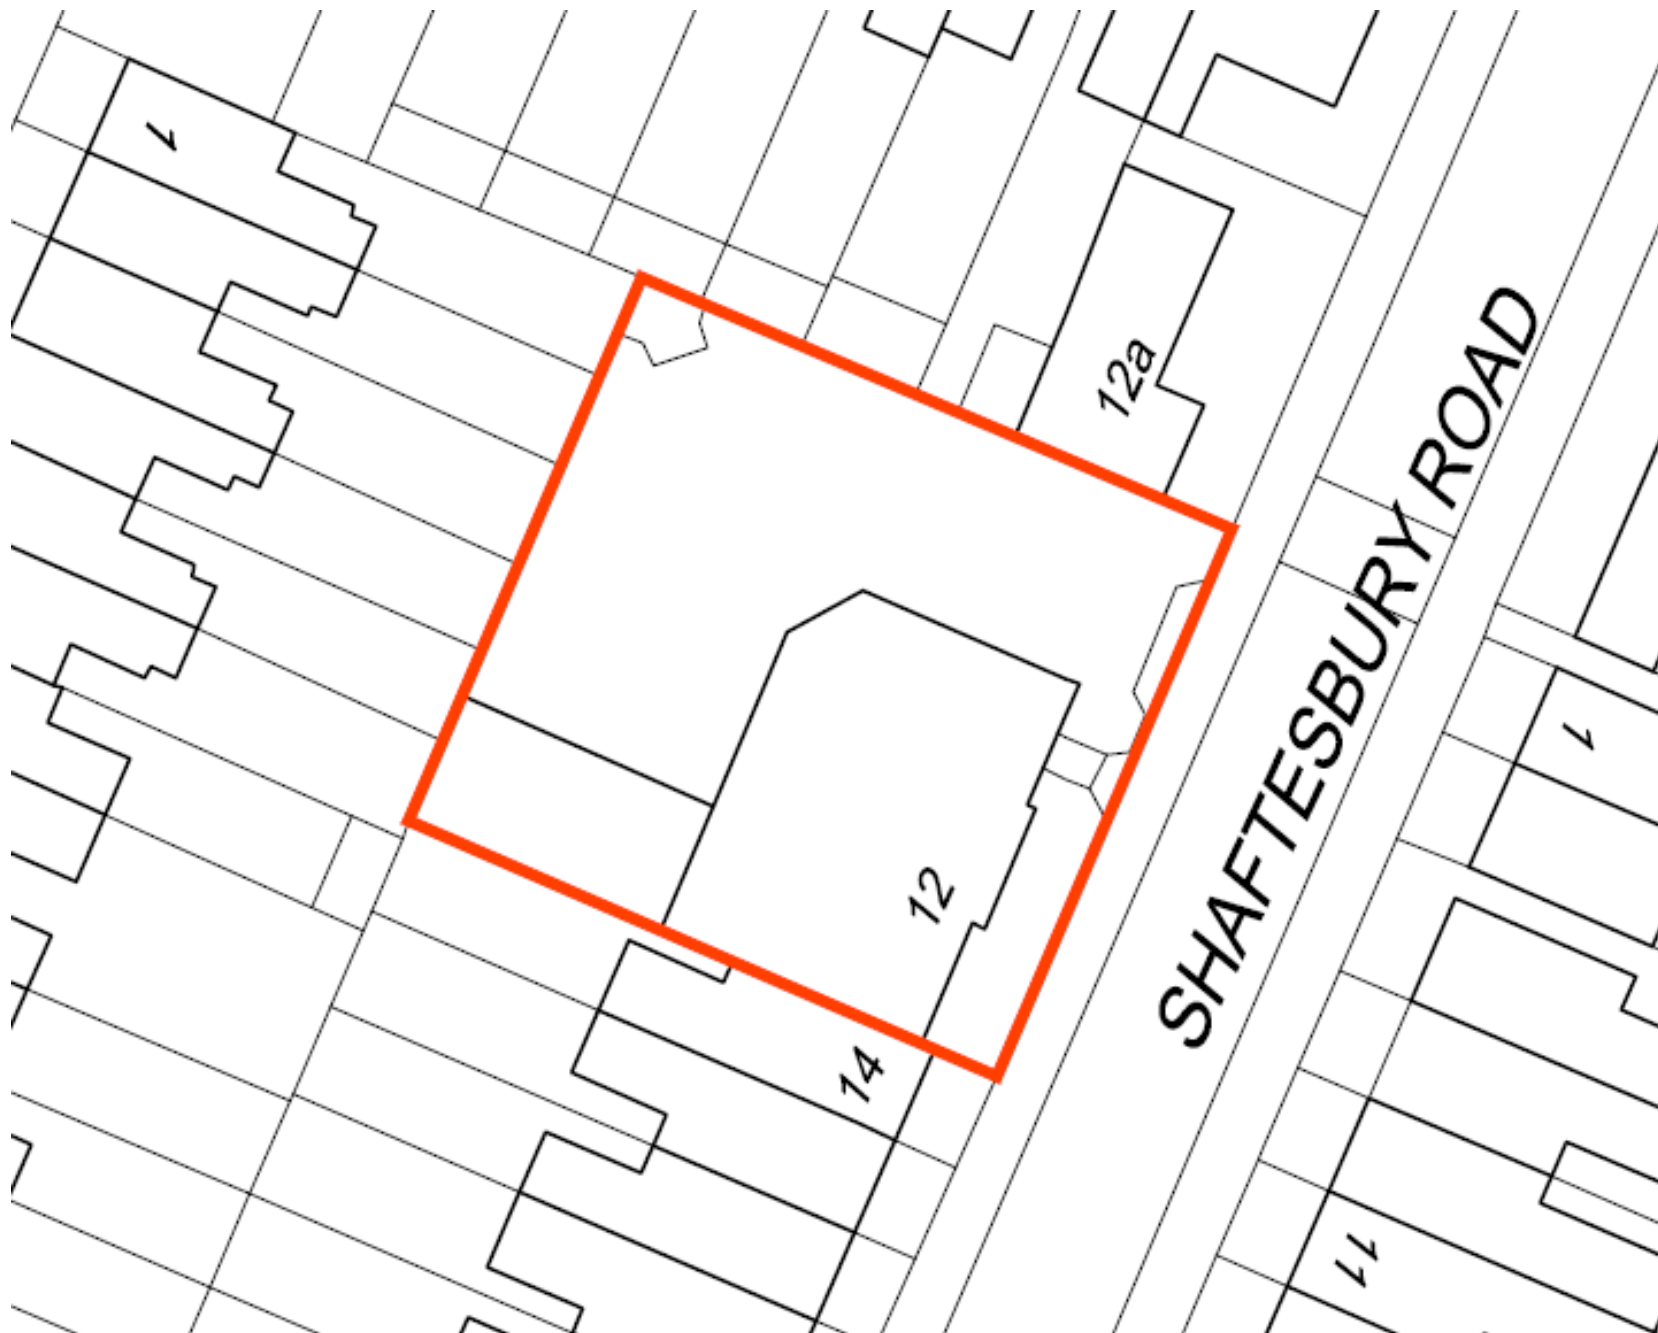
| <b>Site Location</b> | The site is located on Shaftesbury Road within a predominantly residential area of Reading, approximately 130 metres (m) to the north-west of Reading West railway station.<br><br><b>Figure 1</b> is presented as a Site Location Plan. |
| <b>Current Land Use</b> | The site comprises number 12 Shaftesbury Road, a single storey building most recently in use as the County School of Performing Arts, with a single storey workshop to the rear. Presently the site is vacant and being used as parking for the re-development of the adjacent property, no. 12A.<br><br><b>Figure 1</b> is presented as an existing Site Layout Plan. |

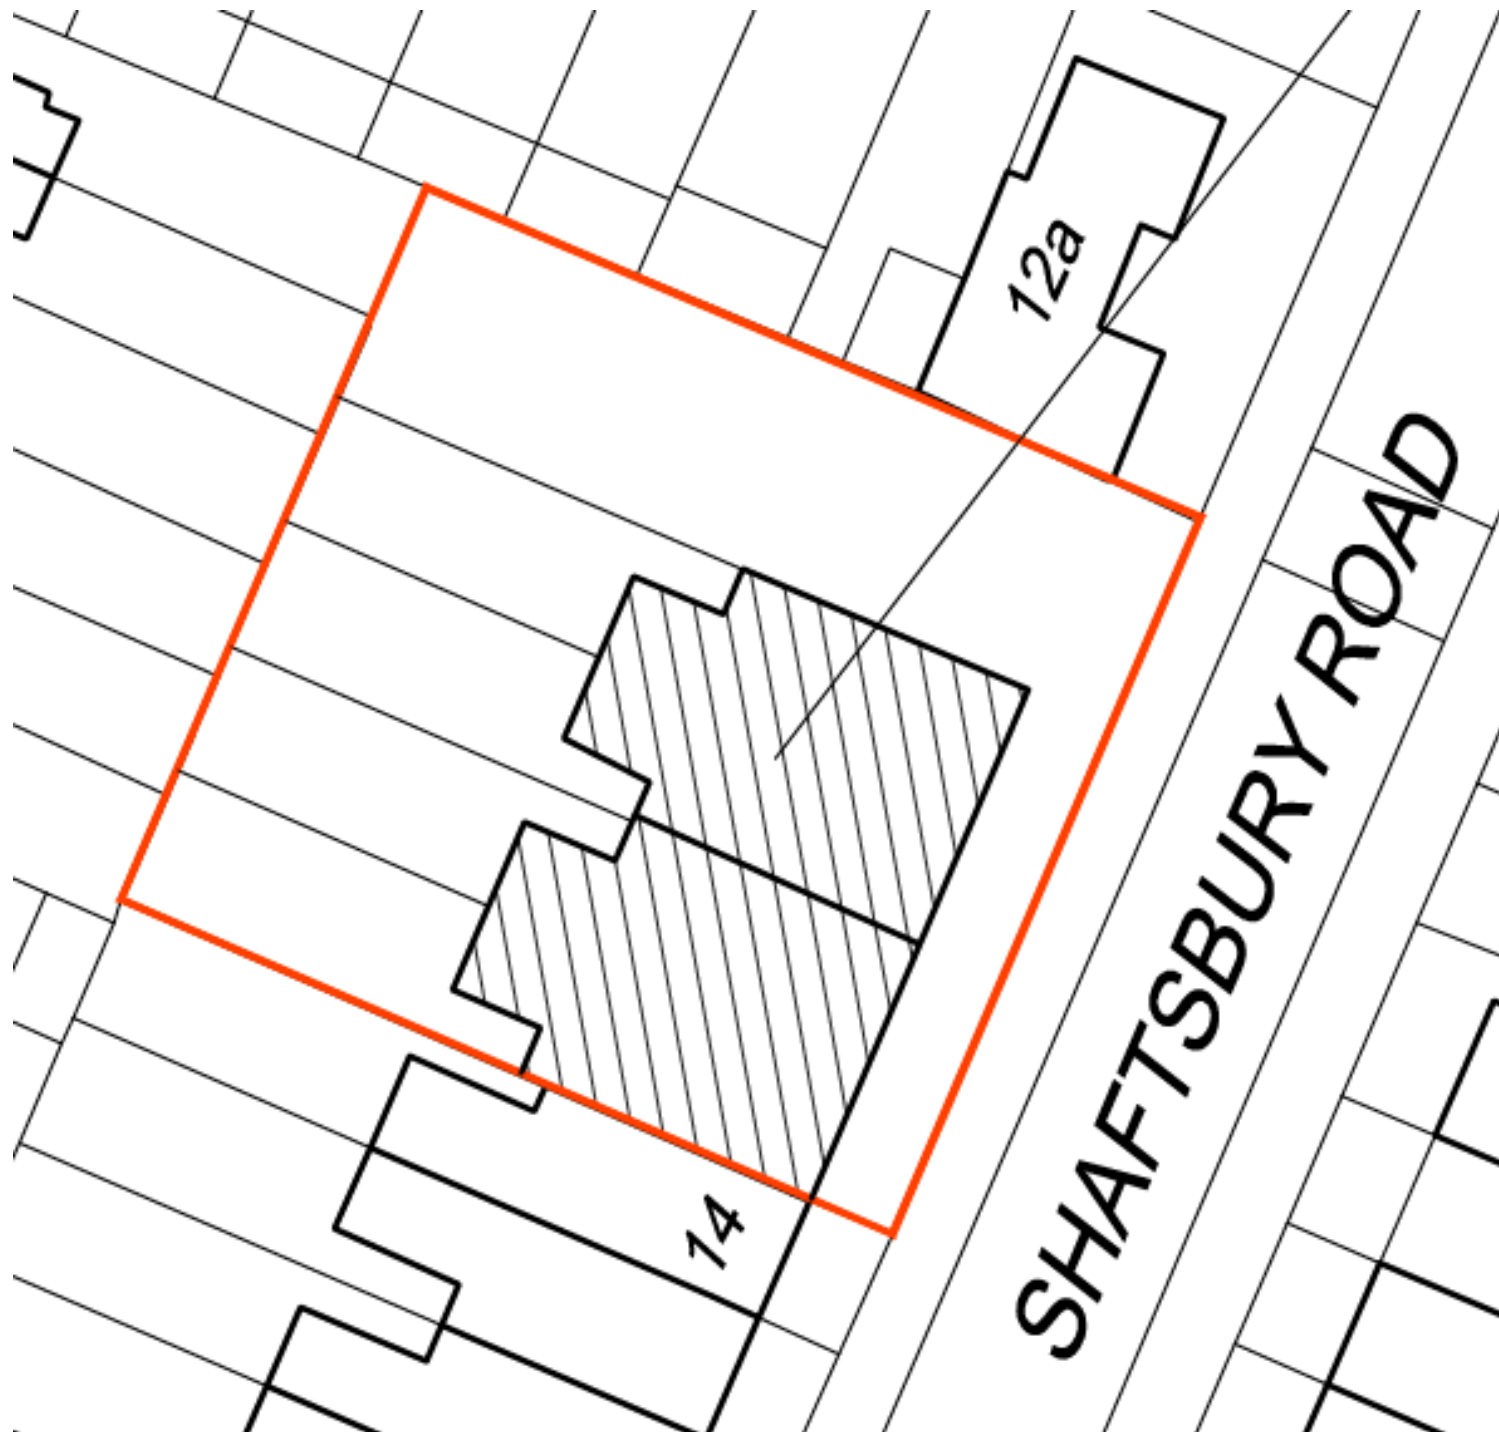
| <b>Proposed Land Use</b> | The proposed development comprises the demolition of the existing buildings and the construction of four new residential dwellings with associated car parking and rear gardens.<br><br><b>Figure 2</b> is presented as a Proposed Development Plan. |

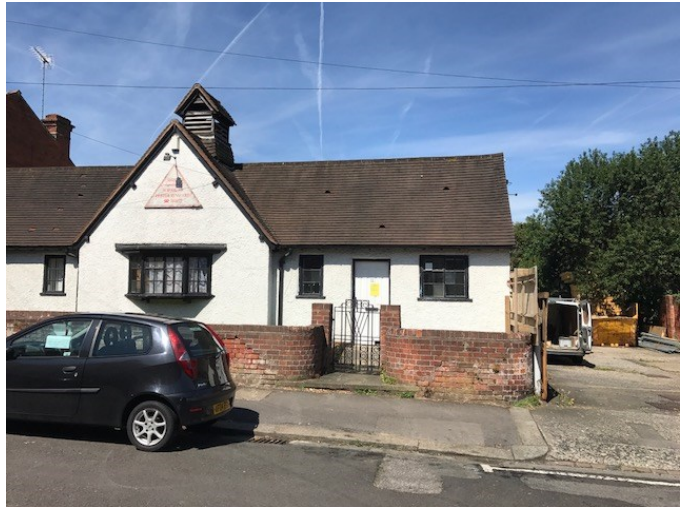
Photo 2  
No. 12 Shaftsbury Road

| Physical Site Characteristics | |
|---|---|
| <b>Existing Structures</b> | Main building comprising a single storey rendered building, with a pitched clay tile roof.<br><br>Workshop to the rear comprising a single storey painted building with corrugated sheet roofing. |

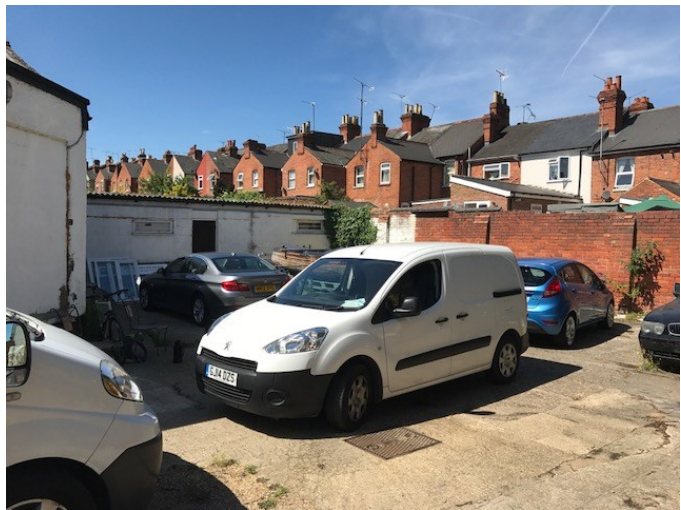
Photo 4  
Rear yard area

| Physical Site Characteristics | |
|---|---|
| <b>Visual Topography and Site Surfacing</b> | The site is slightly sloping to the north and entirely hard surfaced with concrete. A ramp and retaining wall is noted between the school of performing arts and the workshop to the rear. |

| <b>Surface Staining</b> | No surface staining was observed. The workshop has a 'clean' painted floor. |
